Technical Service Bulletin

RATTLE / KNOCK NOISE FROM FRONT DISC BRAKE CALIPER

Bulletin No.: 04-005/19

Last Issued: 09/24/2019

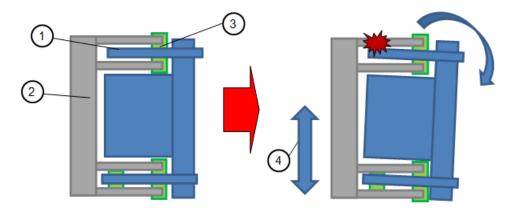
This is caused by the slide pin (1) hitting the mounting support (2) due to insufficient holding power of the dust boots (3) when a shock (4) is applied from the road. To eliminate this concern, the dust boots have been modified to increase holding power.

Customers having this concern should have their vehicle repaired using the following repair procedure.

- 1. Verify the customer concern.
- 2. Replace the dust boots on **both sides** with modified ones according to the instructions on MGSS. **NOTE:** Reuse the lower slide pin bushing (1).
