## Product Update: Display Audio Clock Off by 1 Hour

Supersedes 19-050, dated August 28, 2019, to revise the information highlighted in **yellow**.

Year	Model	Trim	VIN Range
2019-20	RDX	ALL	Check the iN VIN status for eligibility.

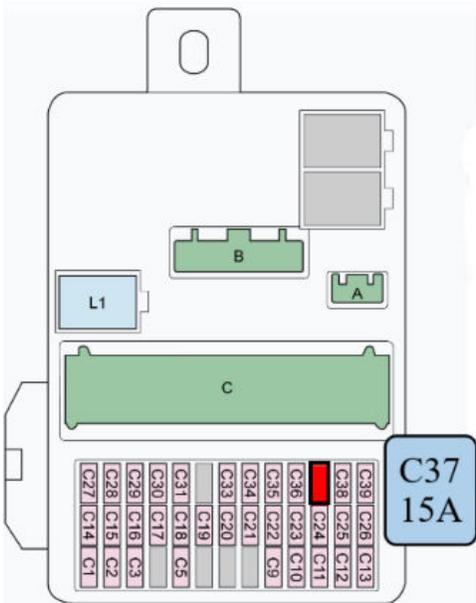
If this step is skipped or not correctly done, the client will still experience the issue.

- If **D.1.1.4** or higher is displayed, go to step 6.
  - If **D.1.1.4** or higher is not displayed, contact Tech Line.
6. **Turn the vehicle OFF and** pull the 15 amp B+ radio fuse from the under-dash fuse box for **10 minutes** to clear the data from the audio unit.
