Thor Motor Coach Technical Service Bulletin

TSB #	TSB 19-02		
Description/Title:	Wi-Fi Power Not Connected		
Affected Product Line(s):	Certain 2020 Model Year Hurricane and Windsport motorhomes		
Service Campaign # :	RC000174	Released Date:	9/20/2019
Repair Codes:	Repair: TMCTS80255W	Document Date:	9/20/2019
Time Allowed:	Repair: 0.5	Document Revision:	A

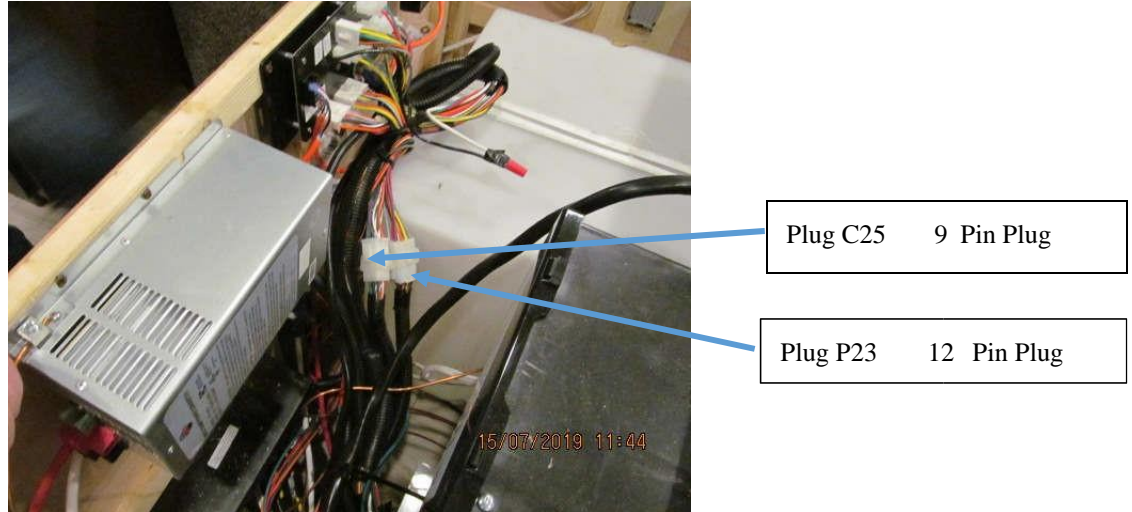
Figure 2

Wi-Fi Power unable to function, as chassis harness is not connected to breaker panel harness

3. Locate the chassis harness plug P23 and C25 they are right behind the load center (Figure 2).

4. Verify that the 18GA orange wire in the plug P23 position 12 is present. If the plug socket 12 is empty, no further action is needed. Proceed to Step 8.
5. If the 18GA orange wire is present, use a pin extractor tool to remove wire from P23 position 12 and insert into C25 position 9.
6. Plug C25 back together to P25.
7. Wi-Fi should now have power. You can test on a browser to verify.
8. Install bed platform and reinstall the removed screws.
9. Reinstall mattress on bed platform.
