## TECHNICAL SERVICE BULLETIN

### 4-Wheel Drive (4WD) - Sustained Steering Wheel Oscillation - Above 72 Km/h (45 Mph)

**19-  
2274**  
10  
September  
2019

<b>Ford</b> 2017-2019 F-Super Duty
---------------------------------------

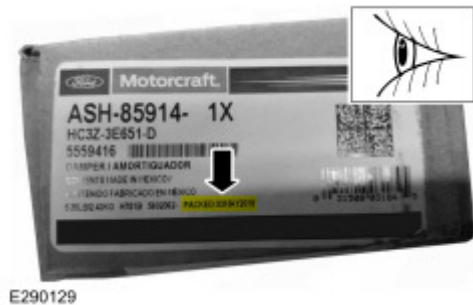
Figure 1

1. Is the customer complaint that the vehicle exhibits a sustained steering wheel oscillation after hitting rough pavement or an expansion joint at speeds above 72 Km/h (45 mph)?
  - (1). Yes - proceed to Step 2.
  - (2). No - this article does not apply. Refer to Workshop Manual (WSM), Section 204-00 for diagnosis.
2. Check and adjust the tire pressure as indicated on the driver's door placard.
3. Obtain a new steering linkage damper. Check the steering linkage damper package date code (Figure 1). Does the package date code indicate a package date on or after 01-May-2018?
  - (1). Yes - replace the steering linkage damper. Refer to WSM Section 211-03.
  - (2). No - repeat Step 3 until a new steering linkage damper is received with a package date code on or after 01-May-2018.
