## TECHNICAL SERVICE BULLETIN

### 2019 Continental/Edge/Nautilus/F-150/Fusion/MKZ/Mustang/Ranger - Infotainment Screen Concerns, Wi-Fi Connection Message, Rear View Camera Operation

**19-  
2282**  
16  
September  
2019

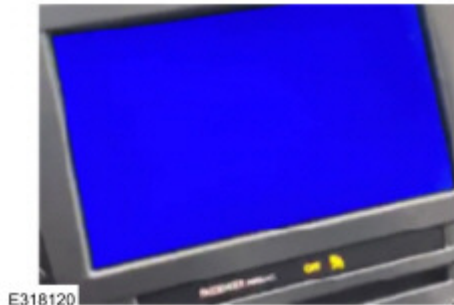
Figure 1

- 2019 Continental/Edge/Nautilus/F-150/Fusion/MKZ/Mustang/Ranger
- Equipped with SYNC 3
- At least one of the following infotainment conditions:
  - Wi-Fi connection message pop up every key cycle
  - frozen unresponsive touch screen
  - solid blue screen when moving forward at speeds above 16 kph (10 mph) (Figure 1)
  - the rear view camera remains on the screen at speeds below 16 kph (10 mph) (Figure 2)
  - poor/no App Link function

1. Run the vehicle in OASIS and select the SYNC page. Is a yellow notice banner present at the top of the page stating the vehicle is at the latest SYNC level?
  - (1). Yes - this article does not apply. Refer to Workshop Manual (WSM), Section 415-00 for normal diagnostics.
  - (2). No - proceed to Step 2.
2. Reprogram the APIM using the latest software level of the appropriate Ford diagnostic scan tool. Refer to WSM, Section 415-00. Follow the onscreen instructions provided by the standard programming process. Proceed to Step 3.
3. To fully complete programming, turn the key off with the door open for 5 minutes. Upon the next key cycle the SYNC 3 screen should indicate that an update was successful.
