Repair Notice

16-041

Suspension - 16

Certain drive axle U-bolts and brackets installed on Flex Air Suspensions in 6X2 drive configurations may fail prematurely

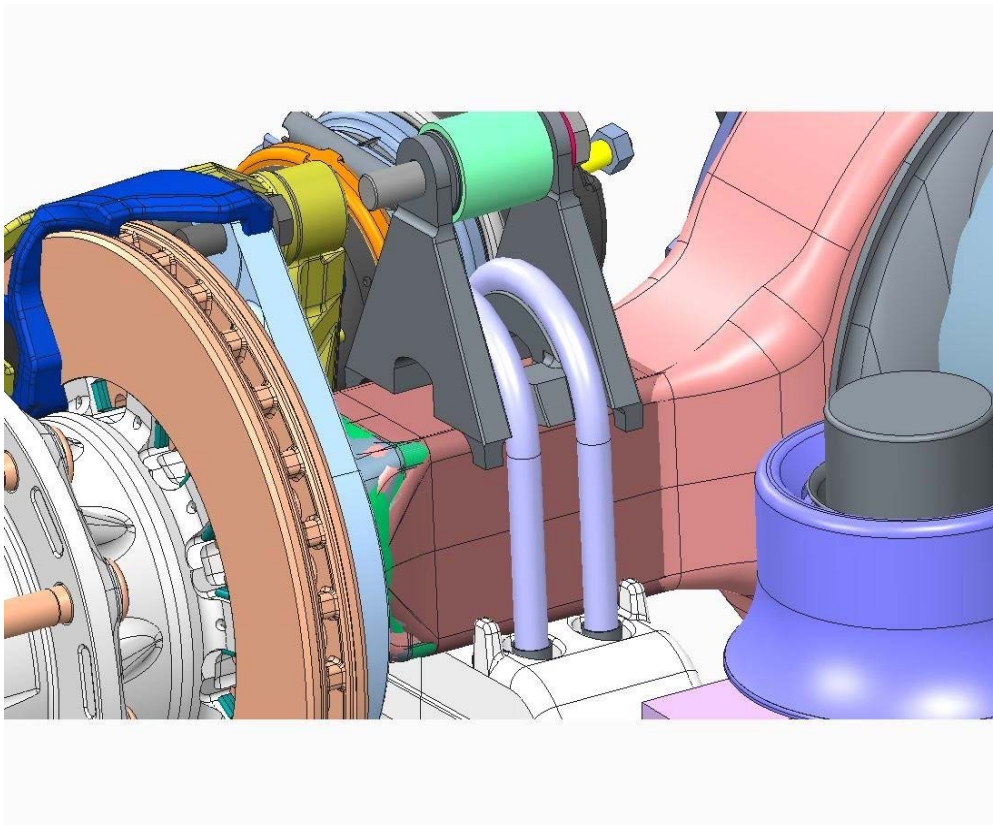
Peterbilt has determined that certain Model 365, 384, 386, 388, 389, 3895, 587 and 579 vehicles built between March 27, 2012 and January 20, 2019 with Flex Air suspension in a 6x2 configuration have U-bolts that may fail prematurely.

Below is an image of the new U-Bolt and bracket that will replace the old style U-bolt and bracket.

- Remove and replace the U-Bolts and U-bolt brackets on both ends of the axle.
- Torque the U-Bolts to 325-375 lb-ft
- Replace the radius rod bolt and hardware which attaches through the new bracket
- Torque the radius rod bolt to 380-460 lb-ft.
- Perform an alignment to the vehicle
