## Service Bulletin

**26-034**

Eaton Endurant / PACCAR AMT Fluid Pressure Sensor Clearance

9/13/2019

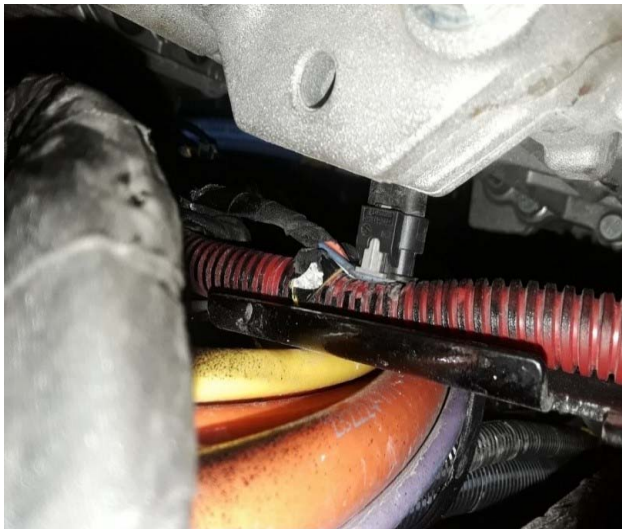
Figure 1

Certain model 579 and 567 vehicles equipped with Eaton Endurant or PACCAR AMT transmissions, built between 5/01/2017 and [4/07/2019](#), may have a fluid pressure sensor rubbing or experiencing hard interference with routing brackets, power cables, wiring harnesses, or air lines in the driver's side frame rail.

1. Inspect for clearance between the transmission fluid pressure sensor and the chassis bundle and surrounding routing brackets.
2. If a rub exists (example in Figure 1), disconnect the harness from the sensor.

If a customer comes into your dealership and demonstrates any of the conditions above, inspect the transmission pressure sensor area and confirm clearance to the surrounding routings. If there is interference or a hard rub, add the 90-degree fitting to achieve the necessary clearance.
