| <b>Tesla, Inc.</b><br><b>Service Bulletin</b> | | <h1>Remove Gap Hiding Seals</h1> | |
| <b>SB-19-11-005</b><br>September 12,<br>2019 | <b>R1</b> | | |
| 2018 - 2019 | Model X | All | All |

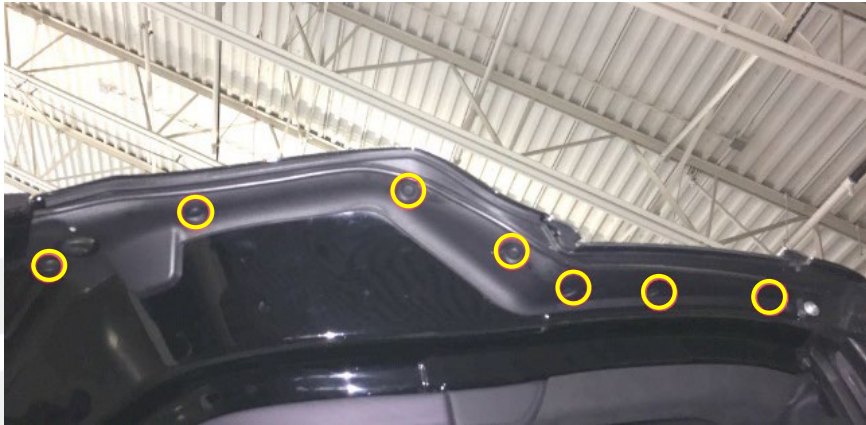
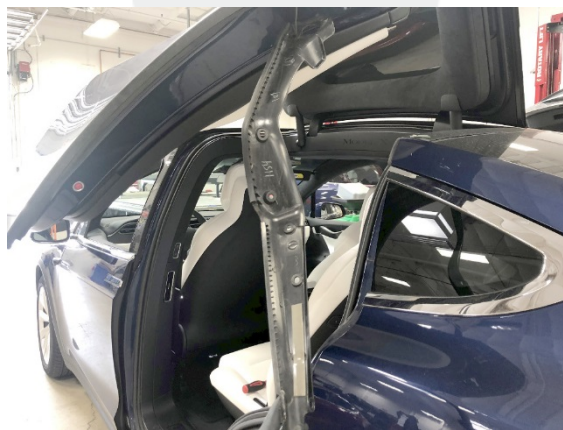
**Figure 1**

For some Model X vehicles, the rear door pinch sensor carrier has a gap hiding seal that applies force to the rear door exterior jamb, which might cause paint issues.

1. Partially open the LH rear door to a comfortable working height.
2. Remove the clips (x7) that attach the LH pinch sensor carrier to the trailing edge of the LH rear door (Figure 1), and allow the carrier to gently hang (Figure 2).
