RS19-005

ITB19-024

September 12, 2019

## DTC B00A0-00 STORED

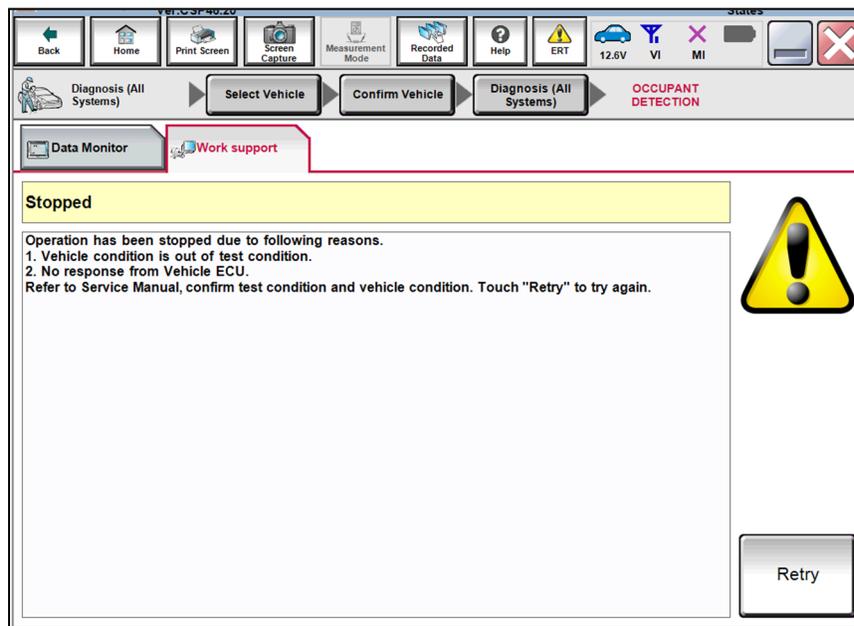
Figure 1

DTC B00A0-00 (OCCUPANT DETECTION SENSOR UNIT) is stored

OCS zero point reset cannot be performed

The following screen will display:

1. Check the Occupant Classification System (OCS) control unit using the ODS Analysis tool software.
  - Refer to **SERVICE PROCEDURE** on the next page.

2. Perform "75-zero RESET".

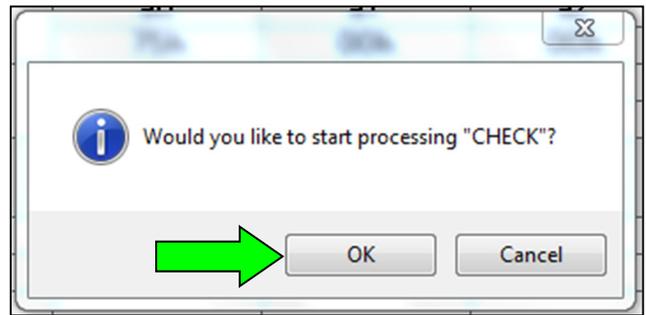
Figure 5

11. Check for code 75h to show under **CURRENT FAILURE CODE**.

- If code 75h shows under **CURRENT FAILURE CODE**, go to step 12.
- If code 75h does NOT show under **CURRENT FAILURE CODE**, STOP HERE.  
This bulletin does not apply. Refer to ASIST and the ESM for further diagnostic assistance.

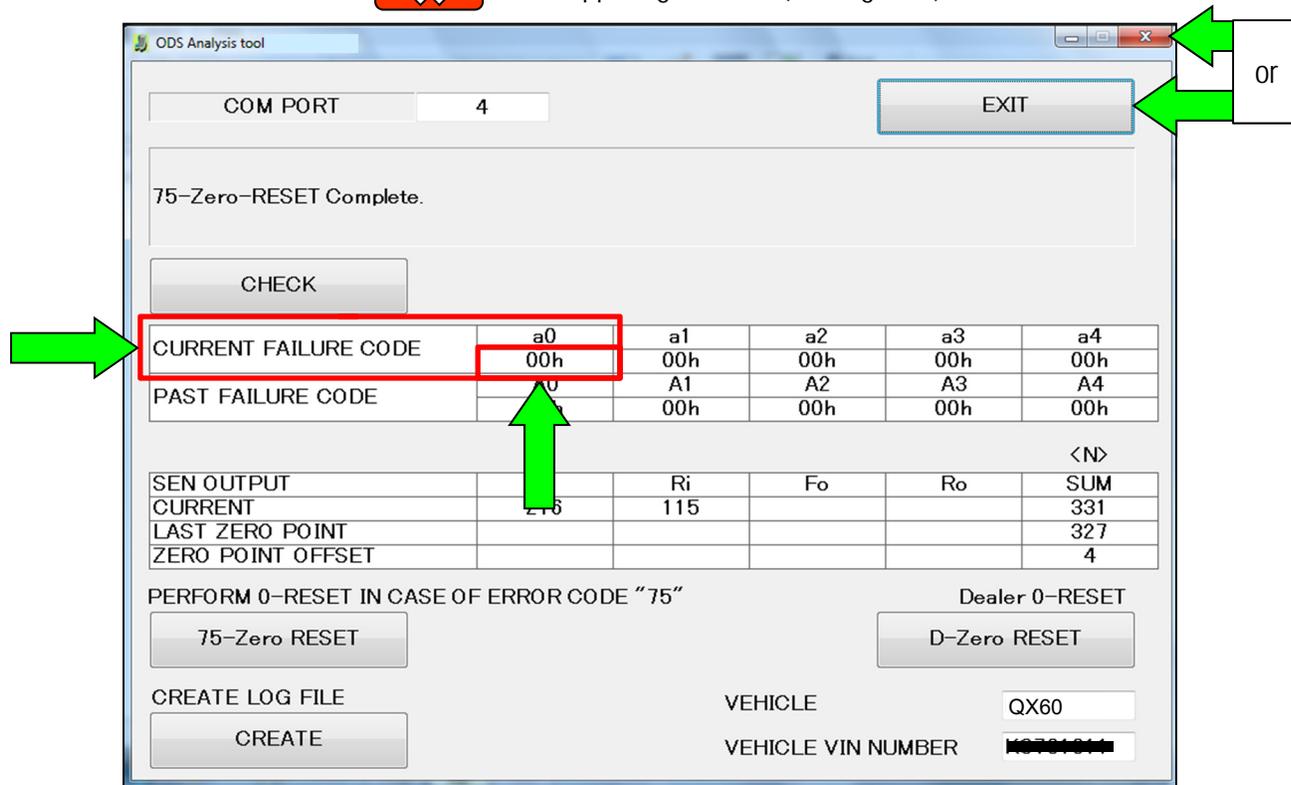
16. When the screen in Figure 9 displays, the 75-zero reset process is complete.
  - Verify code 75h is not displayed under **CURRENT FAILURE CODE**.
17. Select either **EXIT** or the

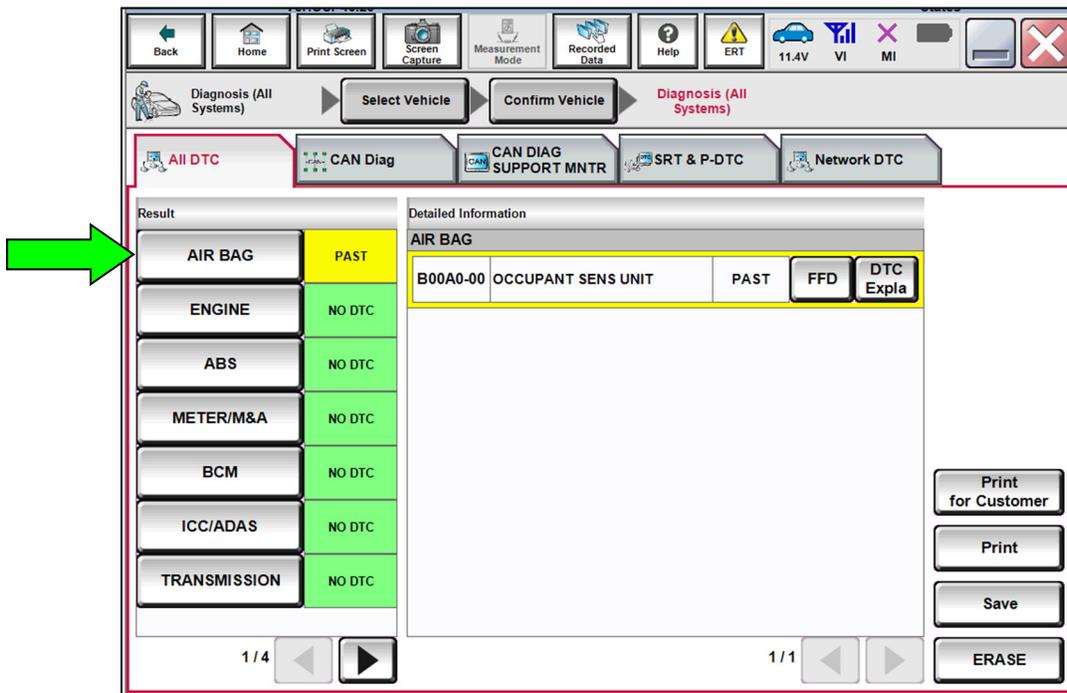
Figure 12

- After selecting **AIR BAG**, B00A0-00 should be the only DTC displaying.

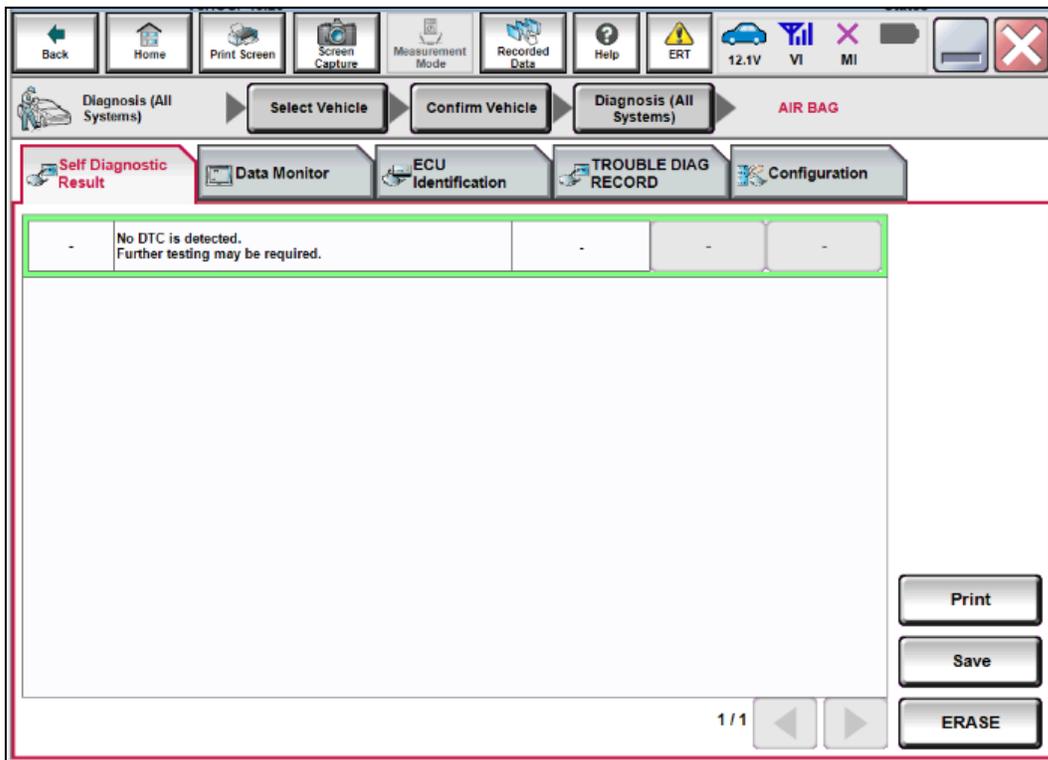
- After selecting **Close**, the screen in Figure 16 should display (the DTC is erased).
