# SERVICE BULLETIN

Classification: EC19-018a	Reference: NTB19-045a	Date: September 19, 2019
------------------------------	--------------------------	-----------------------------

## MIL ON WITH DTC P0087, P0101, P0448, OR P2008

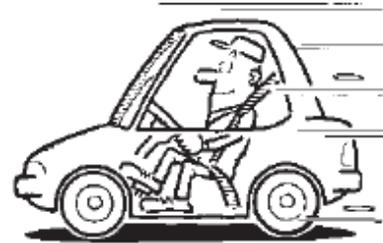
Figure 1

- If you are not familiar with the reprogramming procedure, *click here*. This will link you to the "CONSULT- III plus (C-III plus) ECM Reprogramming" general procedure.
- Take the vehicle for a 10 minute drive in order to meet the following Idle Air Volume Learn (IAVL) conditions:
  - Engine coolant temperature: 70 -100°C (158 -212°F)
  - Battery voltage: More than 12.9V (At idle)
  - Transmission: Warmed up
- After reprogramming is complete, you will be required to perform Throttle Valve Closed Position, Idle Air Volume Learn, Accelerator Closed Position, and DTC erase.
