SERVICE CAMPAIGN BULLETIN

Classification: EL19-016a	Reference: NTB19-064a	Date: September 5, 2019
------------------------------	--------------------------	----------------------------

VOLUNTARY SERVICE CAMPAIGN 2017-2018 ROGUE, ROGUE HYBRID, AND ROGUE SPORT; ICC/ADAS AND LASER/RADAR REPROGRAMMING

CAMPAIGN ID #: P9327
APPLIED VEHICLES: 2017-2018 Rogue (T32)
2017-2018 Rogue Hybrid (T32)
2017-2018 Rogue Sport (J11)

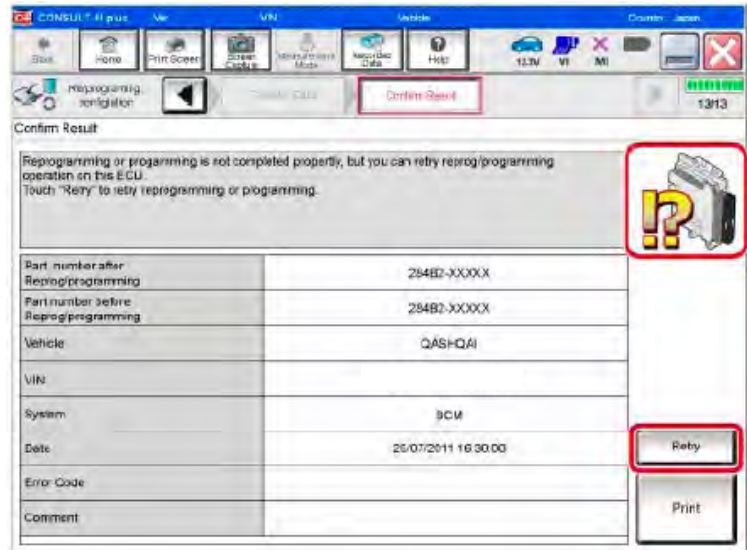
Figure 21

If reprogramming does not complete and the “!?” icon displays as shown in Figure 21:

- Check battery voltage (12.0 - 15.5 V).
- Ignition is ON, engine OFF.
- External Bluetooth® devices are OFF.
- All electrical loads are OFF.
- **Select retry and follow the on screen instructions.**
- **“Retry” may not go through on first attempt and can be selected more than once.**

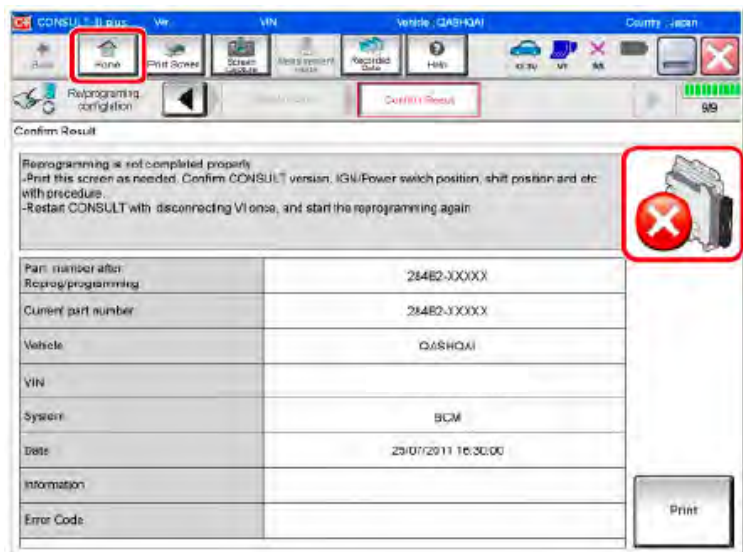
Figure 22

If reprogramming does not complete and the “X” icon displays as shown in Figure 22:

- Check battery voltage (12.0 - 15.5 V).
- CONSULT A/C adapter is plugged in.
- Ignition is ON, engine OFF.
- Transmission is in Park.
- All C-III plus / VI cables are securely connected.
- All C-III plus updates are installed.
- **Select Home, and restart the reprogram procedure from the beginning.**

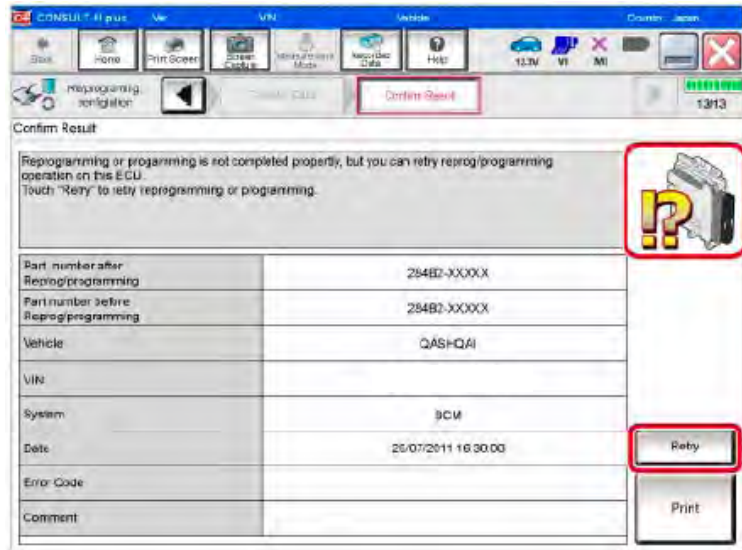
Figure 30

If reprogramming does not complete and the “!?” icon displays as shown in Figure 30:

- Check battery voltage (12.0 - 15.5 V).
- Ignition is ON, engine OFF.
- External Bluetooth® devices are OFF.
- All electrical loads are OFF.
- **Select retry and follow the on screen instructions.**
- “Retry” may not go through on first attempt and can be selected more than once.

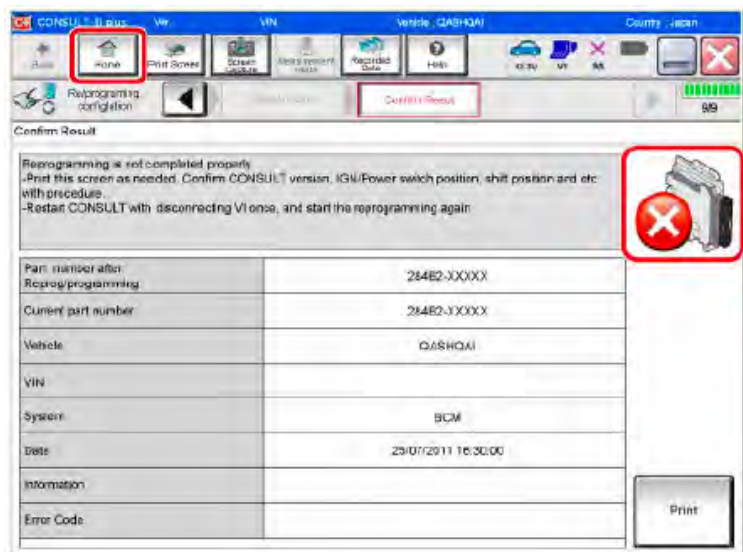
Figure 31

If reprogramming does not complete and the “X” icon displays as shown in Figure 31:

- Check battery voltage (12.0 - 15.5 V).
- CONSULT A/C adapter is plugged in.
- Ignition is ON, engine OFF.
- Transmission is in Park.
- All C-III plus / VI cables are securely connected.
- All C-III plus updates are installed.
- **Select Home, and restart the reprogram procedure from the beginning.**
