SERVICE BULLETIN

BT19-014

RATTLE FROM HEAT SHIELD

APPLIED VEHICLES: 2018 – 2019 Armada (Y62)

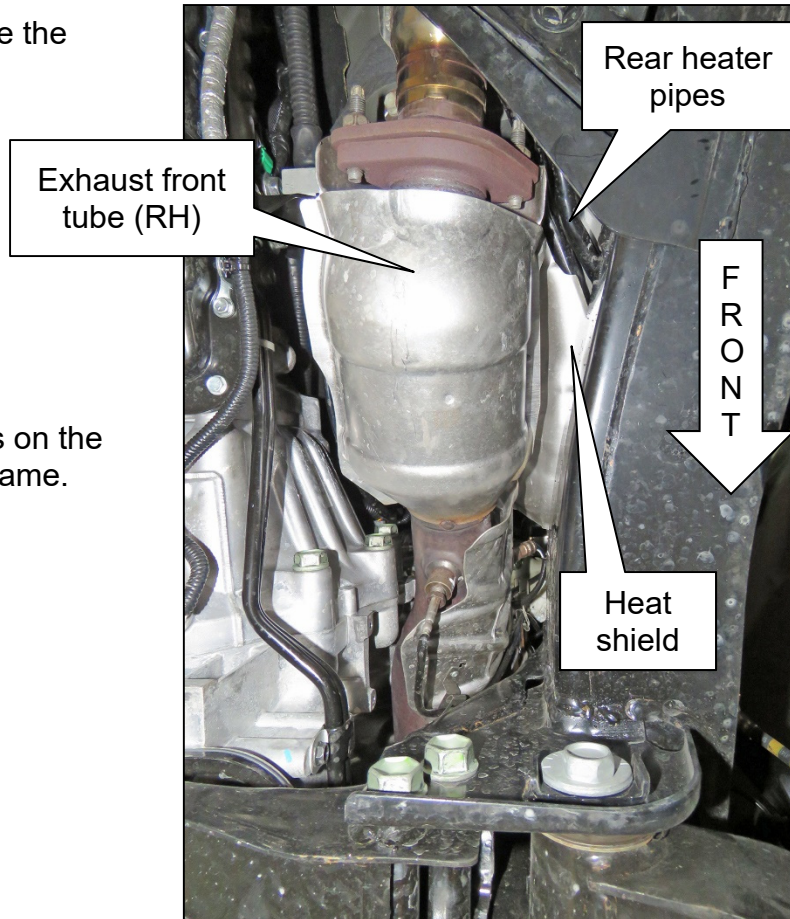
Figure 1

1. Locate the heat shield above the exhaust front tube (RH).

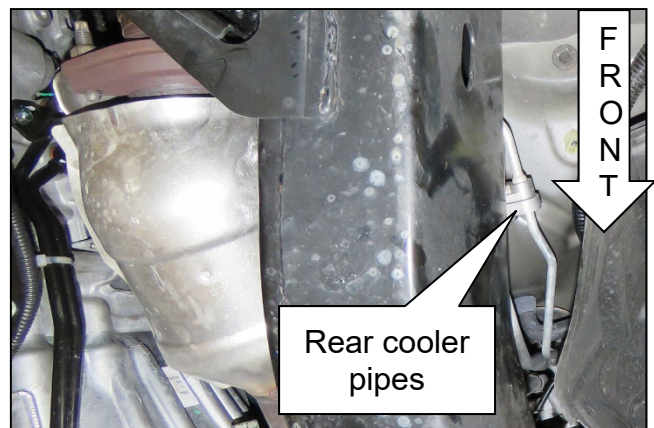
Figure 2

2. Locate the rear heater pipes on the upper **inboard** side of the frame.

3. Locate the rear cooler pipes on the upper **outboard** side of the frame.
