# Technical Service Bulletin

## 91 SOS Emergency call function deactivated message in the cluster, DTC U153E00 stored in the telematics module

91 19 96 2055945/3 October 2, 2019. Supersedes Technical Service Bulletin Group 91 number 19-94 dated September 30, 2019 for reasons listed below.

Model(s)	Year	VIN Range	Vehicle-Specific Equipment
A4, A5, A6, A7, A8, Q5, Q7, Q8, and Audi e-tron quattro	2019 - 2020	All	With ConBox Low

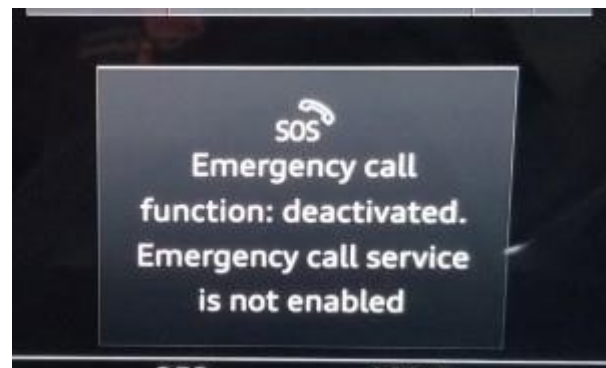
- The warning message “SOS Emergency call function deactivated” is seen in the instrument cluster (Figure 1 or 2).

Figure 1. SOS warning in the instrument cluster.

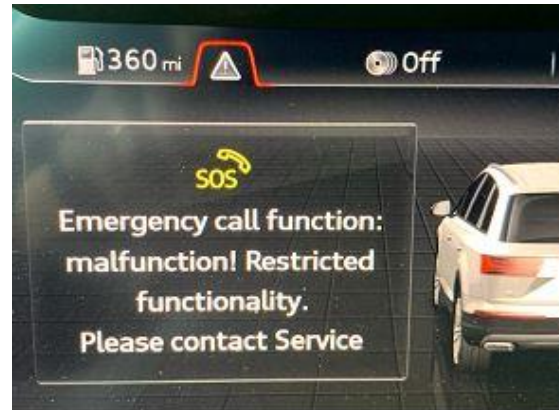
*Figure 2. SOS warning in the instrument cluster.*
