Preliminary Information

PIP5674 Ticking Noise or P0016, P0017, P0018, Or P0019 Set, Oil Very Dark With Low Miles, Possible Coolant Loss.

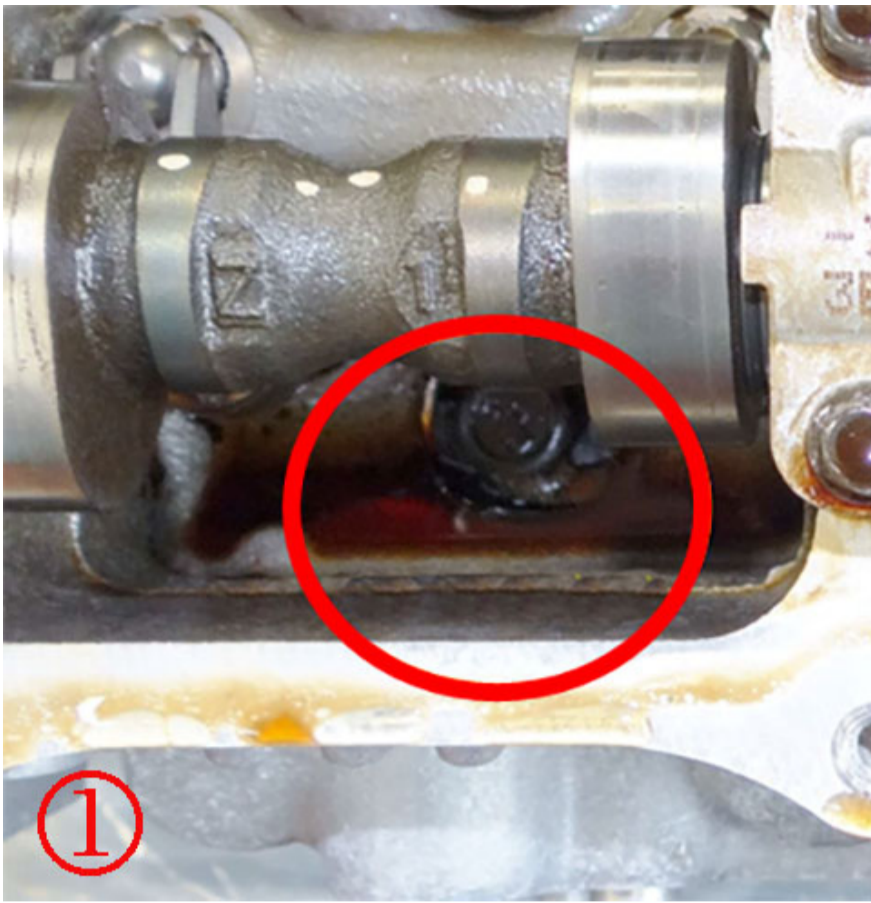
If you see the bubbles or coolant forming in that area the cause is porosity on the head bolt cutout area or column.

1) Moderate Leak

In this case the affected cylinder head will need to be replaced.

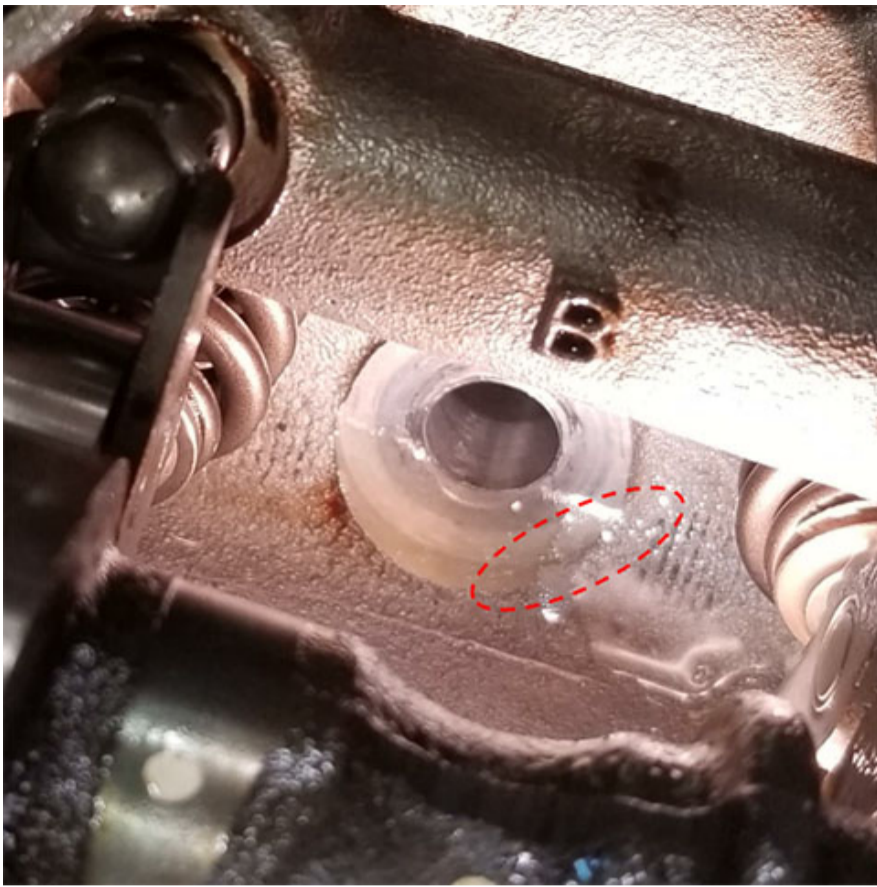
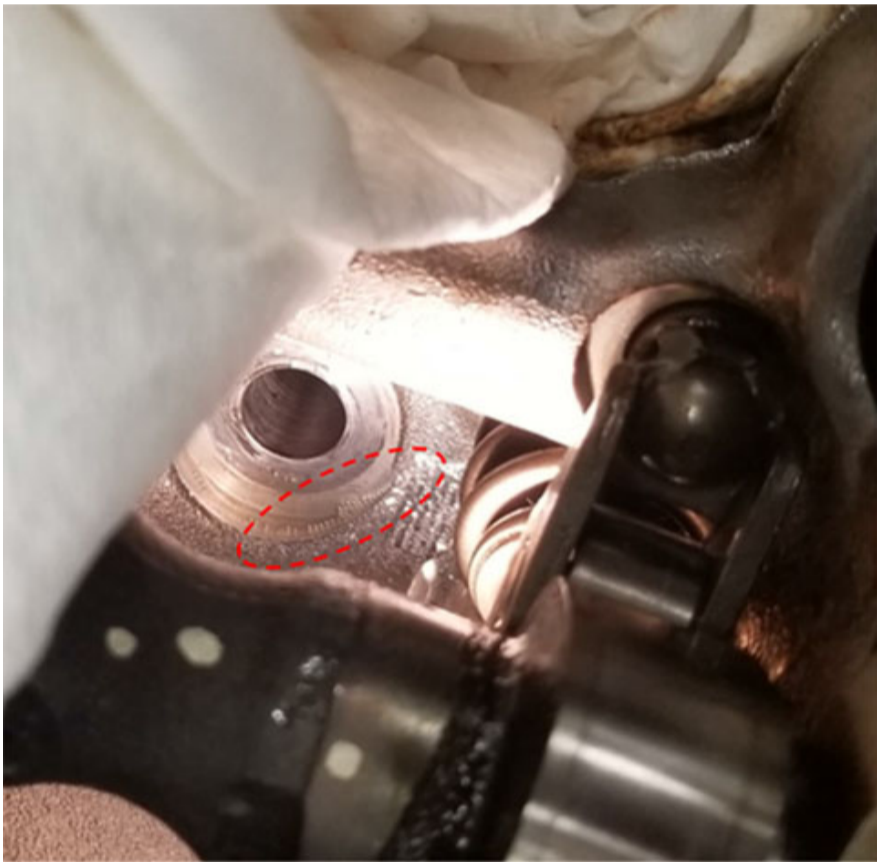
Involved Region or Country	North America
Condition	A customer may come in with any of the following concerns; SES/MIL on with any of P0016, P0017, P0018 or P0019 setting, ticking noise, coolant loss, or the oil looks very dark or black, all with low mileage.
Cause	The cause for this concern may be coolant contaminating the engine oil due to internal porosity on the cylinder head at the outer bolt area.

Locations of actual porosity
