Bulletin No.: PIT5707
Published date: 09/9/2019

PIT5707 ABS MIL and/or Service Stability Message with C050A and/or C0504 set

Brand:	Model:	Model Years:	VIN:		Engine:	Transmissions:
			from	to		
Chevrolet	Silverado 2500HD/3500HD	2020	All	All	All	All
GMC	Sierra 2500HD/3500HD	2020	All	All	All	All

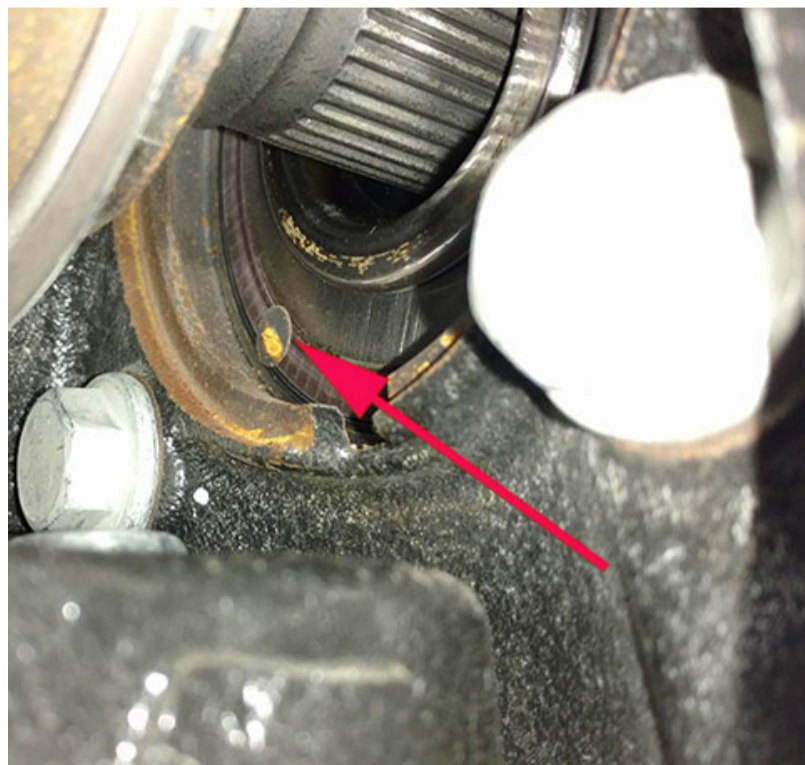
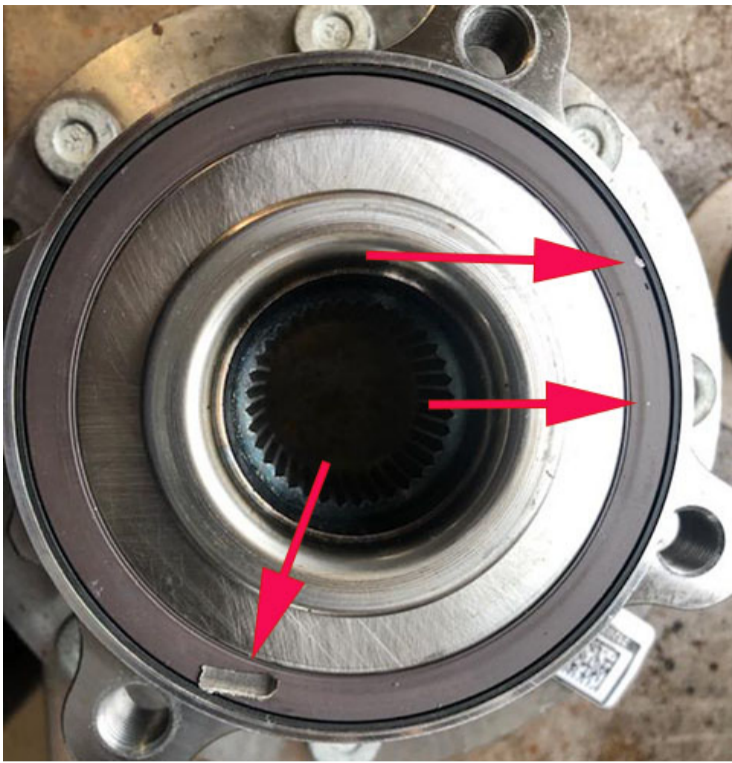
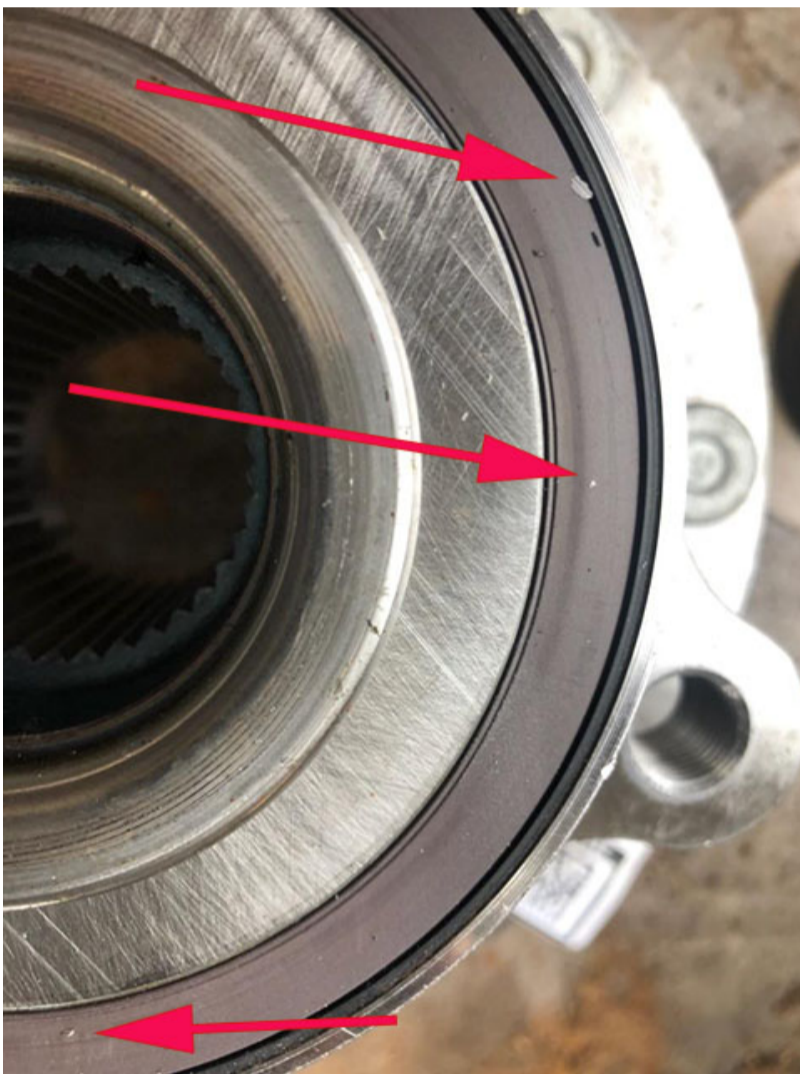
Involved Region or Country	North America
Condition	Some customers may comment the ABS MIL is on and/or Service Stability Message is displayed on the DIC. Technicians may find DTC's C050A or C0504 set in the EBCM.
Cause	There may be debris from manufacturing on the wheel speed sensor reluctor ring (as shown below.)

Clean debris from reluctor wheel, clear DTC's, and test drive to verify DTC's do not reset.

Note: DO NOT use a magnet to remove the debris from the reluctor ring.

It may be necessary to remove the front wheel bearing assembly to find and remove debris.
