Preliminary Information

PIP5676 MIL Due To P06DE and may also have P0521

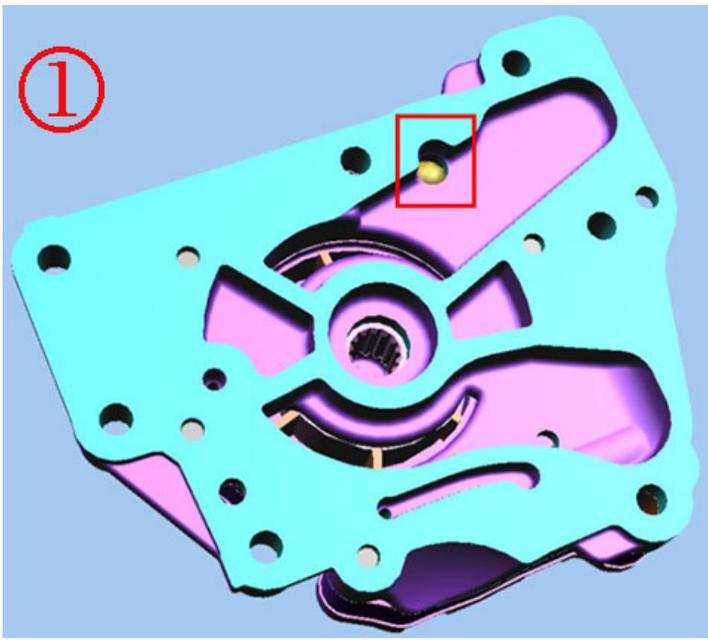
Involved Region or Country	North America
Condition	A customer may come into the dealer for the check engine light being illuminated. The technician may find P06DE stored in the ECM as a history code. The technician may also find P0521 set in history with the P06DE.
Cause	The cause of this concern may be foreign material stuck between the cold start checkball and its seat.

Engine oil pump cold checkball and seat location

When following SI diagnostics for P06DE, if diagnostics lead to inspecting the oil pump or the engine oil pressure is in specification but very low or below specification, inspect the cold start checkball and seat for having foreign material stuck between them. The checkball should be seated fully against the seat in the pump. Look very close because the foreign material can be very small.

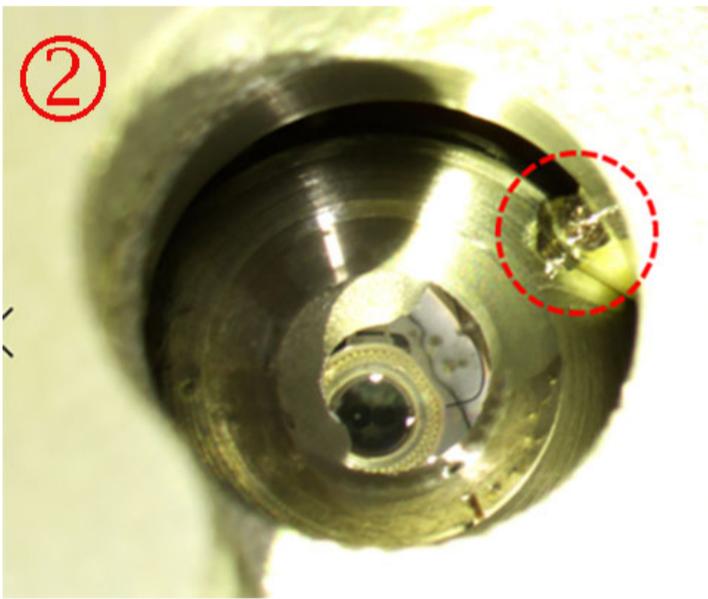
Foreign debris

If foreign material is found between the cold start checkball and seat, remove the foreign material and reinstall the engine oil pump and road test the vehicle.

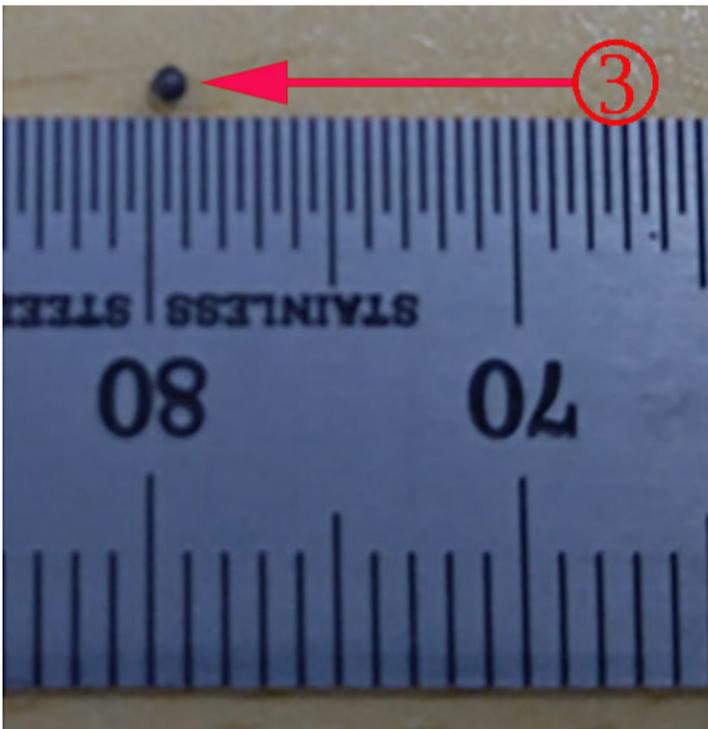
The foreign debris can be very small

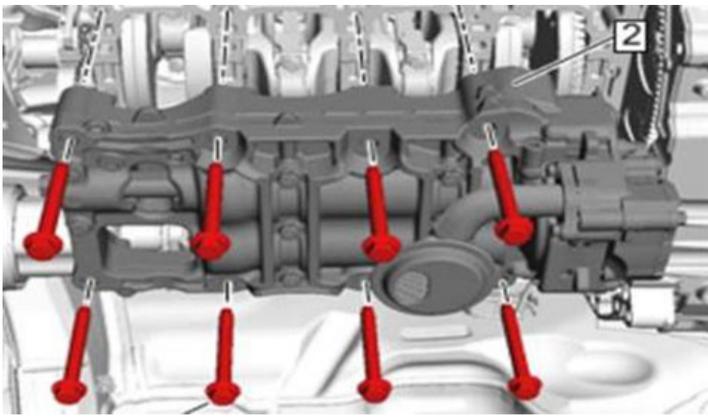
Balancer assembly which includes the engine oil pump assembly

If no foreign material is found between the cold start checkball and seat, replace the balancer assembly which includes the oil pump assembly.
