## Preliminary Information

### PIP5676A MIL Due To P06DE and may also have P0521

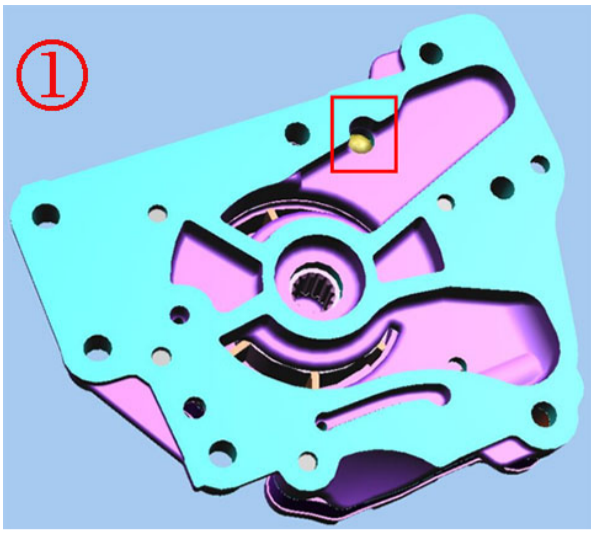
Engine oil pump cold checkball and seat location

**When following SI diagnostics for P06DE, if diagnostics lead to inspecting the oil pump or the engine oil pressure is in specification but very low or below specification, inspect the cold start checkball and seat for having foreign material stuck between them. The checkball should be seated fully against the seat in the pump. Look very close because the foreign material can be very small.**

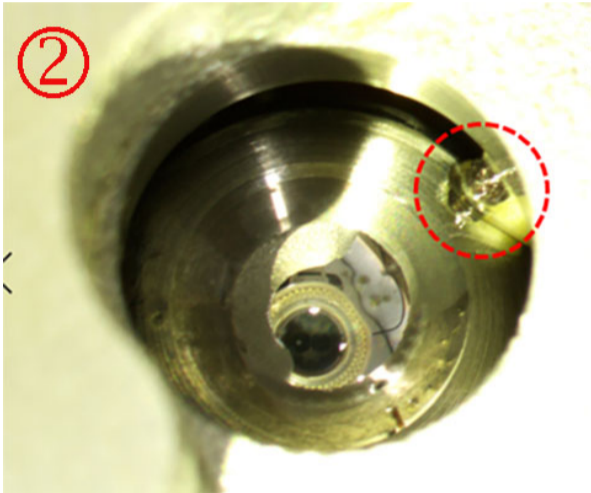
<b>Involved Region or Country</b>	<b>North America</b>
<b>Condition</b>	A customer may come into the dealer for the check engine light being illuminated. The technician may find P06DE stored in the ECM as a history code. The technician may also find P0521 set in history with the P06DE.
<b>Cause</b>	The cause of this concern may be foreign material stuck between the cold start checkball and its seat.

Foreign debris

**If foreign material is found between the cold start checkball and seat, remove the foreign material and reinstall the engine oil pump and road test the vehicle.**

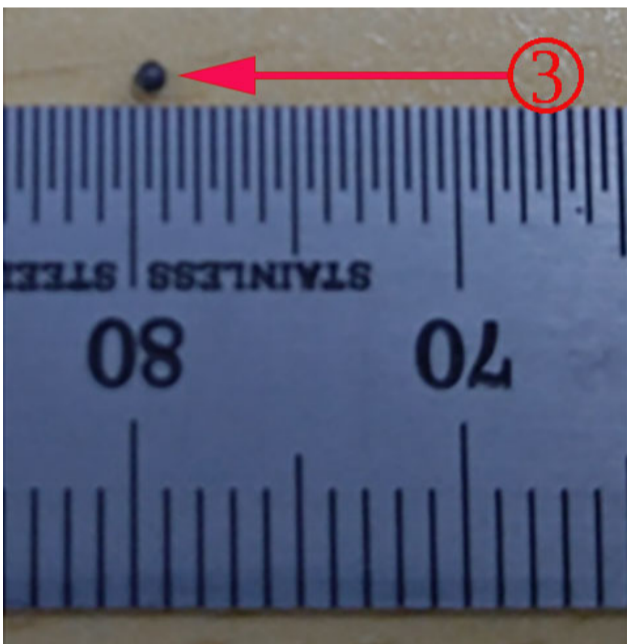
The foreign debris can be very small
