Preliminary Information

PIT5576C Hood Ajar Message

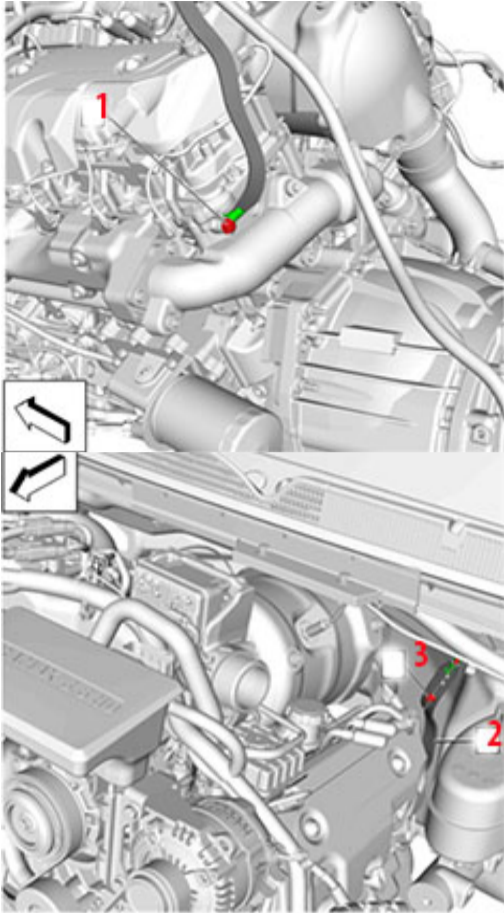
Involved Region or Country	North America
Condition	<p>Some customers may comment of an intermittent "Hood Ajar" message being displayed, even though the hood is not ajar. This concern may be more noticeable when certain electrical loads are operated, such as:</p> <ul style="list-style-type: none"> - Power windows - HVAC blower - A/C compressor - Power seats - Shifting in and out of park
Cause	<p>This condition can be caused by a poor body ground connection at either:</p> <ol style="list-style-type: none"> 1. G218 2. The braided ground strap (2) that connects the left rear cylinder head (1) to the body cowl/front of dash (3), shown below.

1. Inspect G218 for the nut being loose, cross threaded and/or missing. Also, grasp the ground eyelet and verify that it does not rotate on the stud. If any issues are found, perform the necessary repairs.

2. Inspect the body ground strap to ensure it is connected in the proper locations and that the strap eyelet connections are tight and free of any paint or corrosion. In most cases, connection issues with the braided ground strap are caused by poor workmanship during a previous repair. Examples of such repairs include: removing the body, cylinder head, engine, etc. It is important to make sure the braided ground strap is connected in the proper locations. During some of these repairs, the braided ground strap was not reattached at all, or it was reattached to the incorrect location, such as a valve cover. The valve cover is not a proper ground as it is insulated from the main engine block by the gasket and bolt retainers. If any issues are found with the braided ground strap, repair them as necessary.
