# Preliminary Information

## PIP5681 Exhaust leak, Lean Codes, Rattle Noise, or Catalytic Converter Failures.

Brand:	Model:	Model Years:	VIN:		Engine:	Transmissions:
			from	to		
Buick	Enclave	2018 - 2019	All	All	3.6L LFY	All
Chevrolet	Traverse	2018 - 2019	All	All	3.6L LFY	All

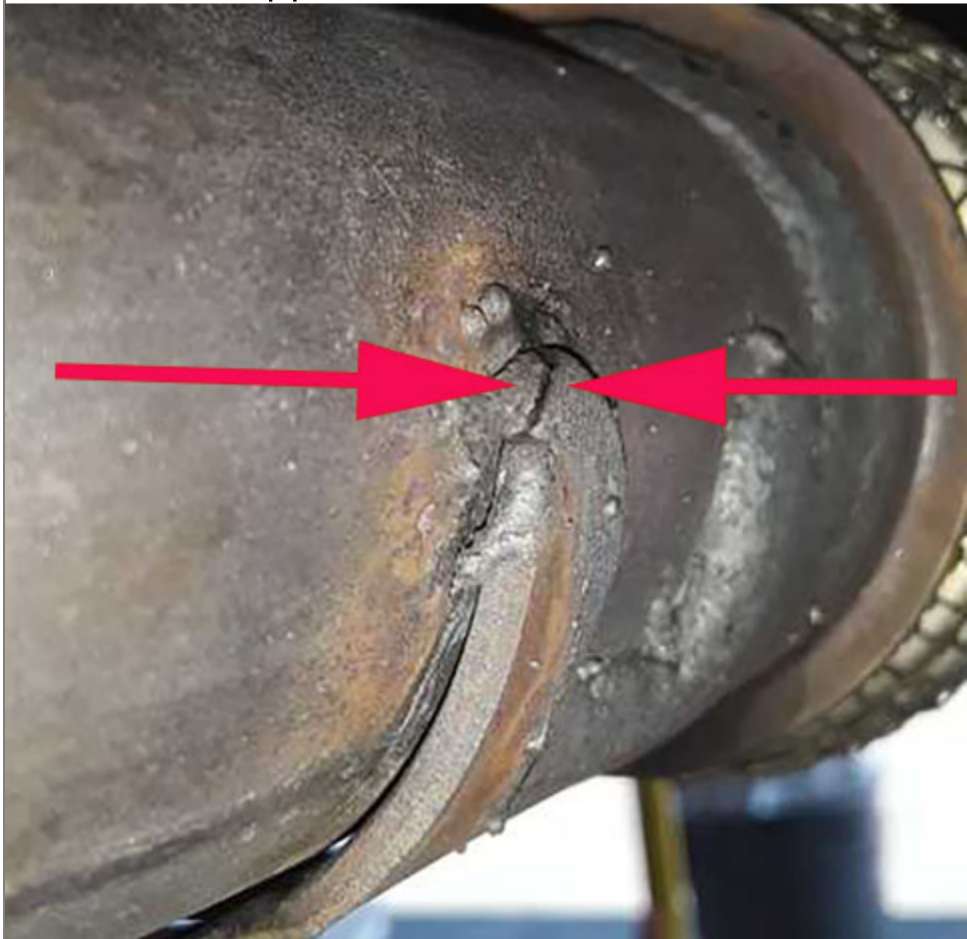
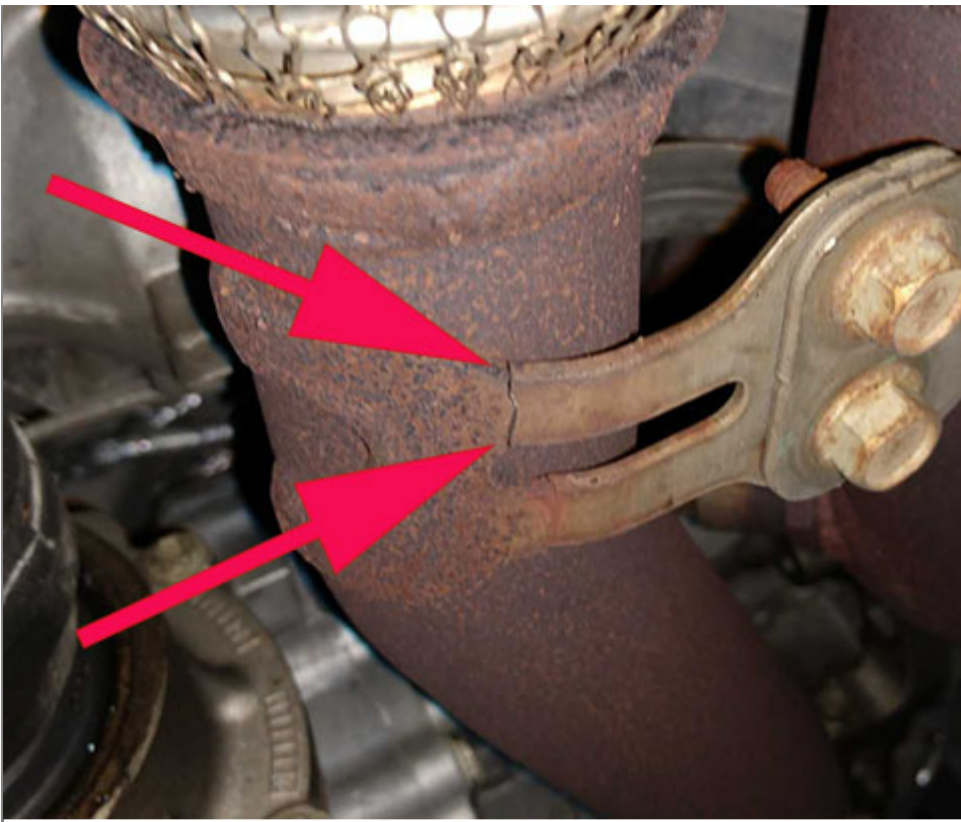
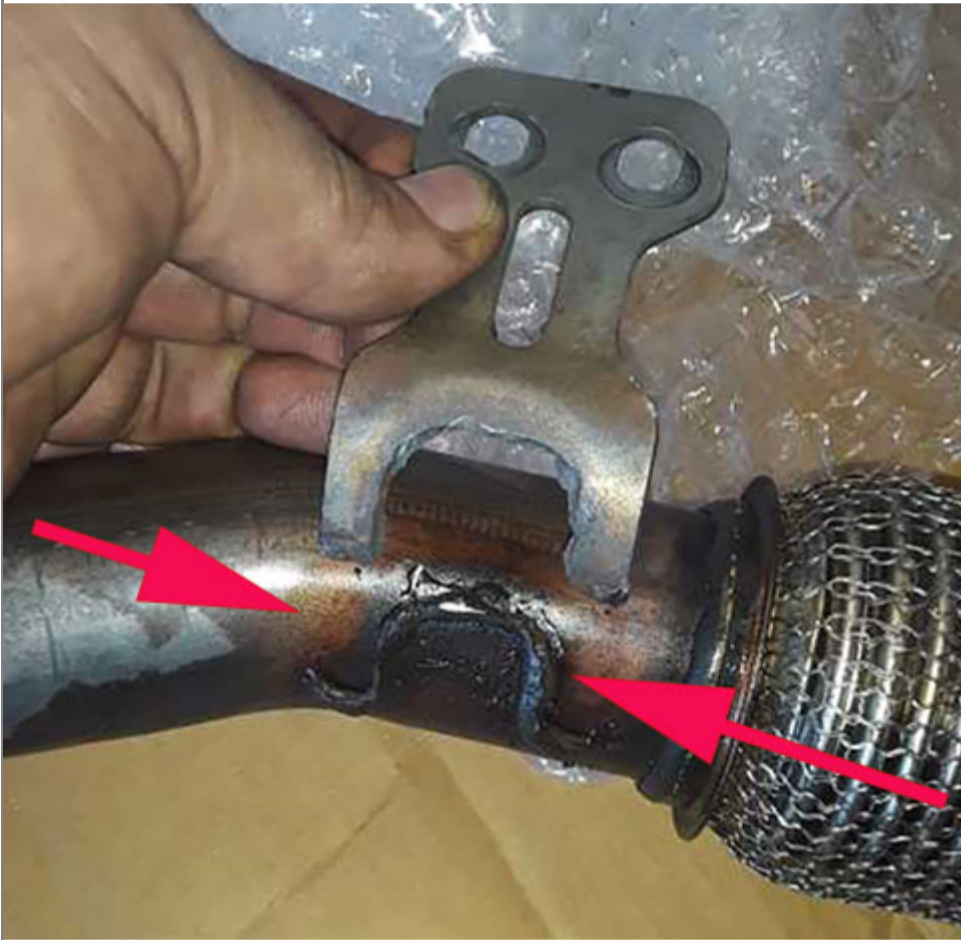
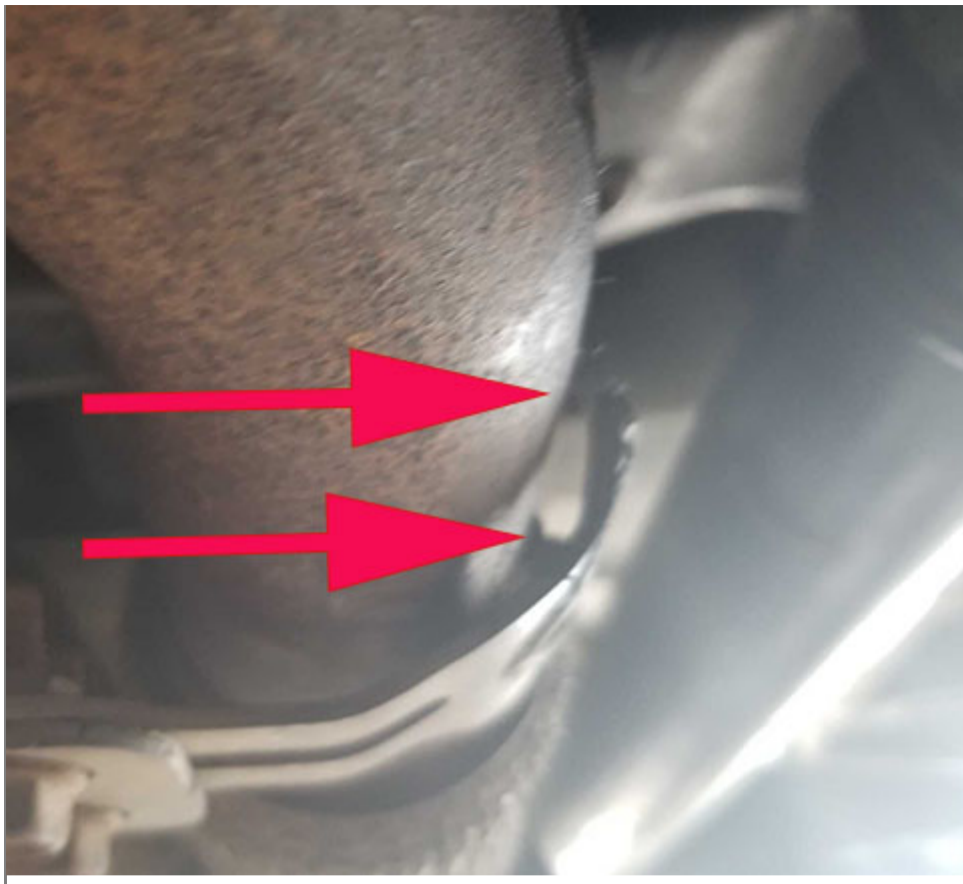
**Condition** Some customers may complain of a rattle or exhaust noise, a CEL/MIL on, or repeat concerns of lean codes or converter failures.  
You may find a cracked pipe on Bank 2, a cracked catalytic converter on Bank 1, or any of these DTC's - P0171, P0174, P0420, P0430, P2096, P2097, P2098, or P2099.

**Cause** The cause for these concerns could be a broken or poor weld with lack of penetration on the Bank 2 exhaust flex pipe bracket as shown below.

The correction for this concern is to replace the pipe from the Bank 2 converter to the mid exhaust assembly. Also inspect for damage to the right catalytic converter and pipes caused by the Bank 2 pipe being broken. Clear any codes that have set and retest the vehicle till the codes have run and ensure they pass.
