Preliminary Information

PIP5407B Code P06DD No Or Low Oil Pressure

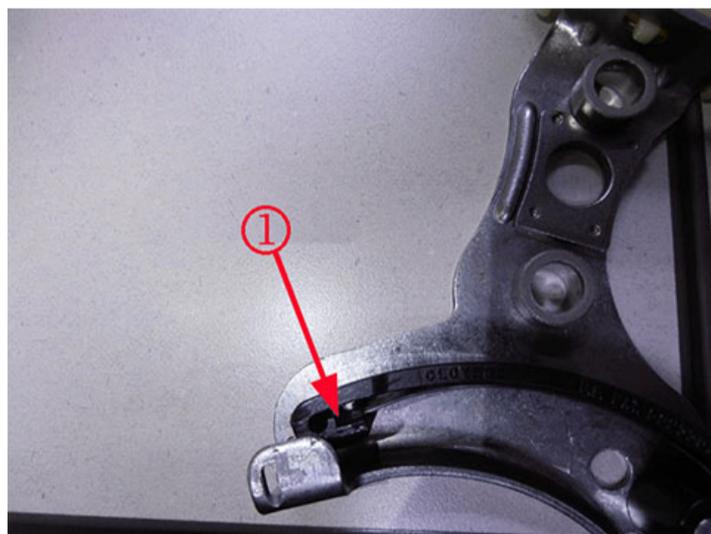
Tensioner spring in timing chain guide may be "short" not fully seating into guide pivot end.

Cycling Oil Pump Control Valve will not cause changes in oil pump response.

1) Short spring not reaching the pivot

Replace timing chain tensioner guide.

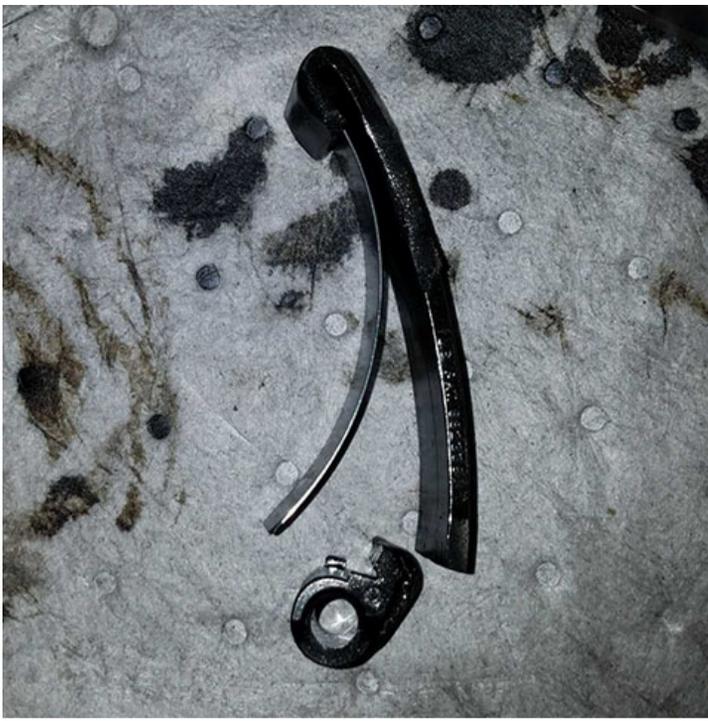
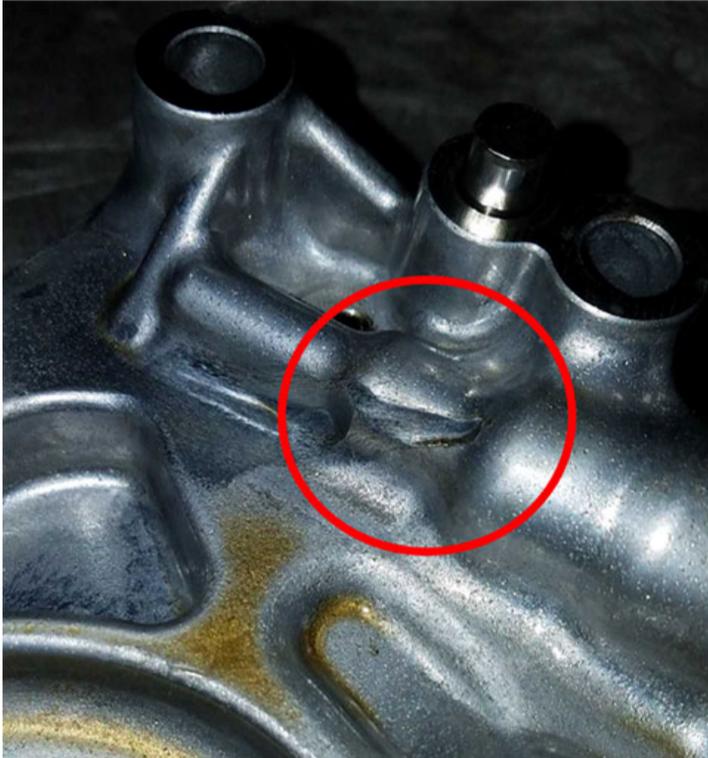
Also a broken tensioner shoe may allow the spring to rub a hole in the oil pump.

The hole in the oil pump

If oil pump face is damaged and or worn thru replace oil pump.

Inspect bearings for damage wear due to debris from oil pump.
