Preliminary Information

PIT5713 SES MIL / IPC Gauges Sweep / IPC Warning Message / Reduced Engine Power / Loss Communication / DTCs U0073 U0100 U0101 u0121 U0128 U0129 U0131 U0140 U0146 U0422 U2413 P0107 P0641 C2A07 (Inspect Engine Harness)

Models

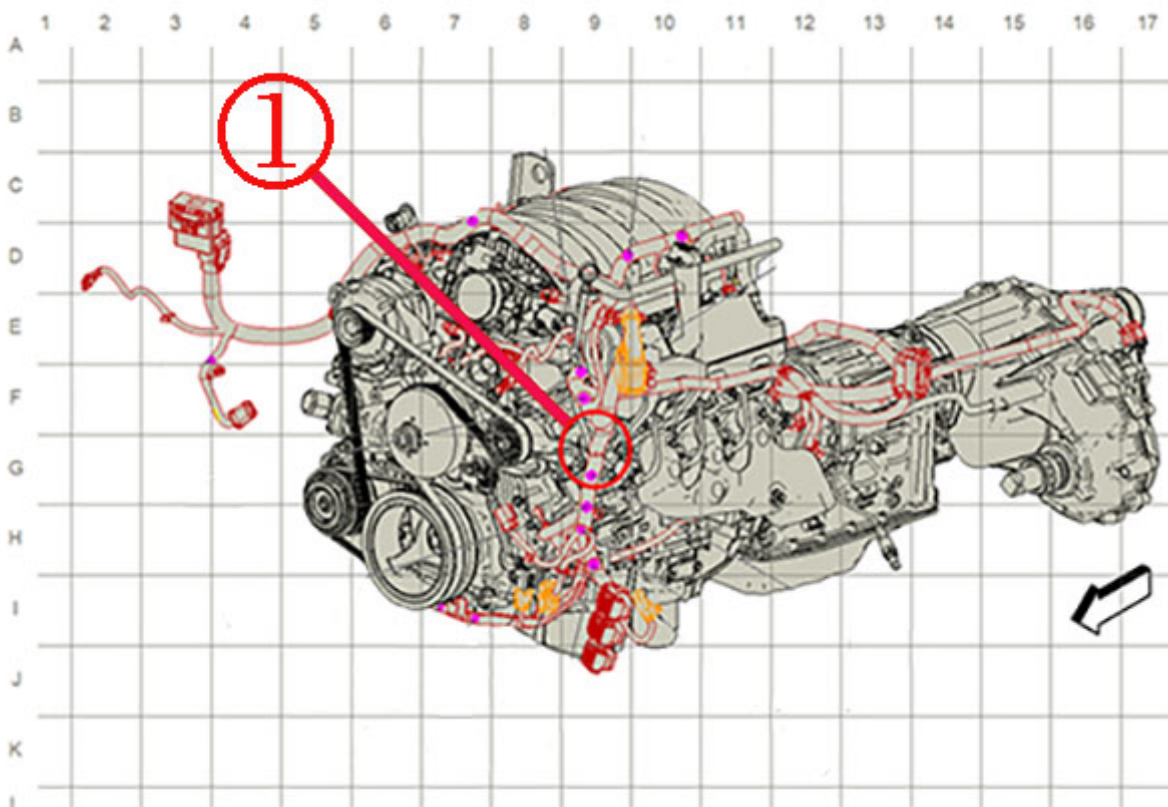
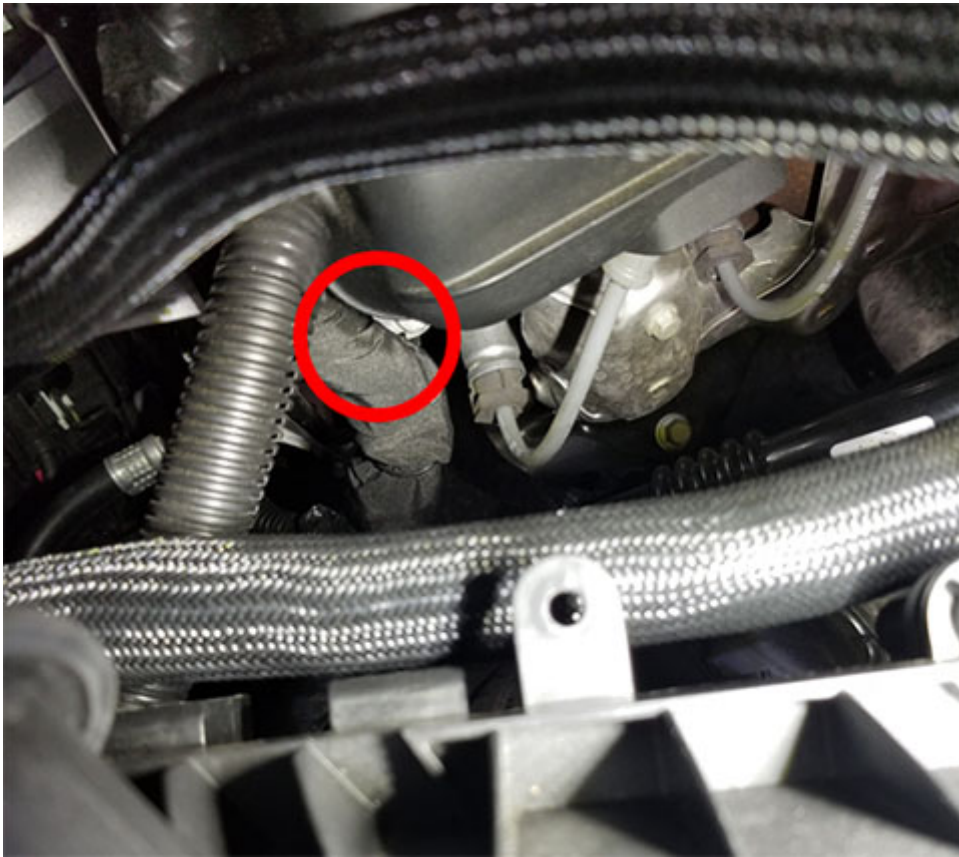
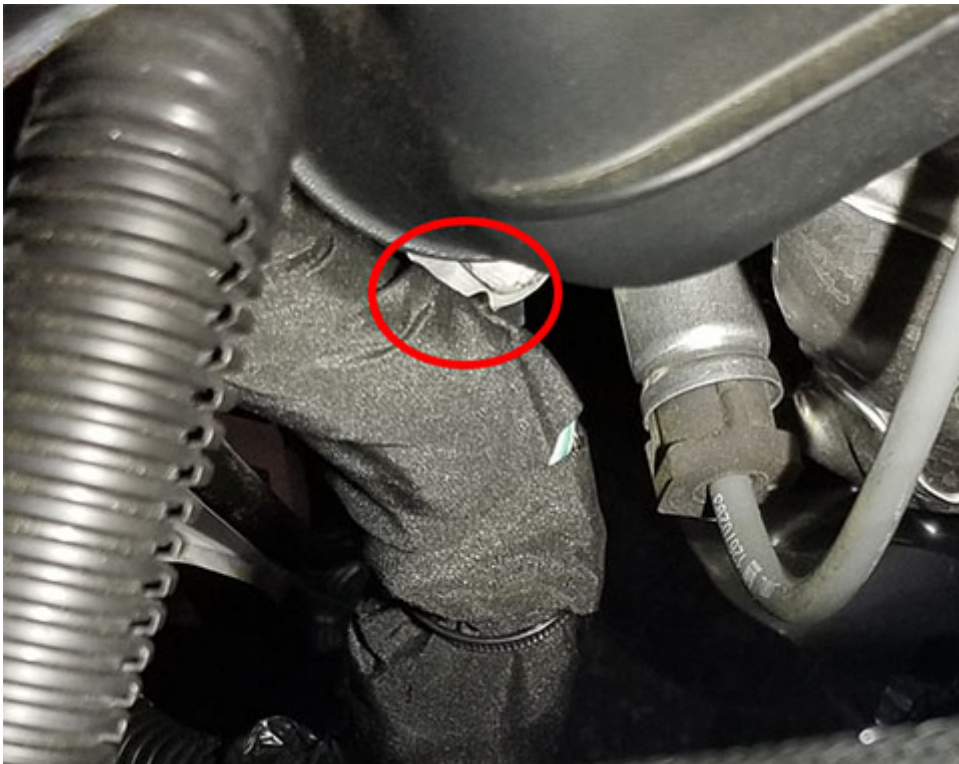
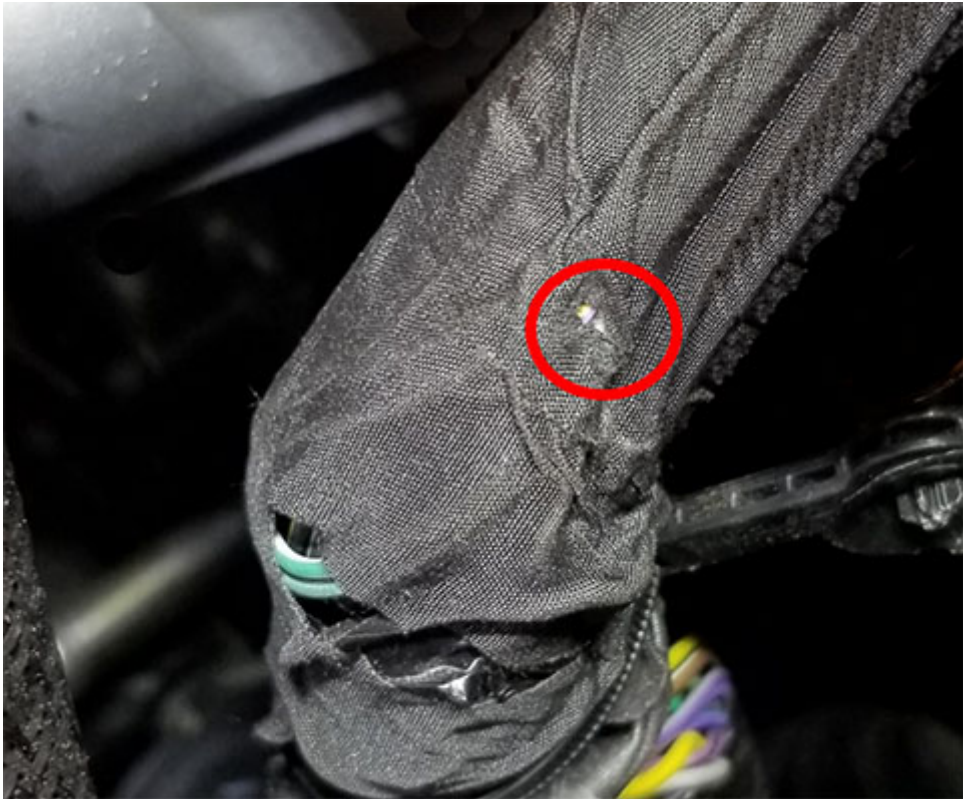
Involved Region or Country	North America
Additional Options (RPO)	With 4.3L V6 Engine RPO LV3
Condition	<p>Some customers may comment on any of the following issues:</p> <ul style="list-style-type: none">- IPC gauges sweeping while driving- Several IPC warning messages and MIL displayed- Any combination of the following DTC's: U0073 U0100 u0101 u0121 u0128 U0129 u0131 U0140 U0146 U0422 U2413 P0107 P0641 C2A07 <p>In most cases, powertrain movement will duplicate the issue, such as, shifting between drive and reverse, accelerating, braking or just driving.</p>
Cause	These concerns could be caused by the engine wiring harness rubbing on the front corner of the left hand cylinder head (1) and shorting any number of circuits to ground, see pictures below.

To correct this concern, repair the damaged wiring following the SI wire-to-wire repair procedures. Once repaired, protect and reposition the engine wiring harness to prevent future harness damage.
