Preliminary Information

PIT5278E Power Lift-gate Erratic Operation will not Power Close DTC B153A and/or Motor Running but Does Not Move

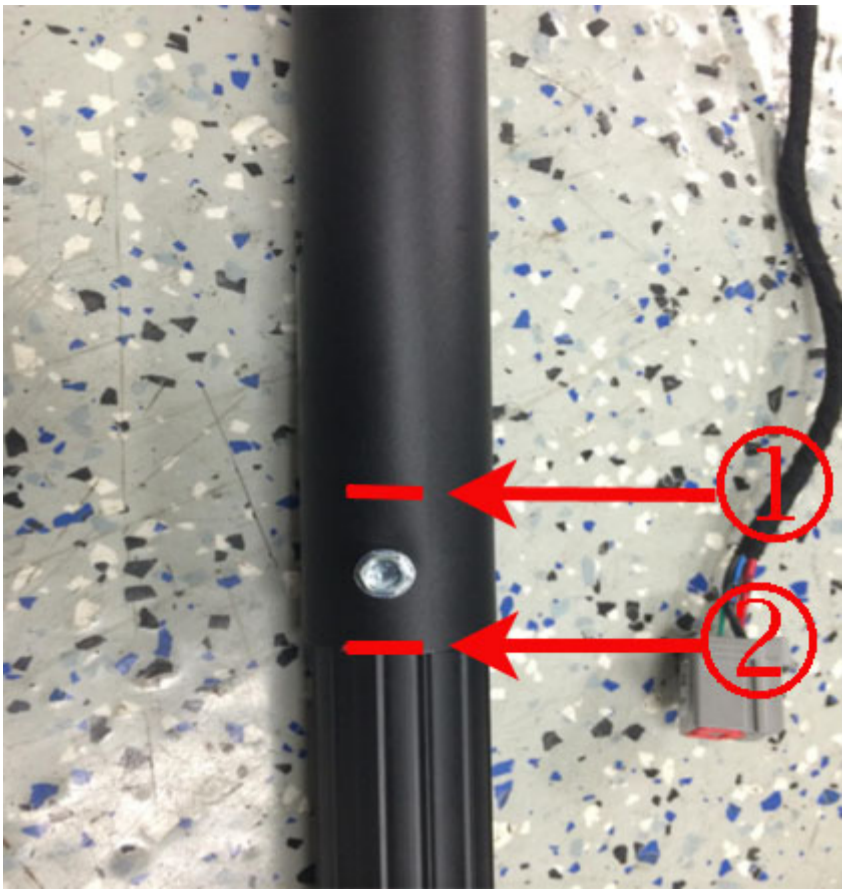
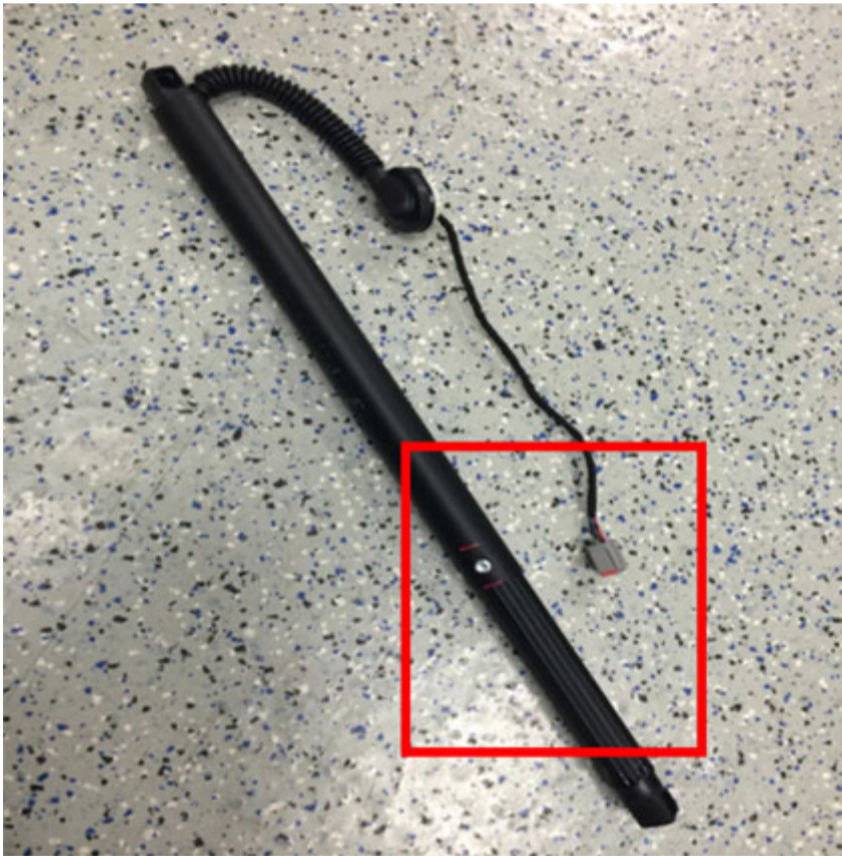
1. Obtain one #8 self-tapping screw 1 1/2 inches long.
2. Fully open the liftgate.
3. Install the self-tapping screw any place in the 30 mm space (from the bottom of the smooth tube) between location 1 and 2. As reflected below, a location of 20 mm (approximately 3/4") is ideal to secure the tubes.

Note: The screw will hold the actuator together for removal.

4. Remove the left liftgate actuator following the Liftgate Power Assist Actuator Replacement procedure in SI.

IMPORTANT: After the left liftgate actuator is removed, DO NOT remove the screws. The part will be requested back to the Warranty Parts Center once the associated warranty claim has paid.
