Complaint - Repair Instructions in the Event of Transfer Case Oil Leaks: Follow recommended course of action (34/19)

Model Line: Cayenne (92A)

Model Year: As of 2011 up to 2018

Subject: Transfer Case

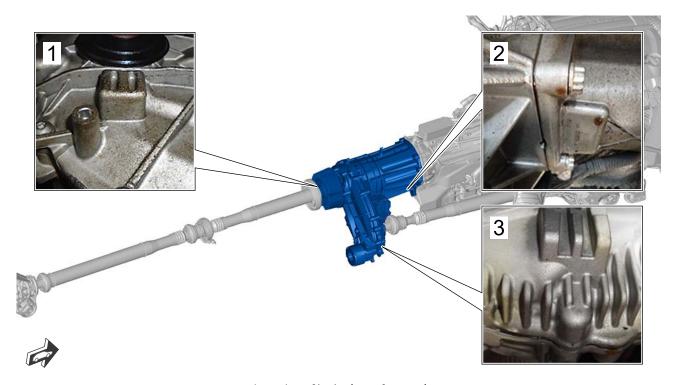
Location of leaks (transfer gear)

- 1 Rear transfer gear housing (oil coating)
- Front transfer gear housing (bottom) (oil leak/oil coating)
- Lower transfer gear housing (oil coating)
