Panoramic Roof Water Management

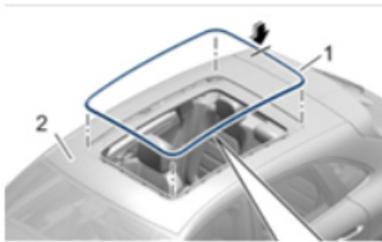
A recent investigation found that the frame is not leaking at the corners due to a sealing issue. Water was found to be leaking at the corners as a result of more water accumulating in the frame than it was designed to handle. Water was overflowing the areas designed to channel the water to the drains.

A combination of factors was causing the accumulation-

1. Too much water leaking past the outer seal (poorly adjusted frames contributed to this).
2. Drains not clogged or not clear enough.

Only change the roof frame if a leak still exists after performing the following work –

1. The roof frame has been properly centered in the roof opening
2. The glass panels are properly adjusted.
3. The outer seal has been replaced
4. The drains have been unclogged
