JLRTB02007NAS1

TECHNICAL BULLETIN

Front Left Exterior Door Frame Finisher Damaged

MODEL:	MODEL YEAR:	VIN:	ASSEMBLY PLANT:
Range Rover Sport (LW)	2020	876107-886053	Solihull

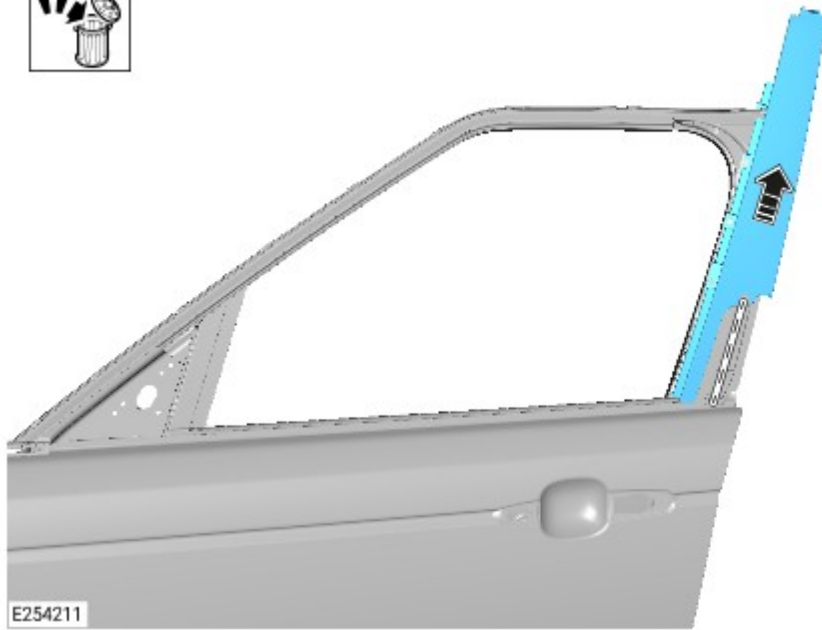
9.

A section of the front left exterior door frame finisher has become damaged or has detached from the vehicle.

Remove and discard the exterior door frame finisher.
