**Solution K90500425**

| Title | <b>Under Review</b> AMT-F Oil In Control Housing Or TECU-- <b>Need specifics on the cleaner. Need to add "bench test before reinstallation"</b> |

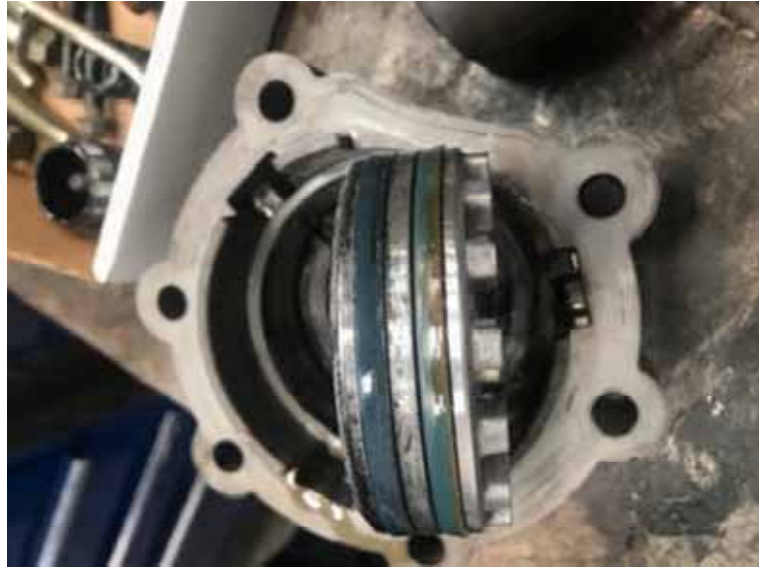
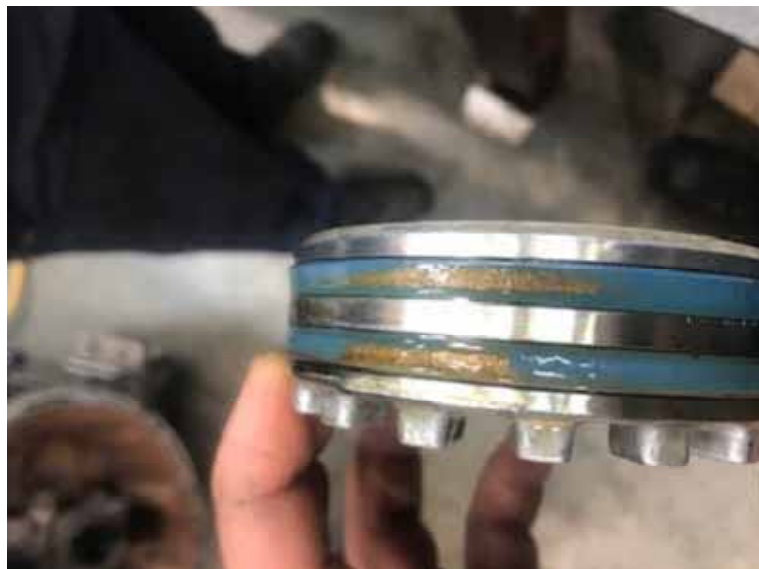
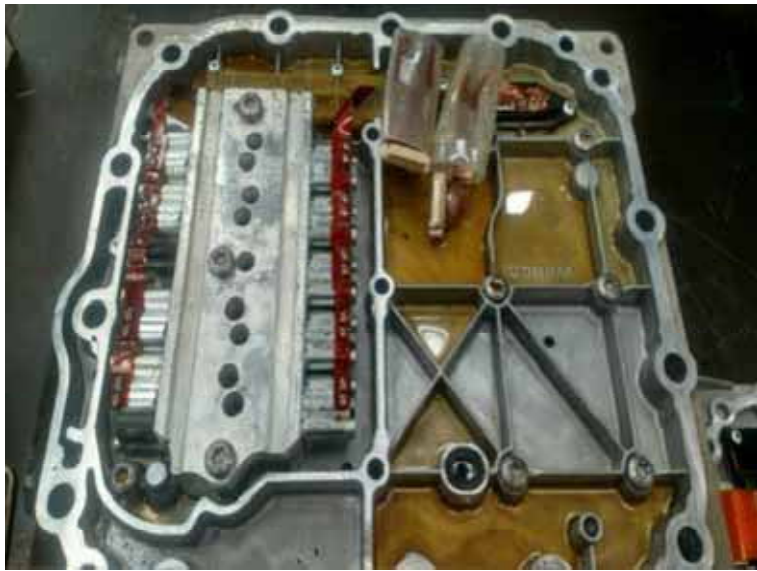
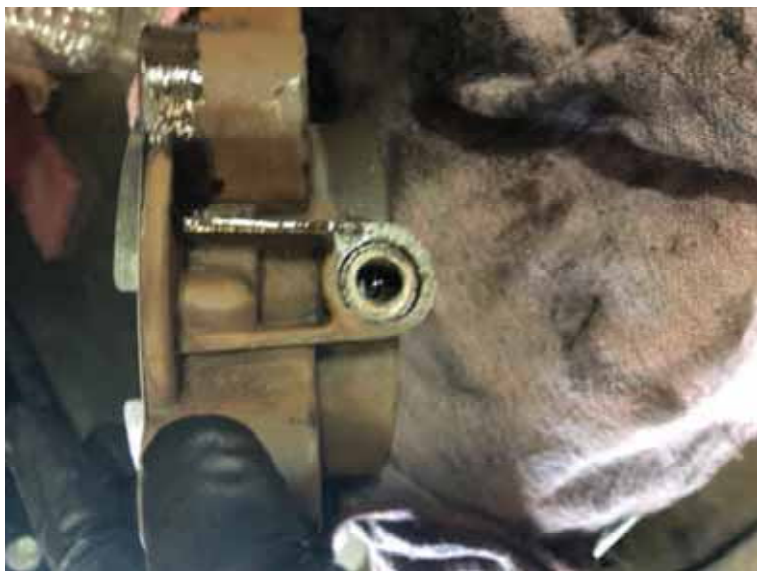
In several instances there has been oil found in the control housing of the transmission during fault investigations. The oil may or may not be a cause of the customer complaint. There may also be excessive oil residue or leakage from the vents on the left side of the gearbox.

If there is no air leakage or only slight air leakage from vents during countershaft brake testing and oil is found in the control housing then remove the gearbox from the vehicle and remove the countershaft brake airline and inspect for oil intrusion. If oil is found in the countershaft brake airline then repair or replace the countershaft brake as needed.

The clutches in the countershaft brake must also be replaced.

The Countershaft brake assembly is not available as an assembly. Order parts as needed. Repair instructions are available in IMPACT for the countershaft brake piston assembly.

Clean the oil from the inside of the control housing and from the TECU with a circuit board cleaning spray and blow it dry with compressed air. Unplug the connectors from the circuit board and clean the oil from inside the connections and blow dry. Clean all the air passages for the countershaft brake and reassemble the unit.
