Title Volvo Chassis - **Model VN**, Hood Release Cable Interference; Hood Release Cable Binding, Hood Latch Tough To Pull - **Model Year 2018 And Newer**

**Volvo Model** VN , VNL , VNM , VNR , VNX

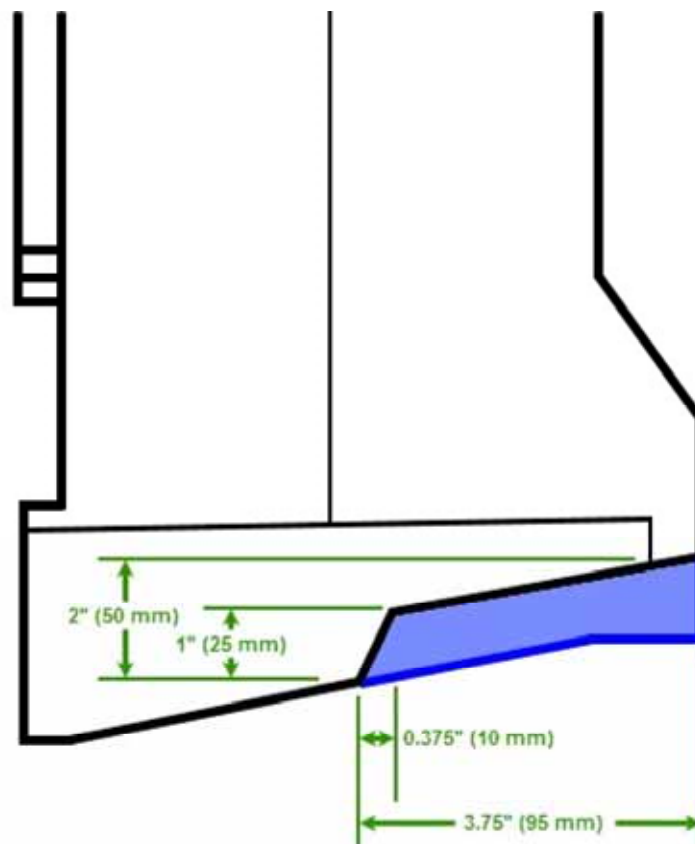
**Cause** For certain vehicles produced for model year 2018 and newer, the hood latch cable for the passenger side latch may be routed around a corner of the air box. This can cause the cable to bind when the hood release is pulled, and may lead to premature failure of the cable.

Using an appropriate tool, cut the corner off of the air box. This will allow the cable to straighten out and prevent fatigue. A diagram with approximate dimensions can be found below. The blue section is the portion that will be trimmed off:

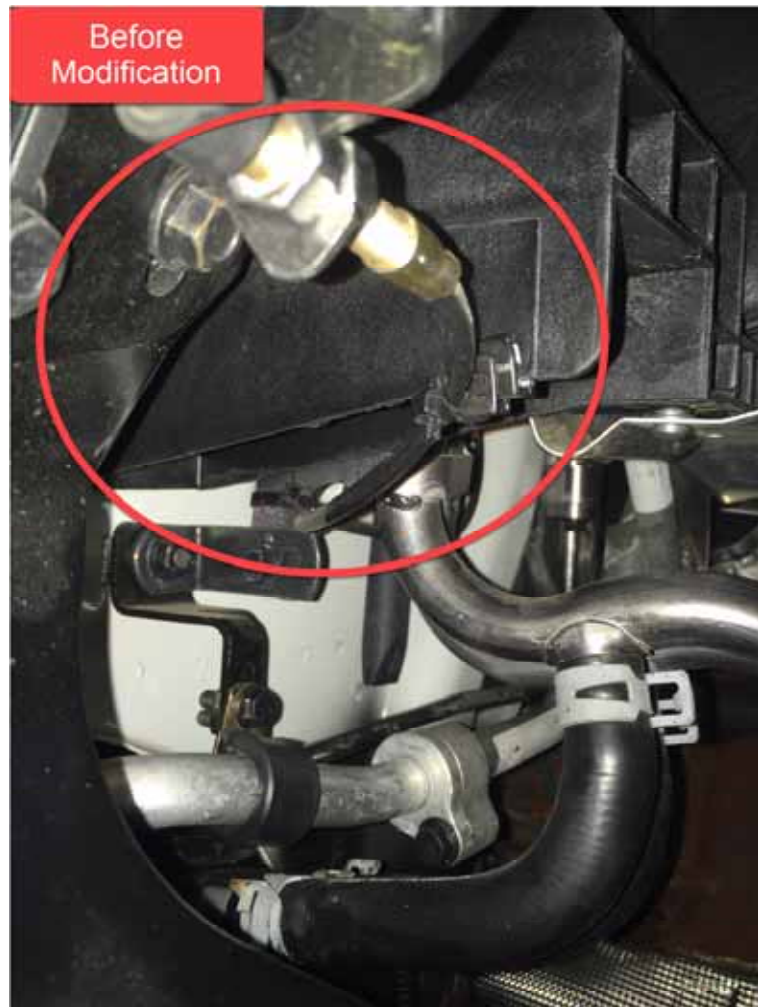
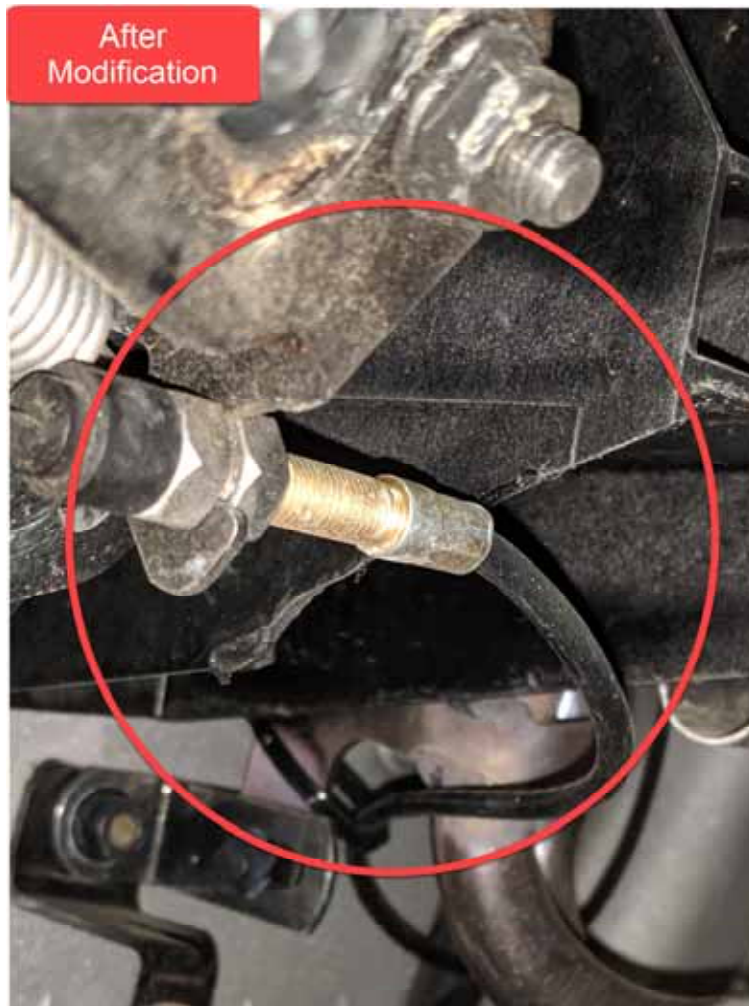
An example of an air box before and after being trimmed can be seen below:
