Fuel Line Rattle/Knocking Noise

Service Category Engine/Hybrid System

Section Fuel System

YEAR(S)	MODEL(S)	ADDITIONAL INFORMATION
2016 - 2018	GS350, IS300, IS350, RC300, RC350	VDS(s): C81D2, CZ1BL, CZ1D2, S85BC, SZ5BC Engine(s): 2GR Drive Type(s): AWD Transmission(s): AUTOMATIC

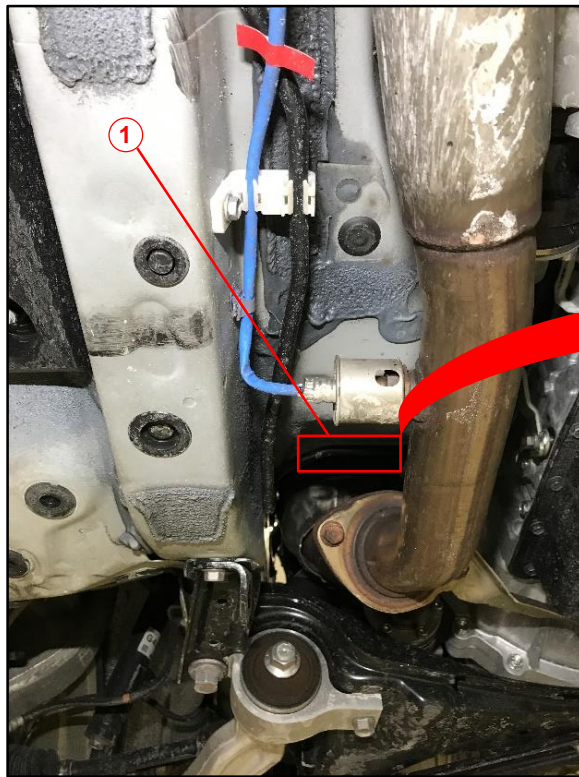
Figure 1.

- Inspect the fuel line for a 0.2-in. (5-mm) clearance with the body in the area illustrated in Figures 1 and 2.

Is there a difference of less than 0.2 in. (5 mm) between the fuel line and body?

1	Contact Area
----------	---------------------

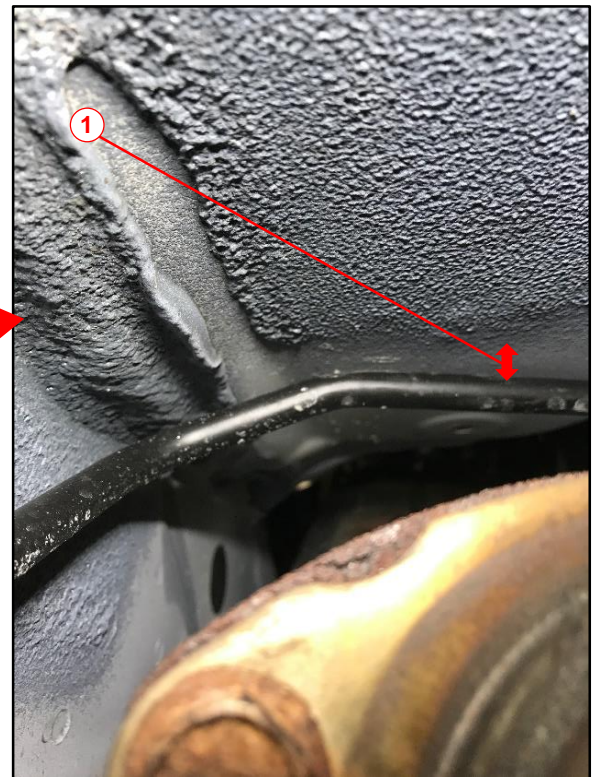
Figure 2.

1	Contact Area
----------	---------------------

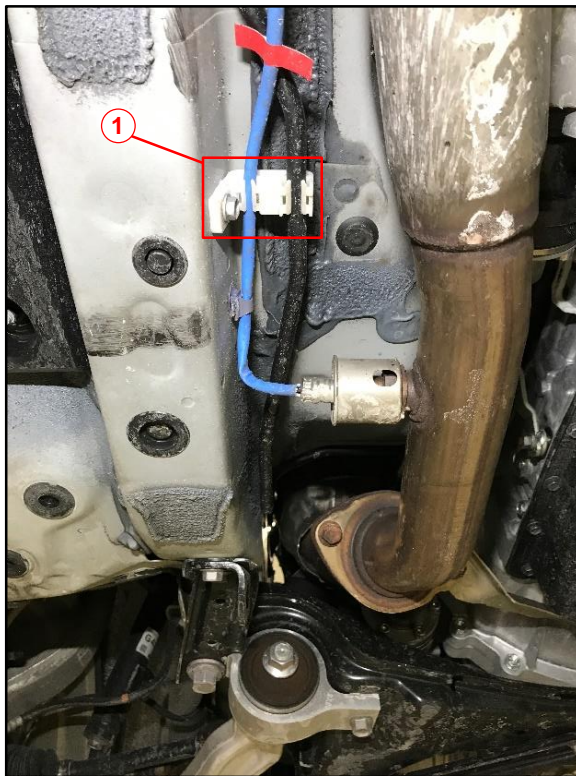
Figure 3.

1	Clip A
----------	--------

- In Clip A (Figure 3) slide the fuel line towards the front of the vehicle (Figure 4), until the clearance at the contact area is greater than 0.2 in. (5 mm).

Do NOT use pliers or ANY tool that may damage, bend, or deform the fuel line.

Ensure the clip does not rotate in place.

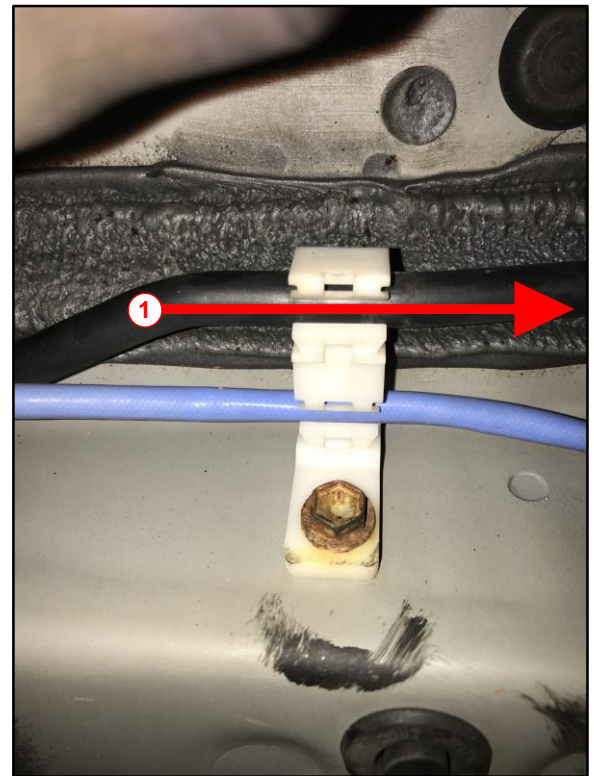
Figure 4.

1	Front of the Vehicle
----------	----------------------
