SIB 31 05 14

2019-09-26

Front Suspension Ride Height Has Dropped

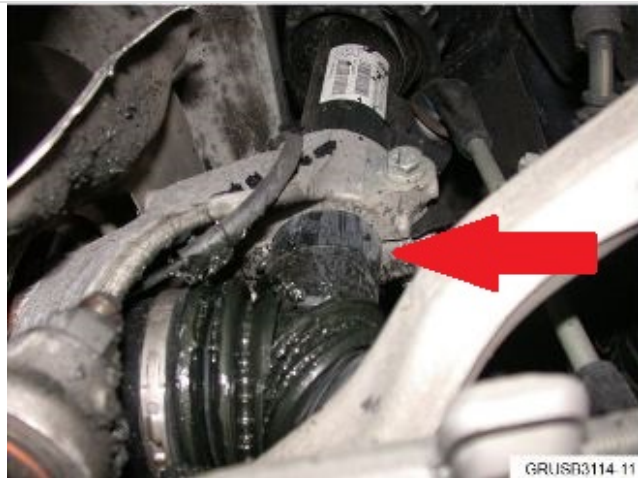
The front suspension ride height has dropped on one or both sides due to overload.

This is caused by driving over obstacles (e.g. potholes), or an impact severe enough for the front spring strut damper to slip through the clamp of the steering knuckle.

The slippage of the dampers from overload is intentional, as it protects the body from severe damage by dissipating kinetic energy through the clamp.

Replacement of steering knuckle and spring strut damper are required, along with any further damaged components (e.g., tires, axles, xDrive) and related required hardware.
