SIB 32 08 19

THUMPING NOISE FROM FRONT AXLE WHILE STEERING

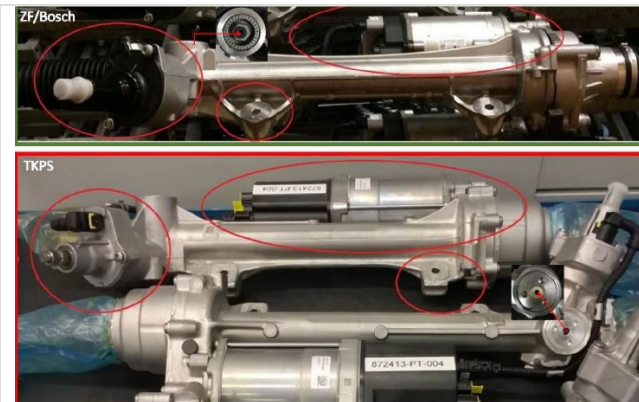
Steering gear identification.
Upper photo: ZF

Lower photo: TKPS

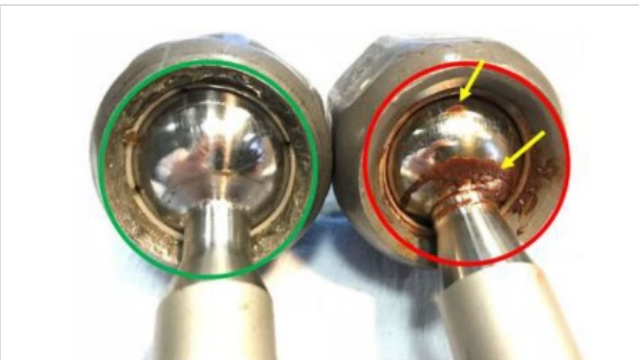
Corrosion as indicated by the yellow arrows on the inside joint of the tie rod.

Replace the tie rod.

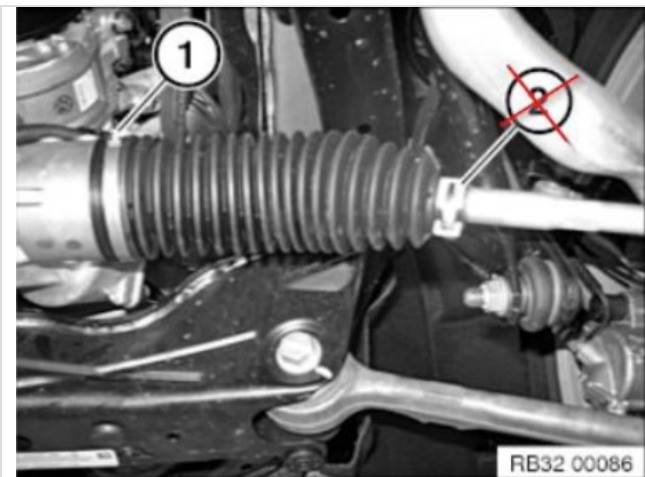
3. Remove the clamp (1) and push back the gaiter to identify which tie rod manufacturer is installed.

4. Is the tie rod by manufacturer CTR installed?
 - Yes- proceed to step 5
 - No- further diagnostic troubleshooting required to identify the source of the noise
5. Is the grease discolored and corrosion found on the joint of the tie rod?
 - Yes- proceed to step 6
 - No- further diagnostic troubleshooting required to identify the source of the noise
6. Replace both tie rods per Repair Instructions REP 32 21 231.
