SIB 51 27 16

RATTLE/POPPING FROM TAILGATE AREA

This Service Information Bulletin (Revision 6) replaces SI B51 27 16 **dated February 2017**.

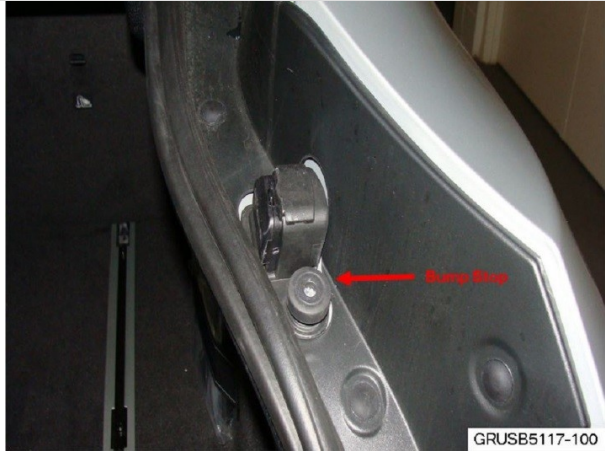
1. Reference repair instruction 41 00... **"Gap dimension, body"**. Inspect and

measure all body and adjustment gaps for the rear tailgate.

Ensure all body gaps and measurements are within the body gap specification before moving to step 2.

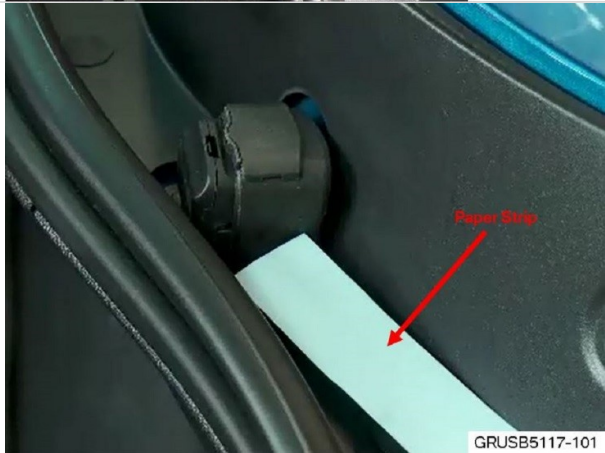
B. Situation B - the bump stops may be adjusted too high, putting torsional stress on the tailgate, causing flexing (popping) noises.

2. Adjust the bump stop height. Refer to repair instructions **REP 51 23...** **“Adjusting/replacing bump stops”**

3. Check the bump stops on both sides for proper adjustment using the paper method (shown at left).

Once correctly adjusted using the paper method, once again adjust each bump stop one half rotation OUT.
