**SIB 51 27 19**  
**SIDE TRIM IS LOOSE OR COMES OFF**

E-Series	Model Description	Production Date	Affected Option Code / Engine
G29	Z4 Roadster	From November 1, 2018- March 31, 2019.	337 M Sport Package, or 760 High gloss shadowline, or 7M9 individual high gloss shadowline

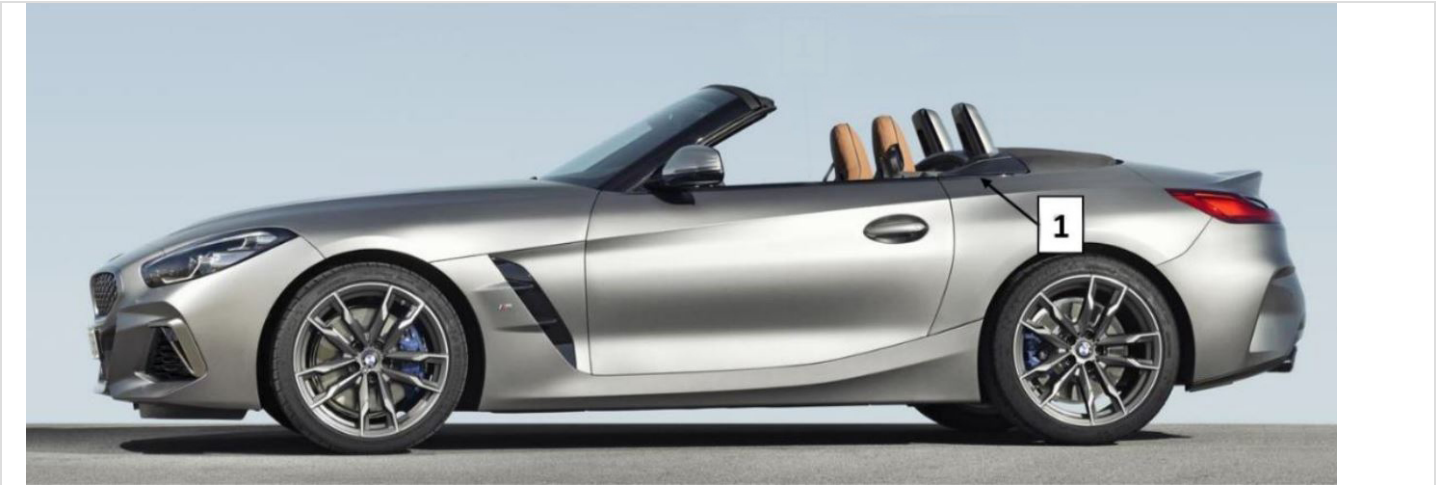
The side trim (1) may be loose or may have come off completely.

Only for vehicles with the option codes listed above, the curved shape of the side trim requires additional adhesive, which was not applied during production.

Install side trim and apply additional adhesive.
