## SIB 51 28 19 NOISE FROM FRONT AREA

E-Series	Model Description
F10	5 Series Sedan

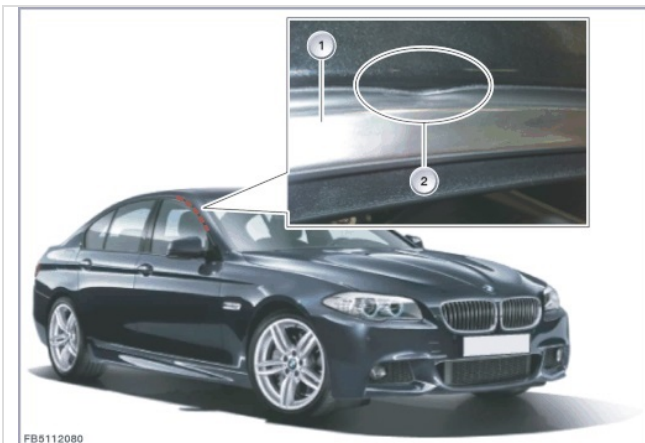
The following are 2 known areas that may cause this noise:

- Visible damage or deformity of the A-Pillar door seal (shown)
- Improper hood adjustment

1. Properly adjust hood
2. Replace the A-pillar door seal

1. Adjust hood following ISTA repair instructions REP 41 61 014 “**Adjusting engine compartment lid**”.
2. Replace the deformed or damaged A-Pillar door seam seal.
