Subject: N192268880 - Emission Recall

Transmission Control Module Memory Diagnostic May Not Illuminate

Malfunction Indicator Light

Models: 2016 -2018 Chevrolet Spark equipped with CVT Transmission (RPO

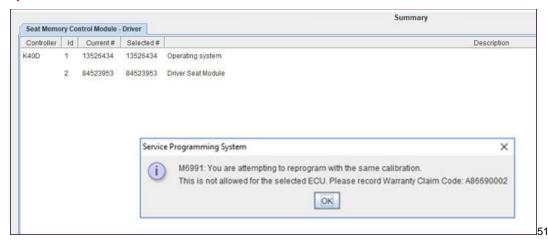
Note: If the Same Calibration/Software Warning is noted on the SPS Summary screen, record the warranty claim code (WCC) and select OK and follow screen instructions. After a successful programming event, the WCC is located in the Service Programming System dialogue box of the SPS Summary screen. No further action is required. Refer to the Warranty section of the bulletin.
