GLOBAL SAFETY FIELD INVESTIGATIONS  
DCS5147  
URGENT - DISTRIBUTE IMMEDIATELY

Subject: N192266190 – Service Update  
Potential reduced Power or Stall

Models: 2018 Buick Lacrosse, Enclave  
2018 Cadillac XT5  
2018 Chevrolet Traverse

## N192266190 Potential Reduced Power or Stall

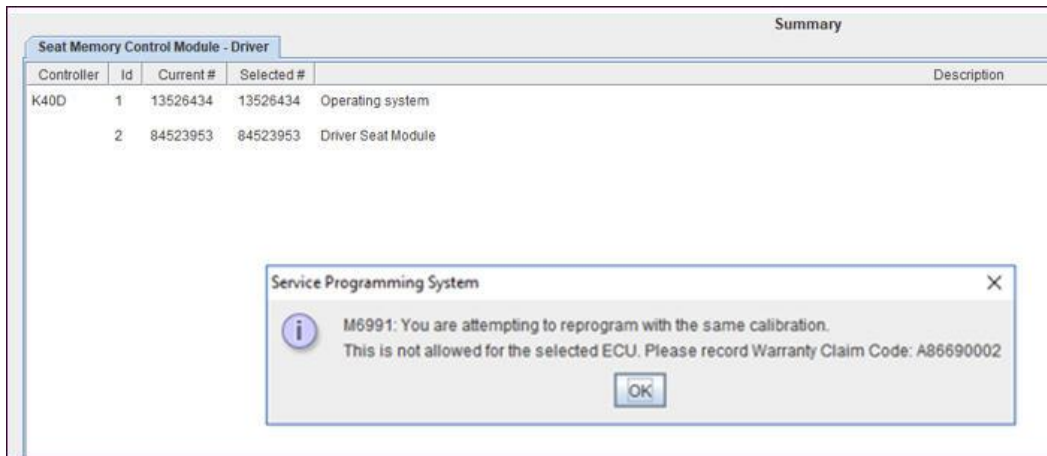
5164840

**Note:** If the Same Calibration/Software Warning is noted on the SPS Summary screen, record the warranty claim code (WCC) and select OK and follow screen instructions. After a successful programming event, the WCC is located in the Service Programming System dialogue box of the SPS Summary screen. No further action is required. Refer to the Warranty section of the bulletin.
