GLOBAL SAFETY FIELD INVESTIGATIONS
DCS5148
URGENT - DISTRIBUTE IMMEDIATELY

Subject: N182206730-01 – Customer Satisfaction Program
Hard Pedal at Low Speed Stops
Revised Model Years

Models: 2018 Chevrolet Silverado
Equipped with Special Service Package (RPO 5W4)
2018 – 2019 Chevrolet Tahoe
Equipped with Police Package (RPO 9C1) or Special Service Package
(RPO 5W4)

N182206730 Hard Pedal at Low Speed Stops

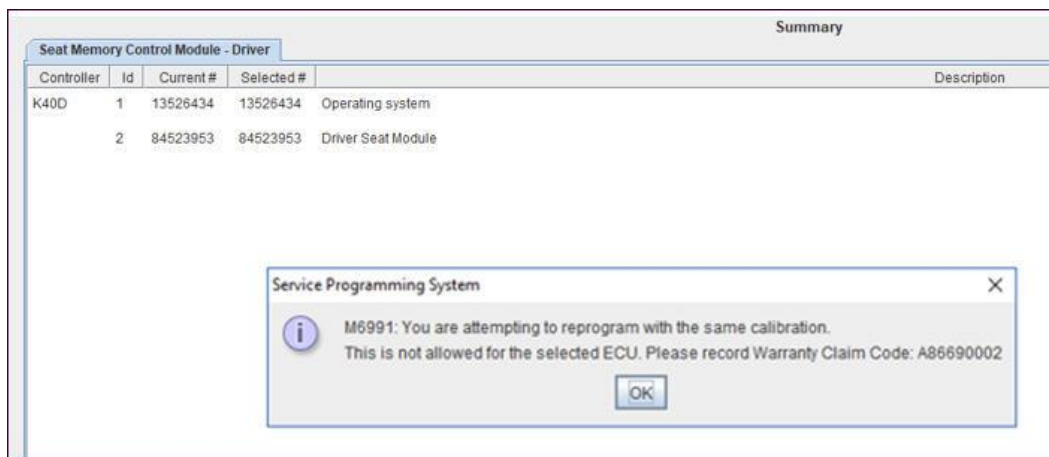
5164840

Note: If the Same Calibration/Software Warning is noted on the SPS Summary screen, record the warranty claim code (WCC) and select OK and follow screen instructions. After a successful programming event, the WCC is located in the Service Programming System dialogue box of the SPS Summary screen. No further action is required. Refer to the Warranty section of the bulletin.
