Subject: N192264760 - Customer Satisfaction Program  
Water Leak at Driver Side C-Pillar

Models: 2019 Chevrolet Silverado 1500 (New Model)  
2019 GMC Sierra 1500 (New Model)

## N192264760 Water Leak at Driver Side C-Pillar

Release Date: September 2019

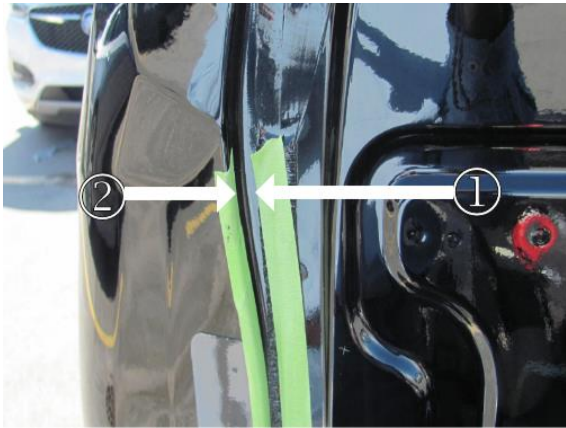
5411916

2. Locate the caulked seam where the left bodyside meets the rear body panel.
3. Use a damp towel to clean the repair area as necessary.
