Subject: N172130462-02 - Customer Satisfaction Program

Loss of Propulsion Due to Low Cell Voltage

Models: 2012 - 2015 Chevrolet Volt

2014 - 2016 Cadillac ELR

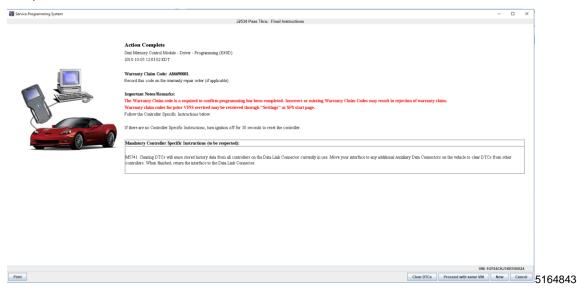
Note: If the Same Calibration/Software Warning is noted on the SPS Summary screen, record the warranty claim code (WCC) and select OK and follow screen instructions. The WCC is located in the Service Programming System dialogue box of the SPS Summary screen. No further action is required. Refer to the Warranty section of the bulletin.

Reprogram the hybrid powertrain control module 2. Refer to Hybrid Powertrain Control Module 2 Programming and Setup in SI.

2. Record SPS Warranty Claim Code on job card for warranty transaction submission.
