SUBJECT:			No:	TSB-19-35-002REV	
				September 2019	
				MODEL: See below	
CIRCULATE TO:	[] GENERAL MANAGER	[X] PARTS MANAGER		[X] TECHNICIAN	
[X] SERVICE ADVISOR	[X] SERVICE MANAGER	[X] WARRANTY PROCESSOR		[] SALES MANAGER

This bulletin supersedes TSB-19-35-002, issued January 2019, to update symptoms in the Purpose section, and to remove Outlander PHEV from the Affected Vehicles. Changes are italicized and indicated by ◀.

PURPOSE

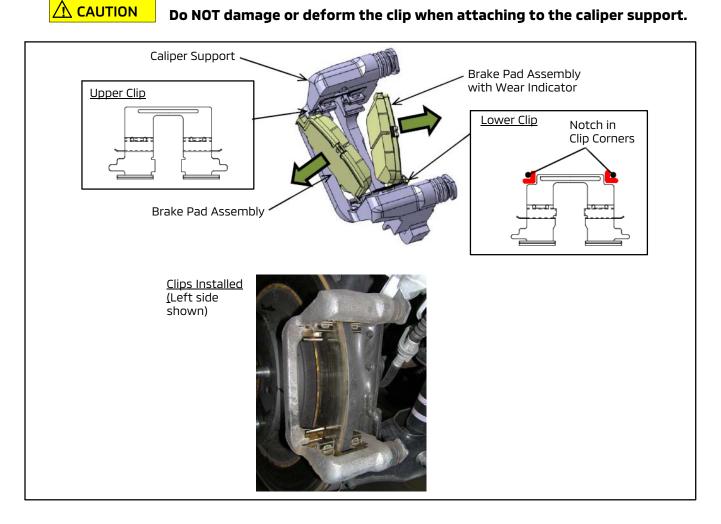
NOTE: Be sure to install the correct clip (upper or lower). Refer to illustration below for identification of upper and lower clips.

3. Attach the clips from the **<u>new</u>** clip set (PN 4605B885) to the caliper support.

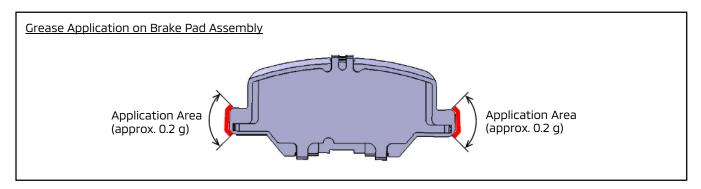
!! IMPORTANT !! Apply grease uniformly so that the base of the brake pads are completely covered with grease, as shown.

- 4. Apply the grease included in the new clip set to the application area of the brake pad assembly, as shown in the diagram below.
 - Apply approximately 0.2 g of grease per application area.

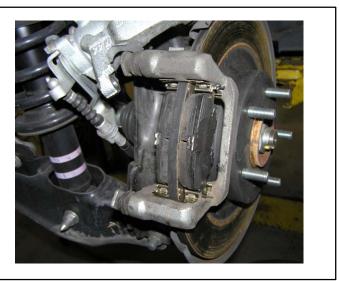
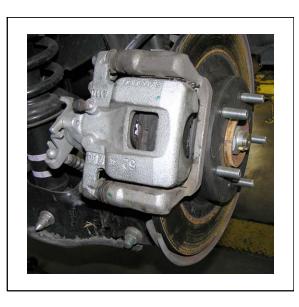
(2) Fit the upper side into the clip, while pressing the lower side of the brake pad assembly. **NOTE: Right rear shown in photo below.**

- Make sure to NOT get any grease on the surface of the brake disc or brake pad.
- If any grease gets on the brake disc or pad, wipe it off with brake cleaner.

- 5. Attach the brake pad assembly to the caliper support.
 - (1) Start assembly from the lower side of the brake pad assembly.
