# Technical Service Bulletin

| SUBJECT: | | | No: <b>TSB-19-54-016</b> |
| <b>WARRANTY EXTENSION OF ON-BOARD CHARGER &amp; DC-DC CONVERTER</b> | | | DATE: <b>September 2019</b> |
| | | | MODEL: <b>2012-13 i-MiEV</b> |

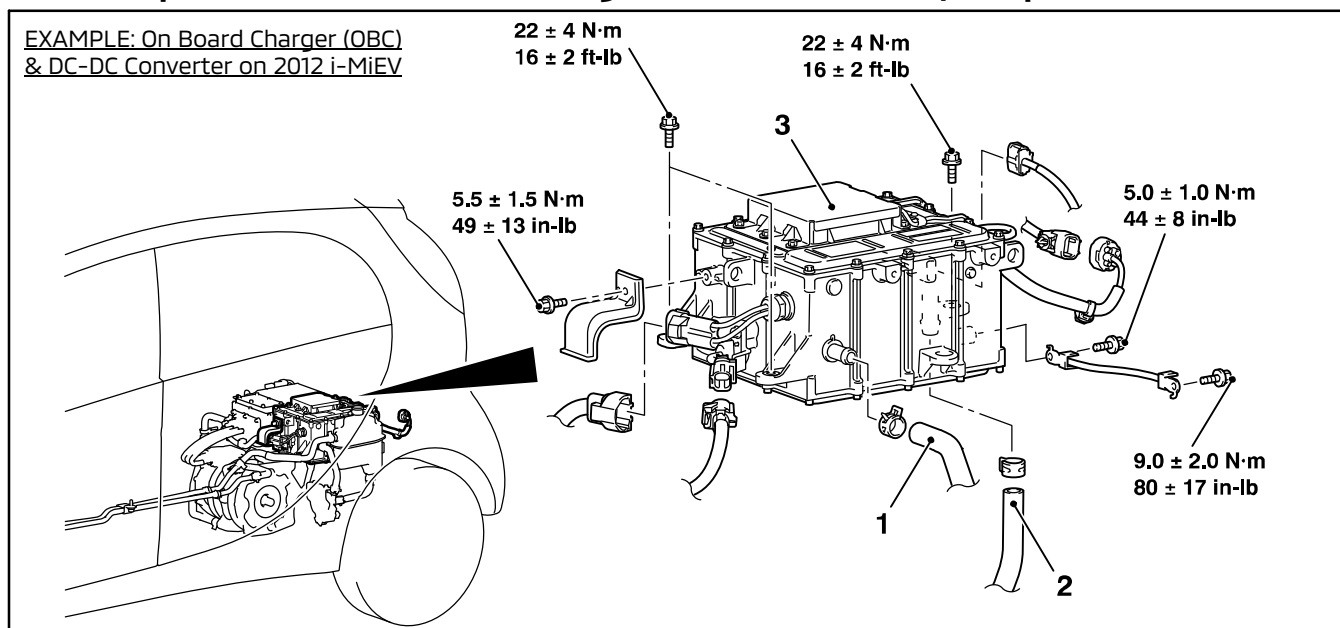
**⚠ WARNING** When servicing high-voltage system parts, be sure to wear the specified protection equipment and disconnect the service plug to interrupt the high-voltage supply (Refer to specific instructions and warnings in the Service Manual, Group 54D).

1. Confirm that DTC P0A09 has set for the DC-DC converter, and that the high voltage fuse in the Motor Control Unit (MCU) is blown.  
For diagnosis of DTC P0A09, refer to the applicable Service Manual, Group 54D, Electric Motor Unit and Traction Battery / EV-ECU / Diagnostic Trouble Code Procedures / DTC P0A09 DCDC Converter. Also see **TSB-19-54-014** (DTC P0A09: DC-DC Converter Revision - SMR).
2. Replace the On-Board Charger (OBC) with a new one, following the procedure in the applicable Service Manual, Group 54D, Electric Motor Unit and Traction Battery / On Board Charger/DC-DC Converter (OBC) / Removal and Installation.

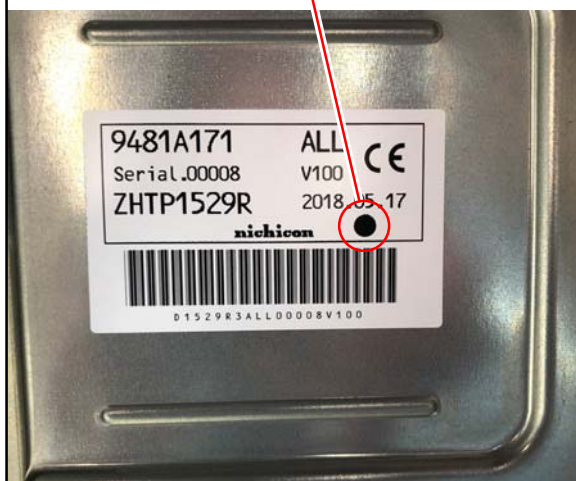
EXAMPLE: Countermeasure Mark on Label of Updated On-Board Charger (OBC)

**NOTE: The countermeasure OBC part (p/n 9481A171) should have a mark (black dot) on the label, as shown.**
