SIB 72 04 17

## FALSE WARNINGS THAT THE FRONT PASSENGER SEAT IS OCCUPIED WITHOUT THE SEAT BELT BUCKLED

This Service Information bulletin (Revision 9) supersedes SI **B72 04 17** dated **September 2019**.

### **PASSENGER OCCUPANCY DETECTION ERROR CORRECTION**

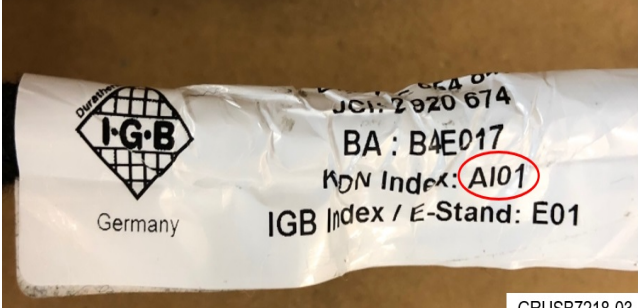
| | <p>As referenced in the Diagnosis Chart attachment, an AI index of 01 is shown (circled).</p> |

3. If steps 1 and 2 do not identify the cause of the warnings, access the label on the seat mat harness and follow the attached diagnosis flow chart. If the flow chart recommends installation of 2 cable ties, proceed to step 4.

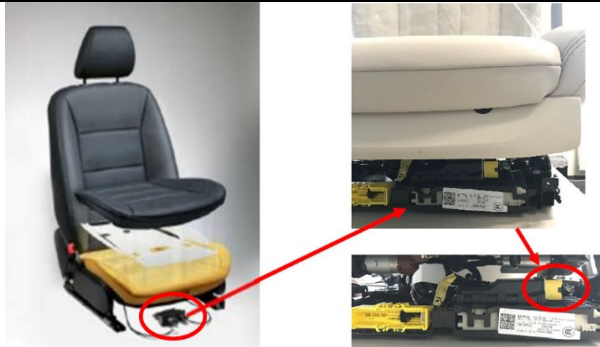
| A composite image showing the process of removing the lower front seat trim. On the left is a diagram of a car seat with a red circle around the base. On the right are two photographs: the top one shows the trim being detached from the seat, and the bottom one shows the internal components with a red circle around a specific area. | <ol style="list-style-type: none"><li>1. Move the front seat to its highest position.</li><li>2. Detach the lower front seat trim.</li><li>3. Disconnect the Evaluation Electronics (CIS) plug connection.</li></ol> |

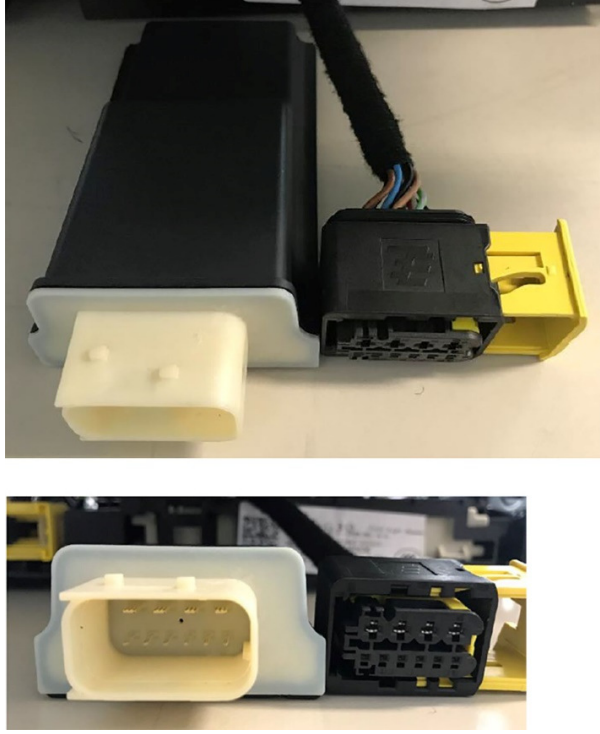
| Two photographs showing the CIS plug and connector. The top photo shows a black control unit with a yellow connector. The bottom photo is a close-up of the yellow connector and the black plug, showing the internal pins. | <ol style="list-style-type: none"><li>4. Check the plug for conditions resulting in possible poor electrical connection – corrosion, bent pins, etc. – removing control unit if needed, as shown.</li><li>5. Repair any connection problems.</li><li>6. Securely re-install control unit, if removed.</li><li>7. Reconnect plug into CIS.</li></ol> |
