SIB 51 30 19 GROANING NOISE FROM DOORS

E-Series	Model Description
F15	X5 Sports Activity Vehicle
F16	X6 Sports Activity Coupe
F85	X5 M Sports Activity Vehicle
F86	X6 M Sports Activity Coupe

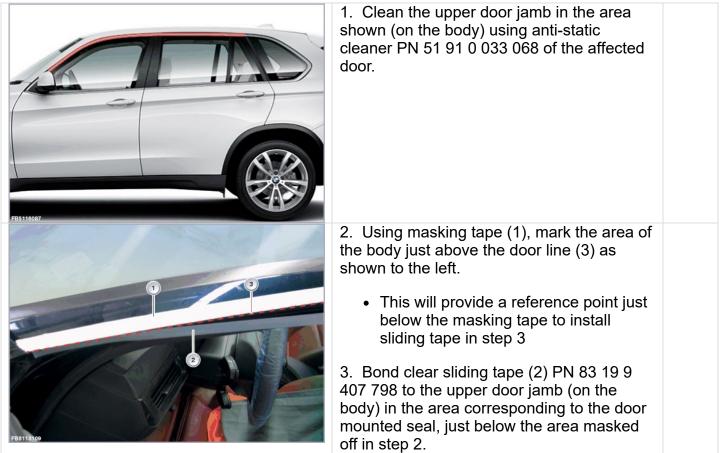
A groaning noise is present from the door frame of any door, most commonly when driving over rough roads or during body flex.

Excessive friction between the window guide and the door opening.

Install anti-friction sliding tape to the door jamb area.

• Press firmly over the entire tape surface for maximum adhesion

4. Remove the masking tape from step 2 and ensure bubbles are not present in the clear sliding tape.
