SIB 52 22 19

2019-09-12

## NOISE DURING FORWARD / BACK SEAT ADJUSTMENT OVER THE ENTIRE LENGTH OF TRAVEL

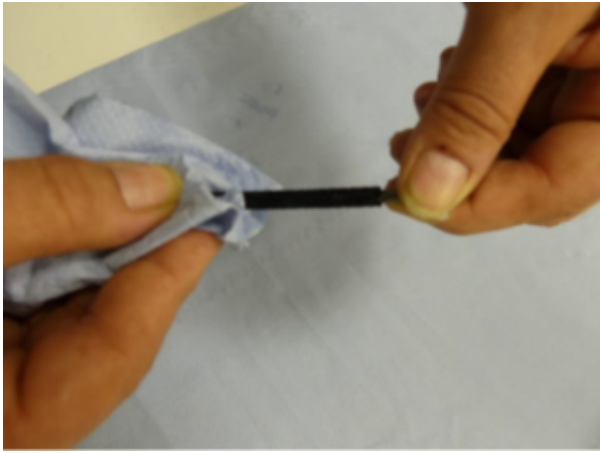
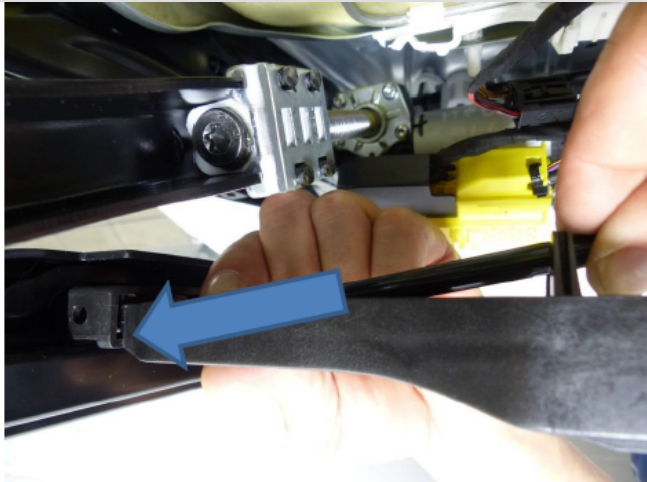
This picture shows the disassembled motor and drive shafts.

1. Motor
2. Outer housing of the cable
3. Flexible drive shafts

Remove the drive shafts from the seat track assembly.

Slide the inner flexible drive shaft out of the outer housing on the cable (2x).

Lubricate the flexible drive shaft over its entire length using a lint-free cloth and P/N 83 23 9 407 810 Grease (NBU 12K)

Reassemble the flexible drive shaft into the outer housing for the cable (2x).
