SIB 54 07 19

GURGLING NOISE FROM SUNROOF DRAINS

E-Series	Model Description
F15	X5 Sports Activity Vehicle
F85	X5 M Sports Activity Vehicle

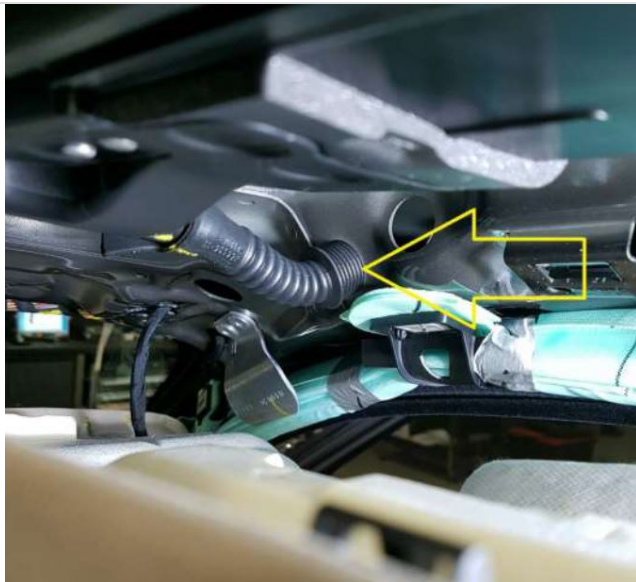
The photo shows a sunroof drain hose which has come out of position, hangs down, and allows water to collect.

Note: In this example, the rubber grommet has pulled out from the body of the vehicle.

4. Correctly install the drain hose(s) back into the vehicle body.

Note: Ensure that the hoses are completely seated into the vehicle body as shown above.

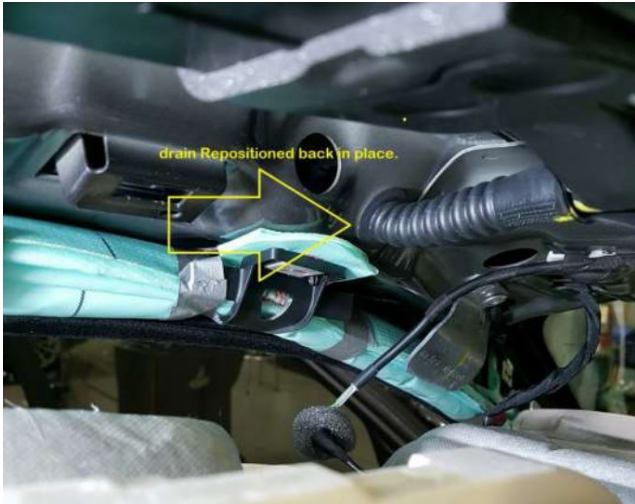
Properly installed drain hose.

- The drain hose does not hang down
- Water cannot collect
