SIB 54 09 19

RUBBER BUMPER PAD PULLS OFF OF CONVERTIBLE TOP LATCH

E-Series	Model Description	Production Date
G14	8 Series Convertible	Produced until January, 2020
G29	Z4 Roadster	Produced until January, 2020

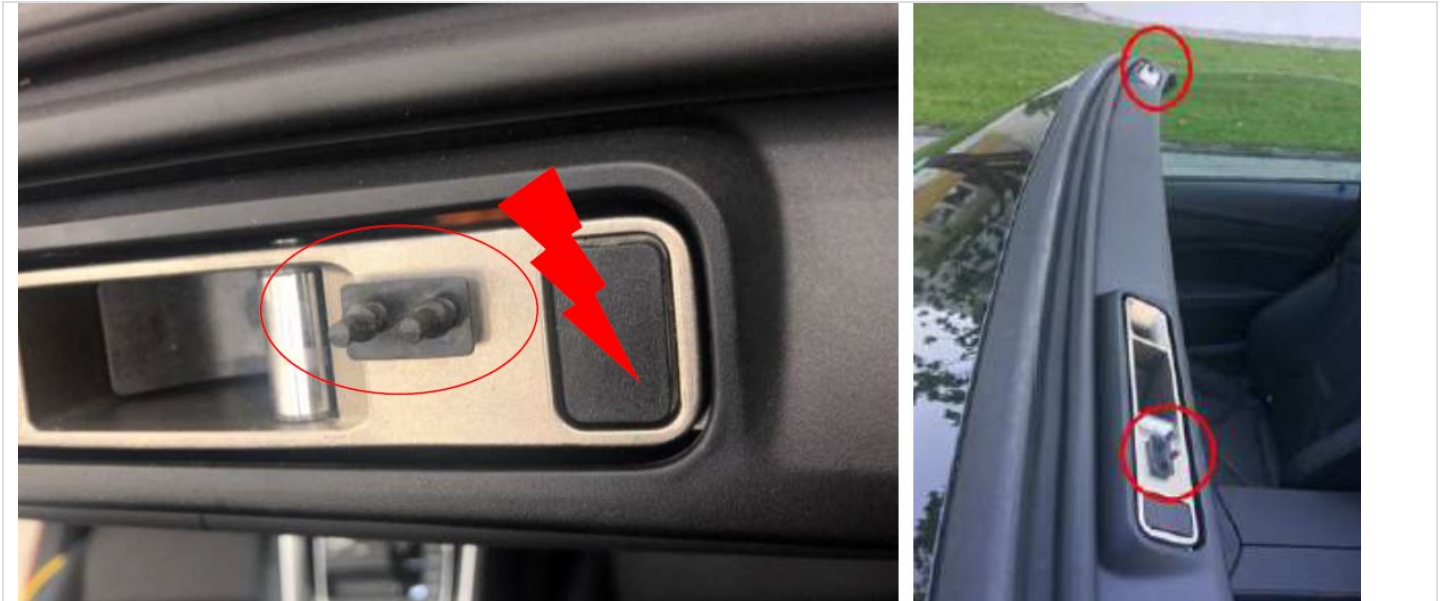
Rubber bumper pads (circled) are normally attached to the latch on the convertible top. Under certain circumstances, one or both pads stick to the corresponding latch plate above the windshield, pulling away from the latch. This can also cause a check control message 270 stating that the soft top is not locked.

The mating surface of the bumper pad is too smooth, so that it can possibly stick to the latch plate above the windscreen panel.

Scuff the mating surfaces of the bumper pads and reinstall. No adhesive is necessary.
