## SIB 54 11 19 SUNROOF WATER LEAK DIAGNOSIS

This bulletin outlines multiple known areas of possible water entry for the vehicles listed above. It serves only as a diagnostic resource in troubleshooting water leak complaints from the roof area.

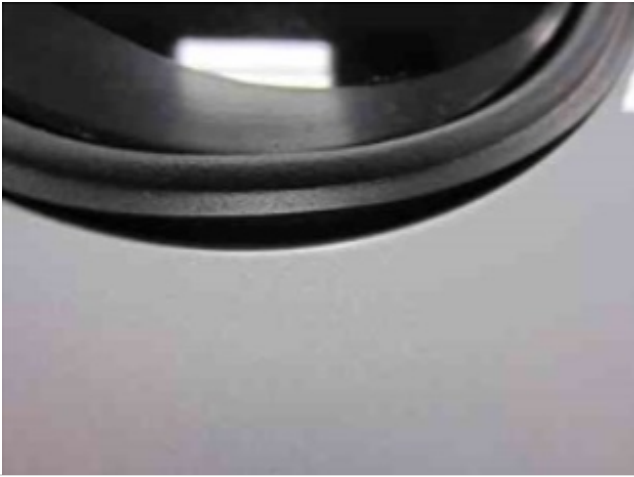
#### **Damage to the sunroof perimeter seal mounted to the roof**

This typically occurs in the corners.

Additional damage may include indentation or deformity at any point of the perimeter seal.

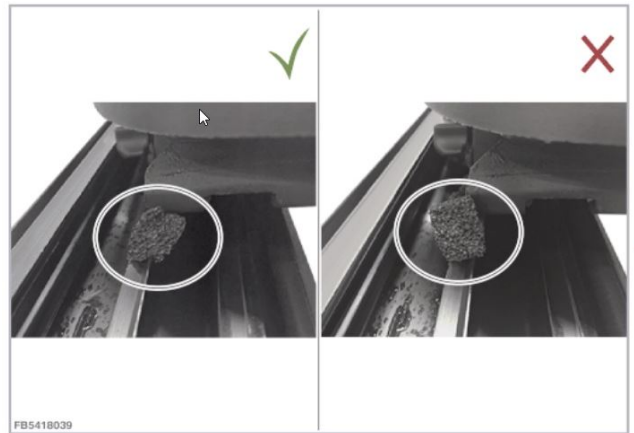
**Misplaced or damaged support foam for the center drip tray**

Photo shows correct (green) vs incorrect (red).

If the foam has become misplaced:

- Correctly position support foam, operate sunroof 5 times, and check to ensure proper position remains.
- Replace foam if found out of place after operation.

If the foam is missing or damaged:

- Replace support foam, ensuring proper installation as shown to the left.

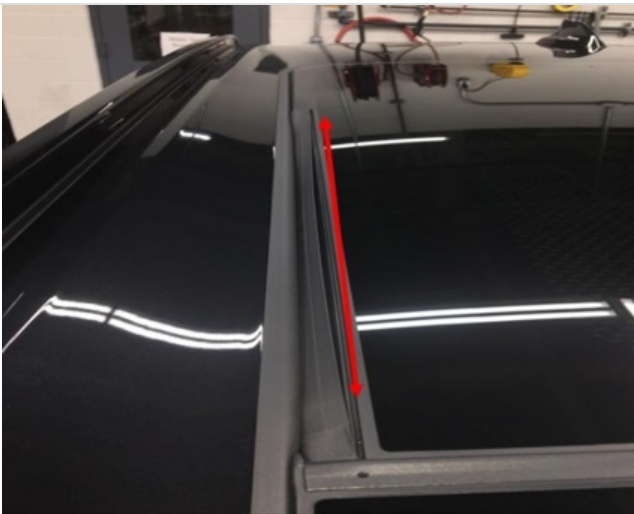
**Damaged side seals of the rear sunroof glass panel**

Note the gap and incomplete installation of the side seal (long arrow; passenger side shown, looking rearward).

If the seal is incorrectly installed:

- Replace the glass panel side seals.

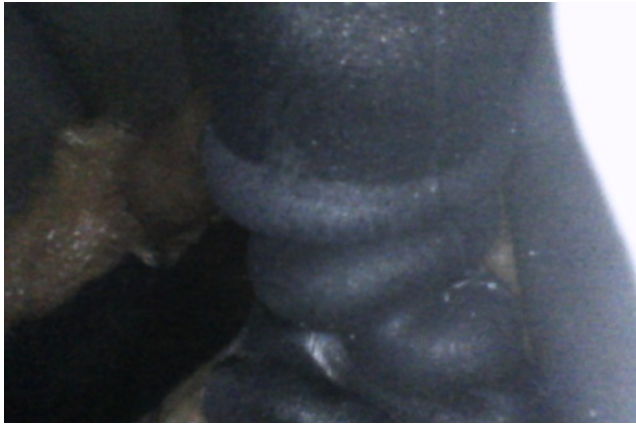
**Improperly installed, clogged, or kinked panoramic sunroof drain(s)**

- Position the vehicle on a flat surface
- Familiarize yourself with which sunroof "track" is used for water management. Ensure water is ONLY introduced to the water management track of the sunroof.

- Introduce approximately 300ml of water to each drain tube and compare drainage speed at all the tubes.

If water enters the vehicle during testing, or one drain tube is slower than the others, remove the corresponding interior trim as needed to investigate causes of potential blockages.
