SIB 64 09 19

SERVICE ACTION: CHECKING HEATER HOSE FOR PROPER
INSTALLATION

E Series	Model Description	Production Date
F97	X3 M Sports Activity Vehicle	April 2019 to July 2019
F98	X4 M Sports Activity Vehicle	April 2019 to July 2019

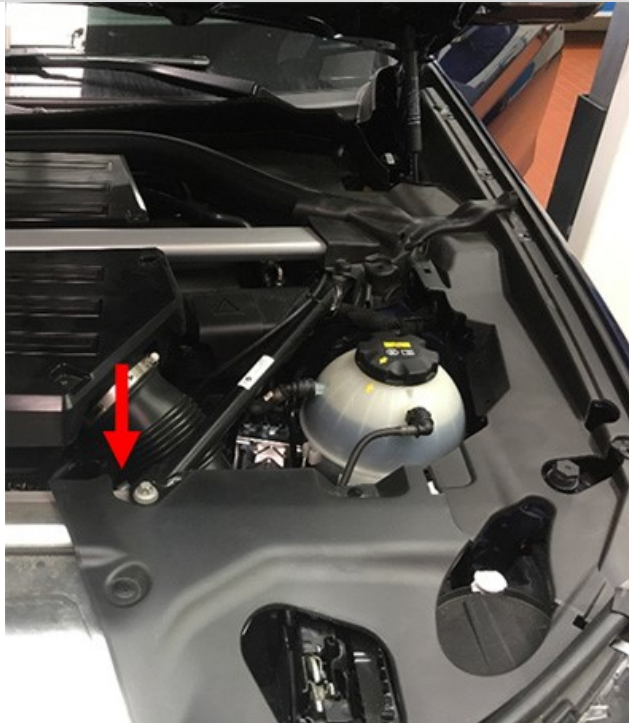
1. To gain access, the intake air nozzle on the driver's side of the engine should be moved. This can be done by loosening the clamp.

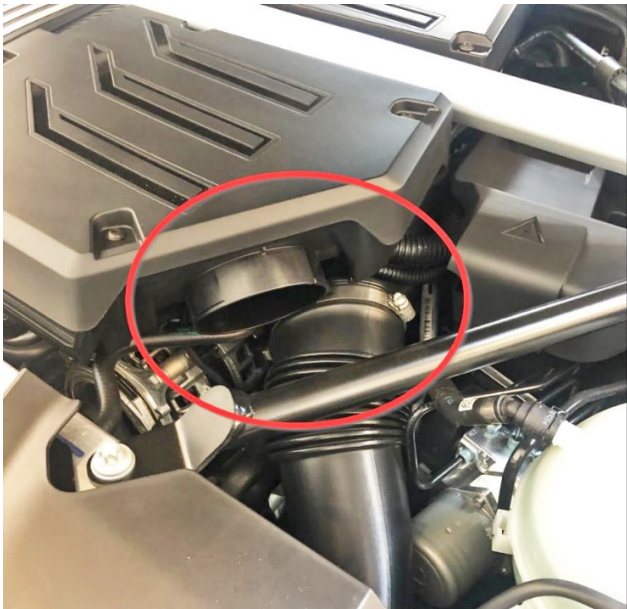
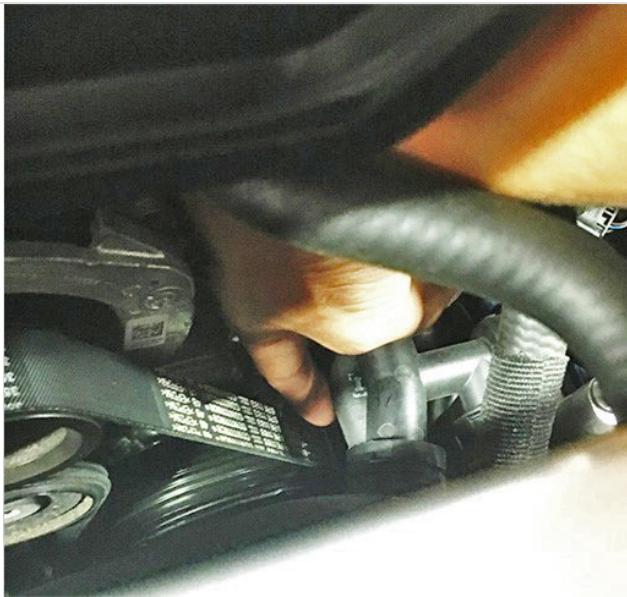
2. Move the intake nozzle to the side (circled).

3. Locate the lower heater hose and check the distance between the drive belt and the heater return hose. A finger should fit between the drive belt and the heater return hose. If a finger fits, the clip of the heater return hose is correctly fastened.

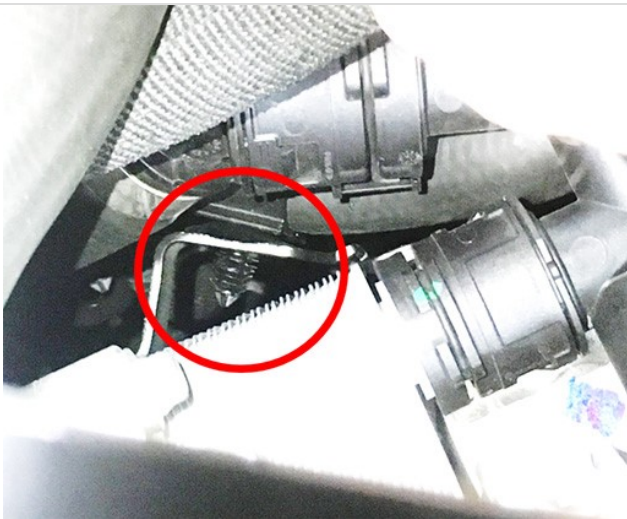
4. If the clip is not correctly mounted, the clearance between the drive belt and the heater return hose is too small. Therefore, the hose is not secured and can be moved easily.

- If necessary, push the clip into the metal holder (circled)

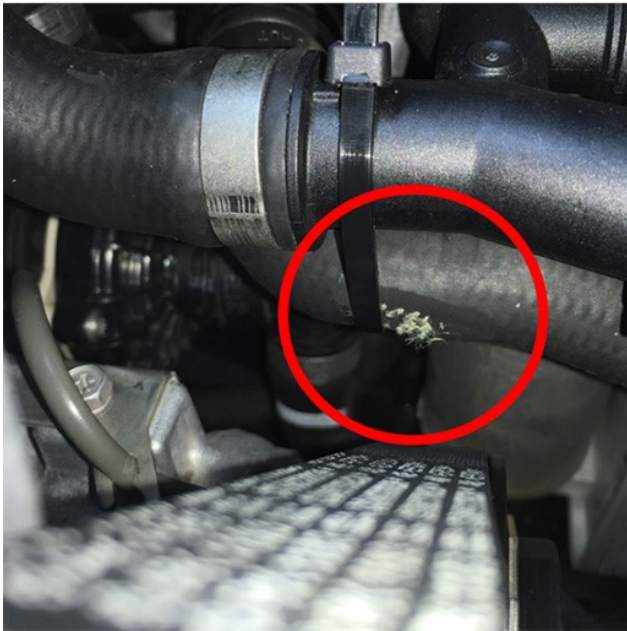
- If it is already scoured or shows other evidence of abrasion (circled), it must be replaced
