SIM 52 01 19

## NOISE DURING FORWARD / BACK SEAT ADJUSTMENT OVER THE ENTIRE LENGTH OF TRAVEL

F54 MINI Clubman

F60 MINI Countryman

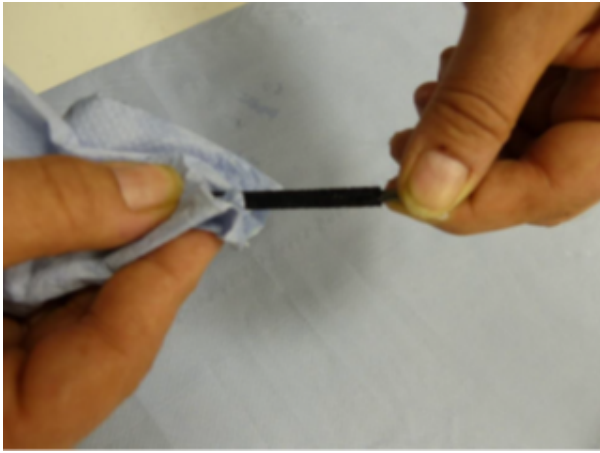
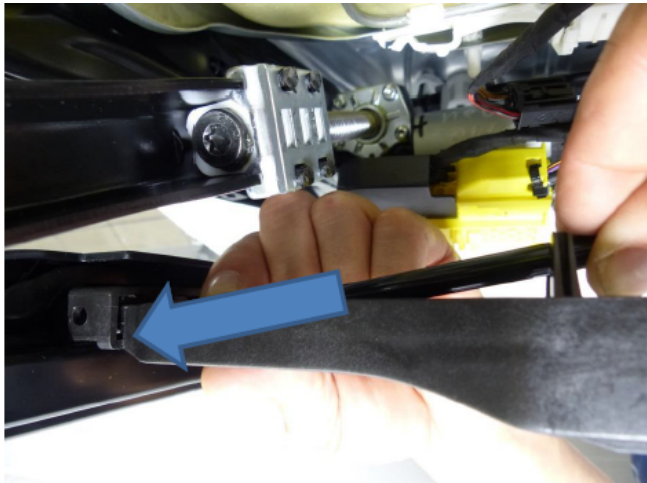
This picture shows the disassembled motor and drive shafts.

1. Motor
2. Outer housing of the cable
3. Flexible drive shafts

Lubricate the flexible drive shaft over its entire length using a lint-free cloth and P/N 83 23 9 407 810 Grease (NBU 12K)

Reassemble the flexible drive shaft into the outer housing for the cable (2x).
