NSX Interior Squeak and Rattle Repairs

This job aid shows the common sources of interior noise in the NSX, and how to repair them.

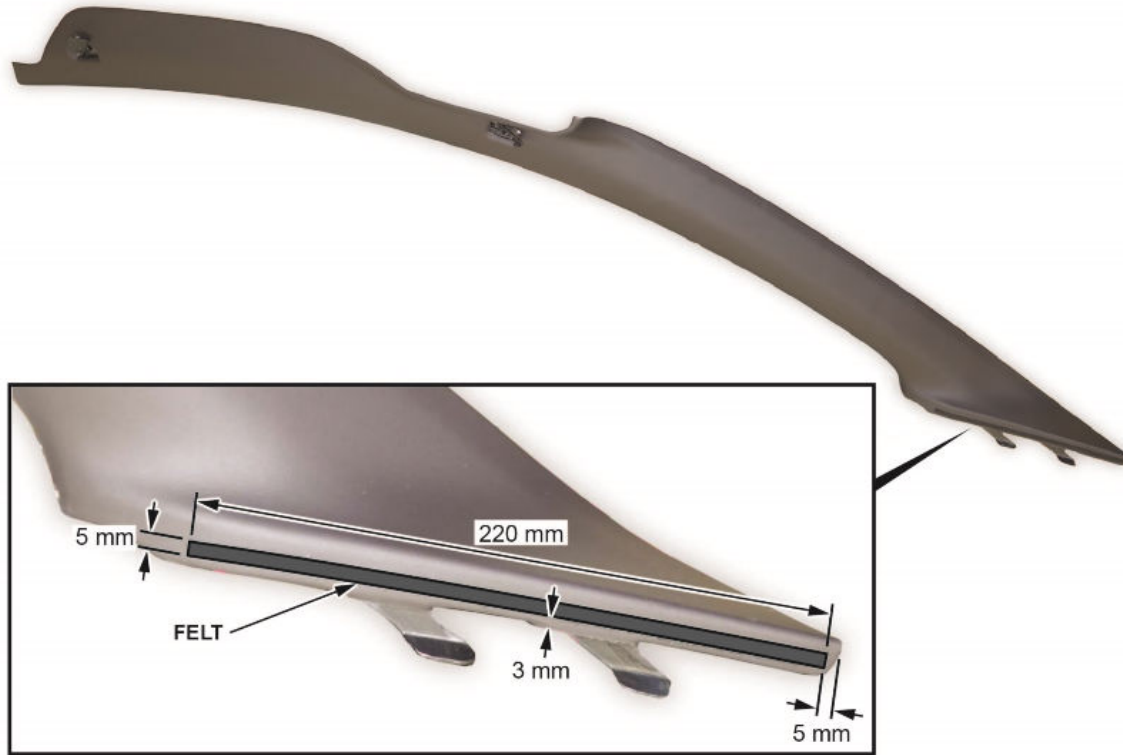
1. Remove the driver's A-pillar trim. Refer to the service information.
2. Check the felt at the base of the A-pillar. Replace the felt if it is missing or damaged.

- Remove any old felt from the A-pillar trim.
- Clean the area with isopropyl alcohol.
- Cut and apply a 220 x 5 mm piece of 1 mm-thick felt tape (P/N 06993-SA5-000).

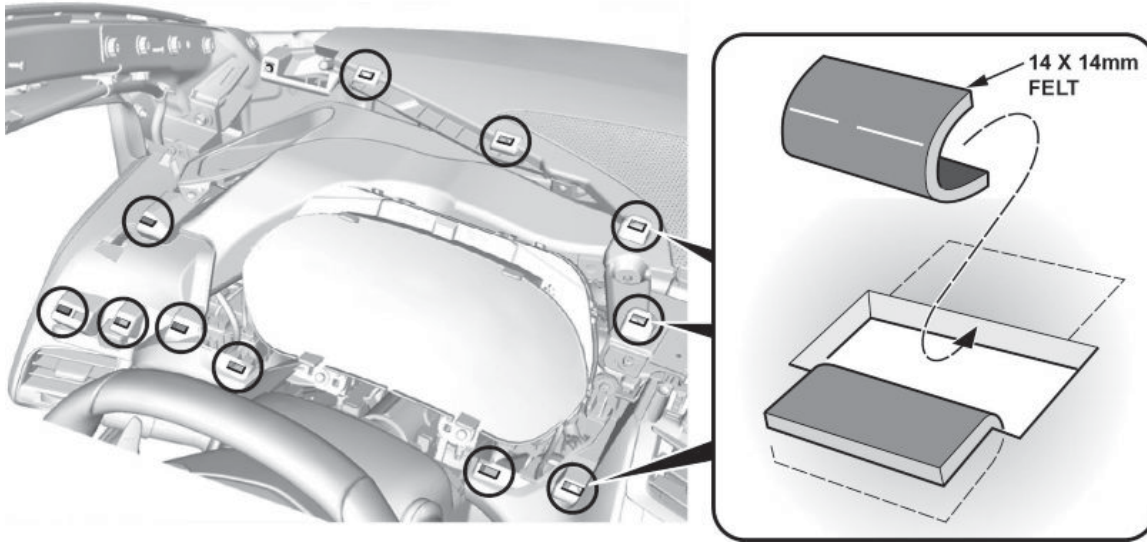
3. Remove the driver's dashboard panel. Refer to the service information.
4. Check if felt is applied to all 11 clip holes as shown. Replace the felt if it is missing or damaged.

- Remove any old felt from the dashboard.
- Clean the area with isopropyl alcohol.
- Cut and apply a 14 x 14 mm piece of 1 mm-thick felt tape (P/N 06993-SA5-000).

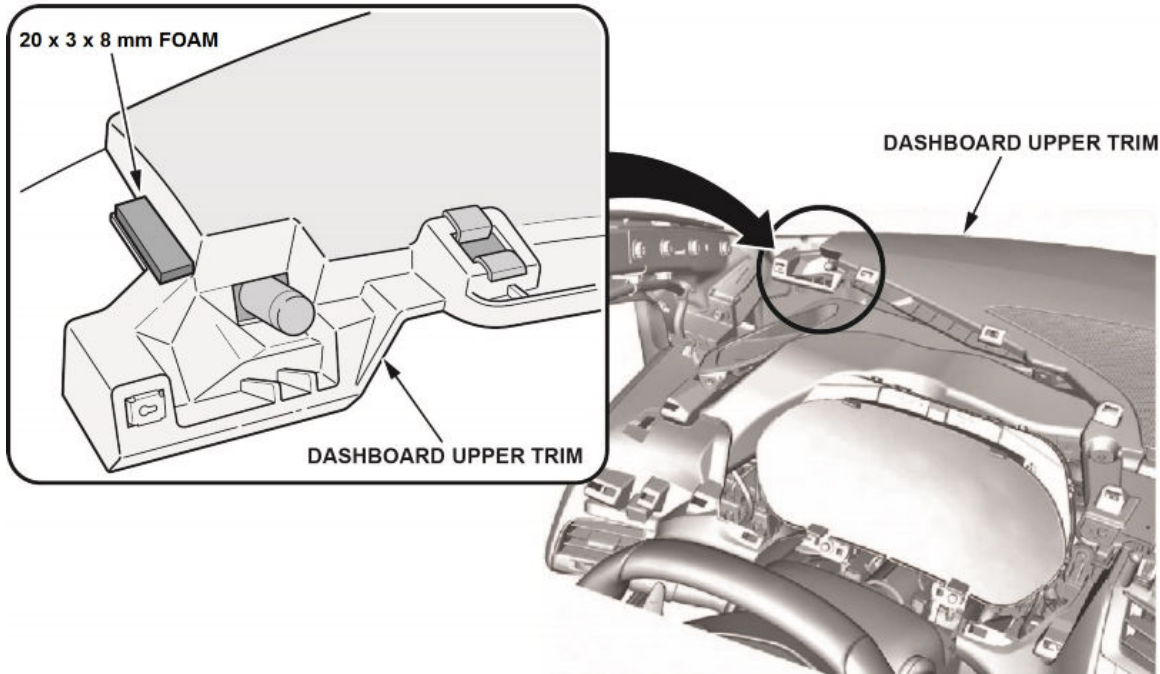
5. Check for foam at the edge of the dashboard where it contacts the A-pillar trim as shown below. If the foam is missing or damaged, replace it.

- Remove any old foam from the dashboard.
- Clean the area with isopropyl alcohol.
- Cut and apply a 20 x 8 mm piece of 3 mm-thick foam tape (P/N 06990-SA5-000).

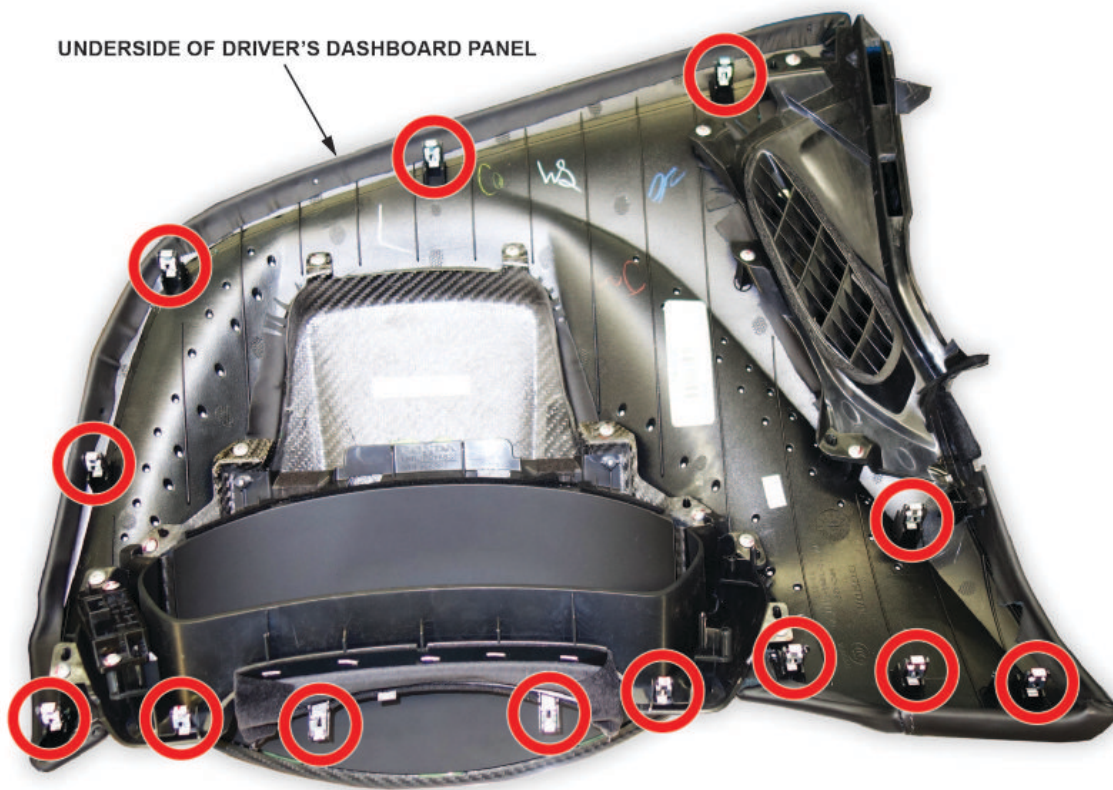
6. Turn over the driver's dashboard panel, and check if all of the 11 metal snap-fit clips are present and properly installed. Replace any clips if they are missing or distorted.

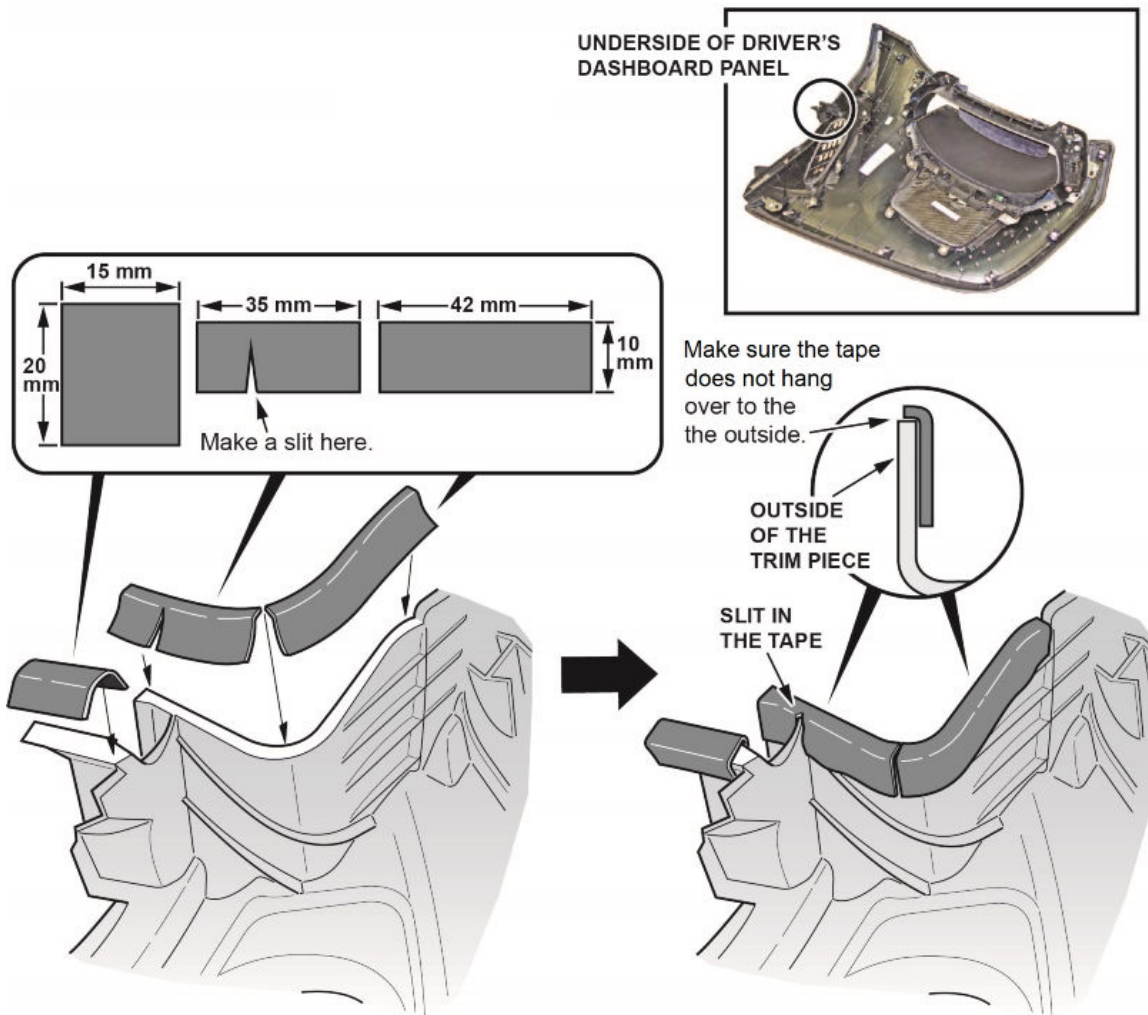
7. Check the underside of the dashboard panel, and make sure felt tape is properly applied to trim area as shown.

Cut and apply one 15 x 20 mm strip, one 35 x 10 mm strip, and one 42 x 10 mm strip of 1 mm-thick felt tape (P/N 06993-SA5-000). Slit the 35 x 10 mm strip as shown to clear the molded ridge behind the panel. Apply the felt strips as shown.

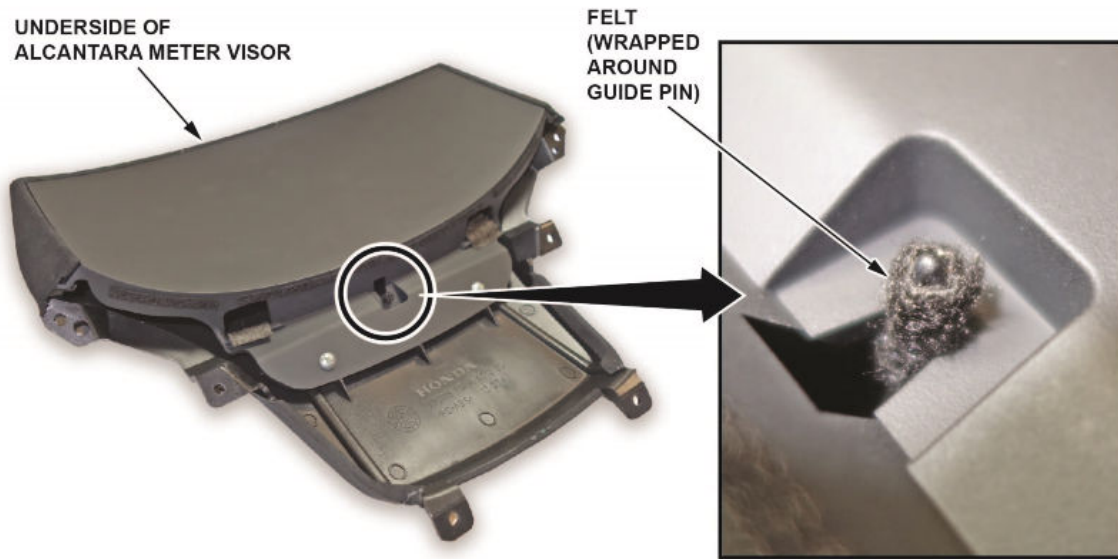
9. *Driver's dashboard with Alcantara covering*: Remove the meter visor from the dashboard panel. Refer to the service information.
10. Check the felt on the guide pin as shown. Replace the felt if it is missing or damaged. Use 1 mm-thick felt tape (P/N 06993-SA5-000).

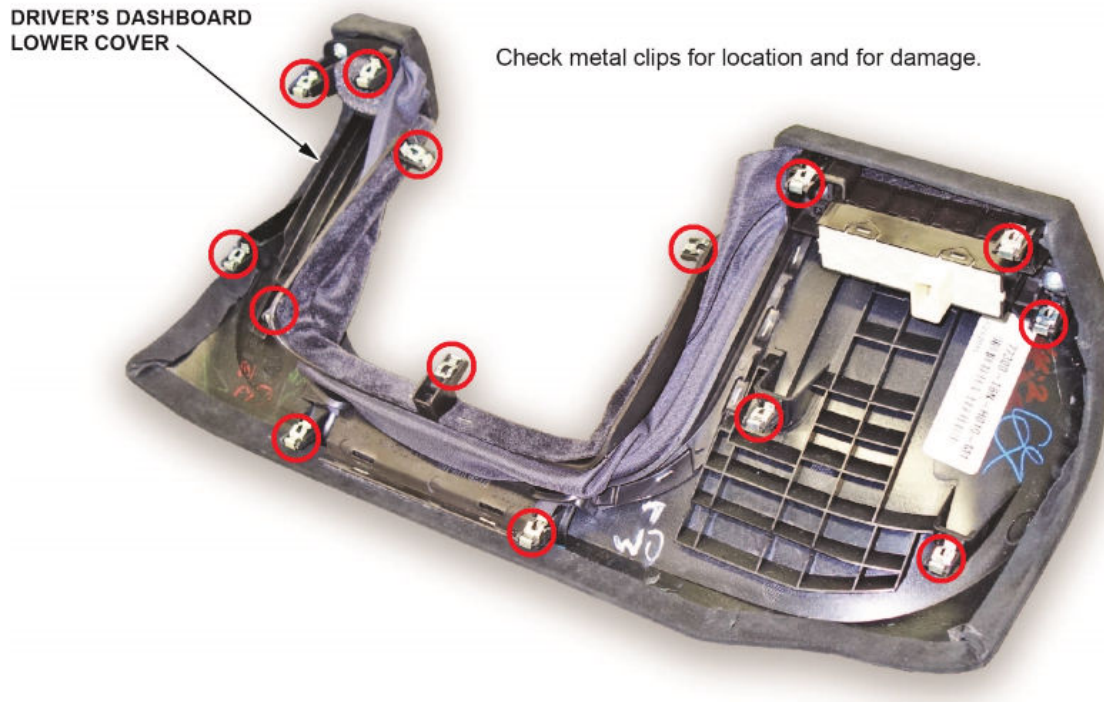
11. Remove the driver's dashboard lower cover. Refer to the service information.
12. Check if the metal snap-fit clips are present and properly aligned. Replace any clips if they are missing or distorted.

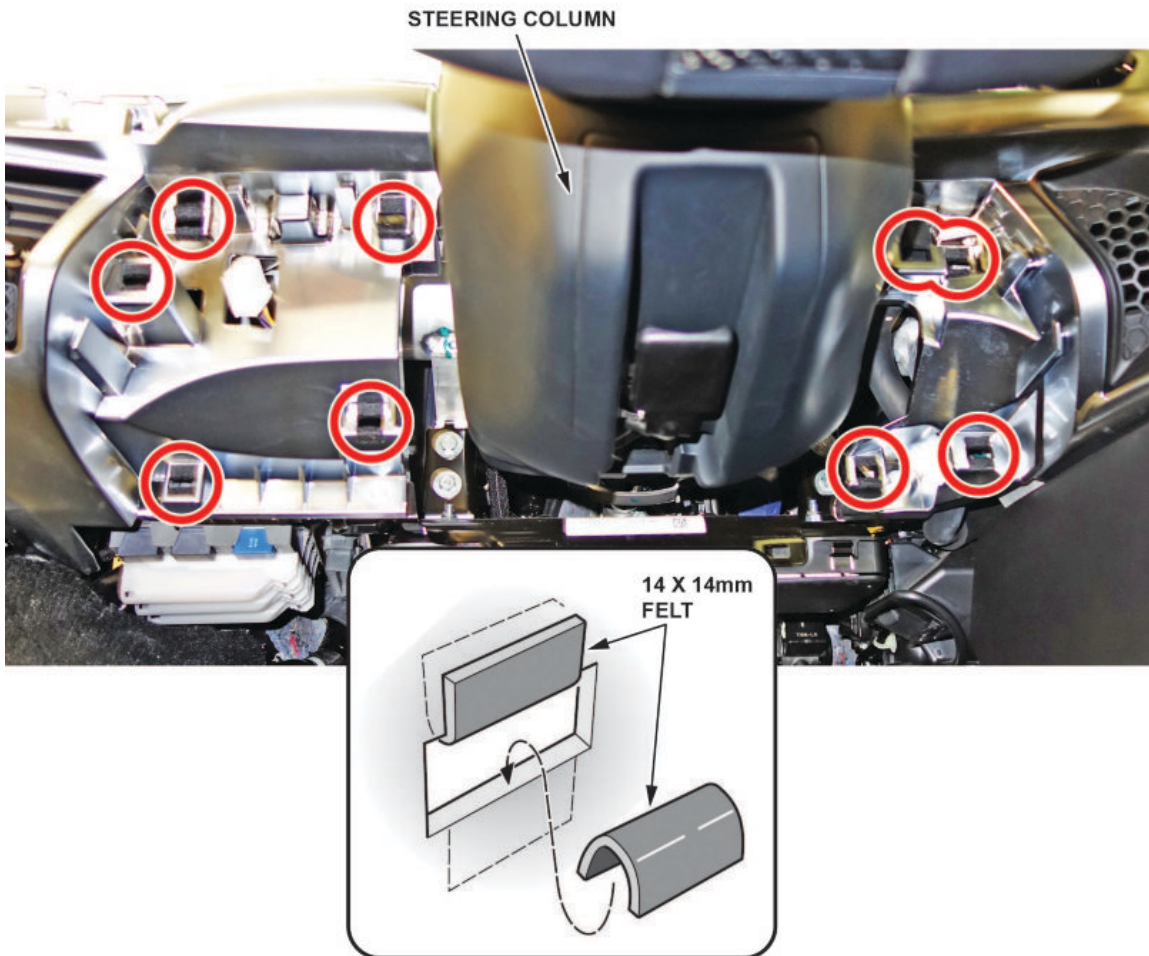
13. Check if felt is applied to the nine clip holes on the lower dashboard. Replace the felt if it is missing or damaged.

- Remove any old felt material from the dashboard, if present.
 - Clean the area with isopropyl alcohol.
 - Cut and apply a 14 x 14 mm piece of 1 mm-thick felt tape, (P/N 06993-SA5-000).
14. Install all parts in the reverse order of removal.

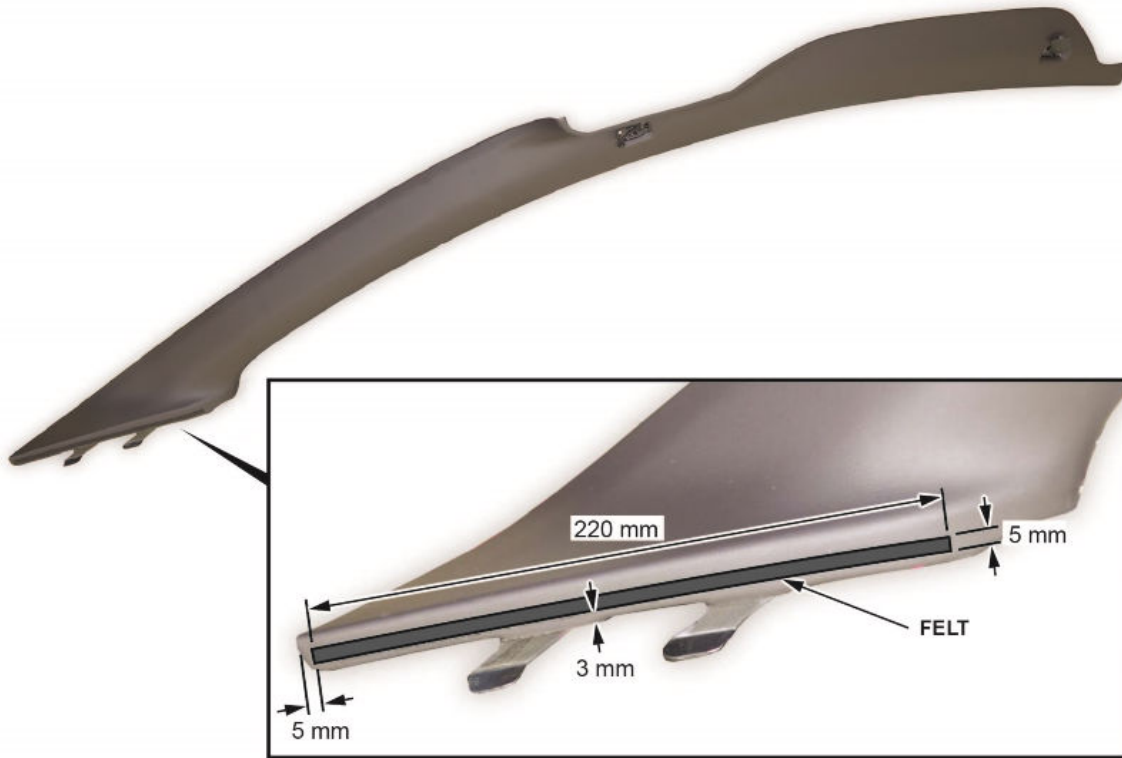
1. Remove the passenger's side A-pillar trim.
2. Check the felt at the base of the A-pillar. Replace the felt if it is missing or damaged.

- Remove any old felt from the A-pillar trim.
- Clean the area with isopropyl alcohol.
- Cut and apply a 220 x 5 mm piece of 1 mm-thick felt tape (P/N 06993-SA5-000).

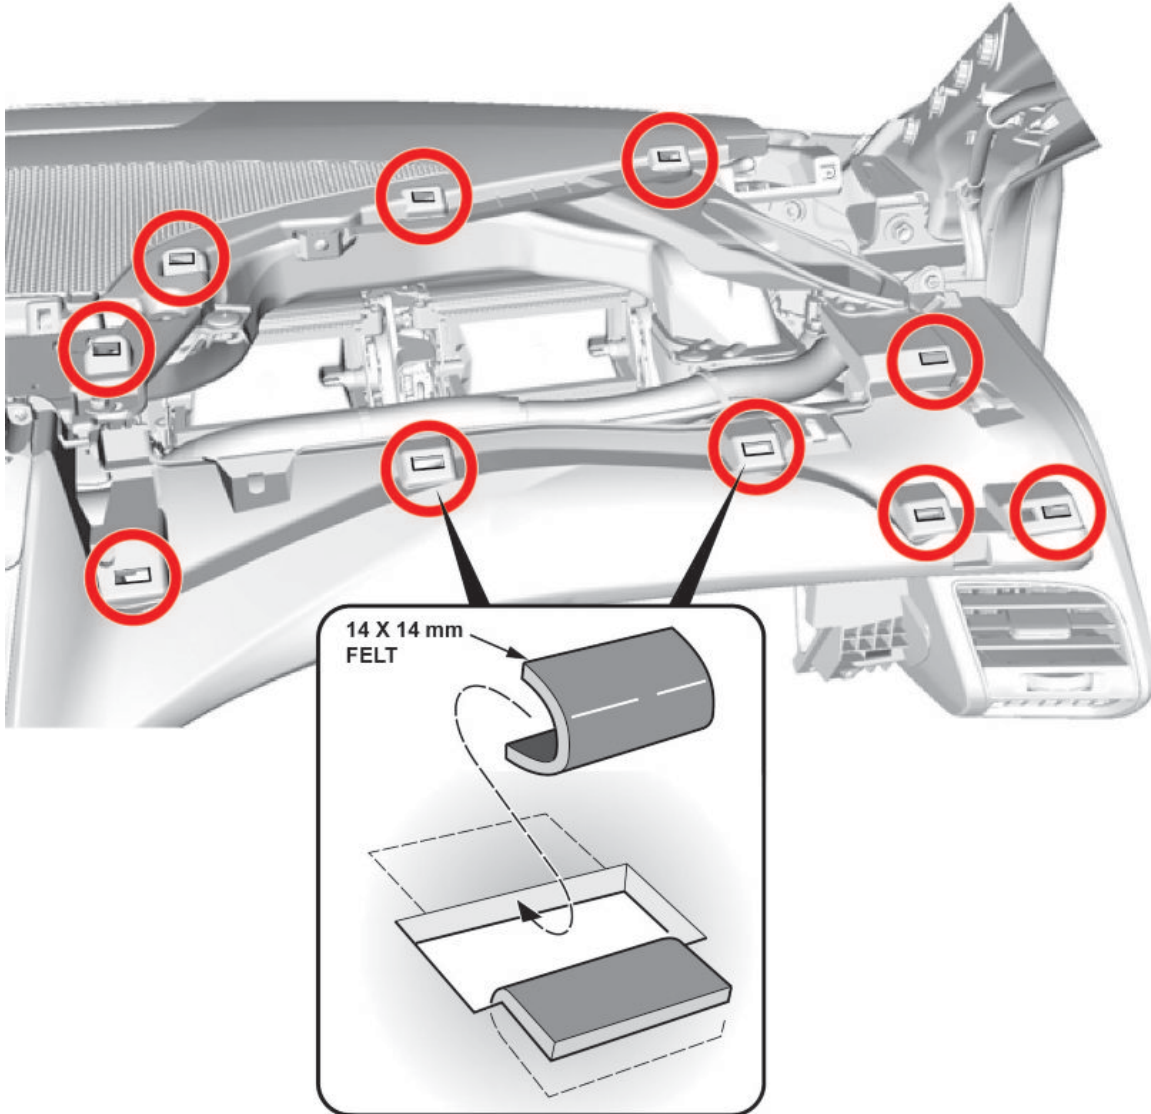
5. Check if felt is applied to all ten clip holes as shown. Replace the felt if it is missing or damaged.

- Remove any old felt from the dashboard.
- Clean the area with isopropyl alcohol.
- Cut and apply a 14 x 14 mm piece of 1 mm-thick felt tape (P/N 06993-SA5-000).

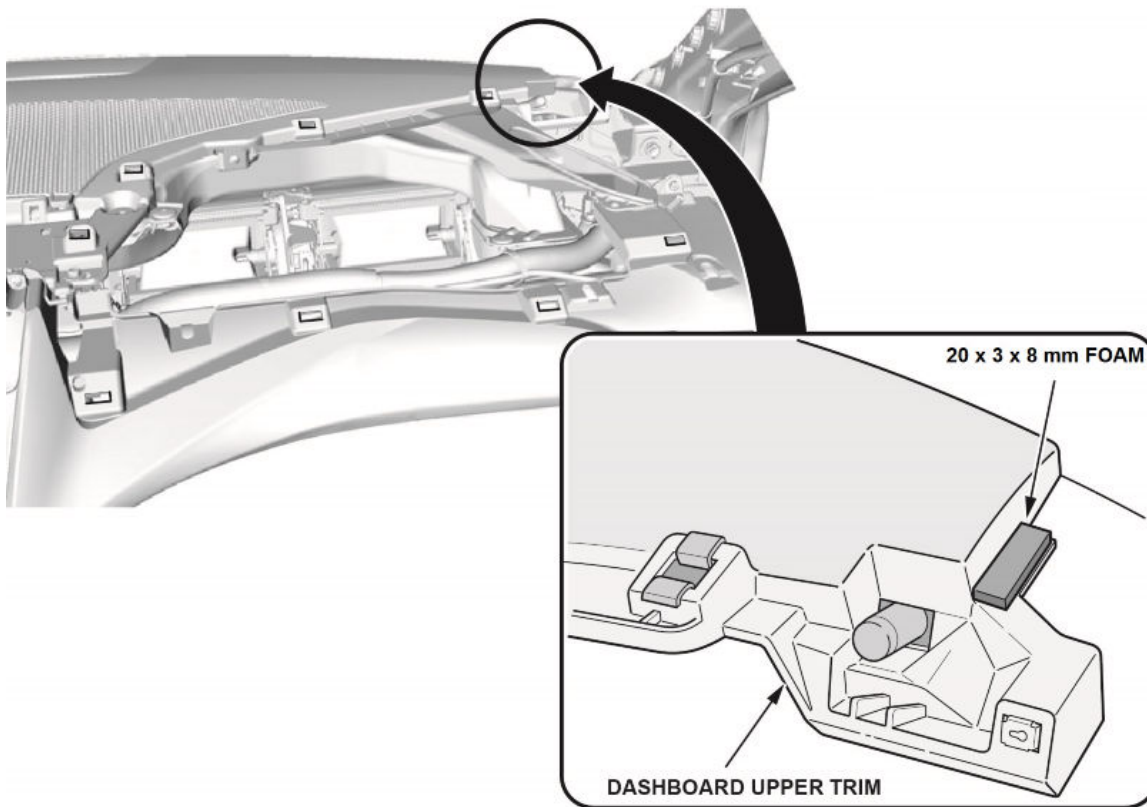
6. Check for foam at the edge of the dashboard where it contacts the A-pillar trim as shown below. Replace the foam if it is missing or damaged.

- Remove any old foam material from the dashboard if present.
- Clean the area with isopropyl alcohol.
- Cut and apply a 20 x 3 x 8 mm piece of 3 mm-thick foam tape (P/N 06990-SA5-000).

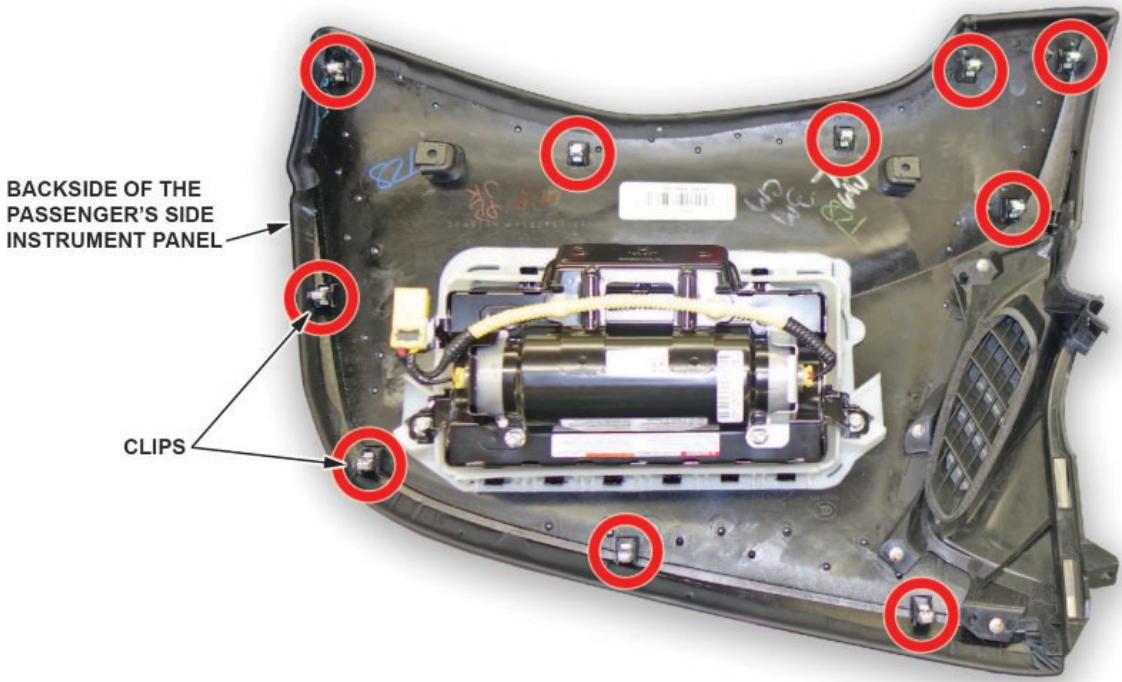
7. Turn over the passenger's dashboard panel, and check if all of the 10 metal snap-fit clips are present and properly installed. Replace any clips if they are missing or distorted.

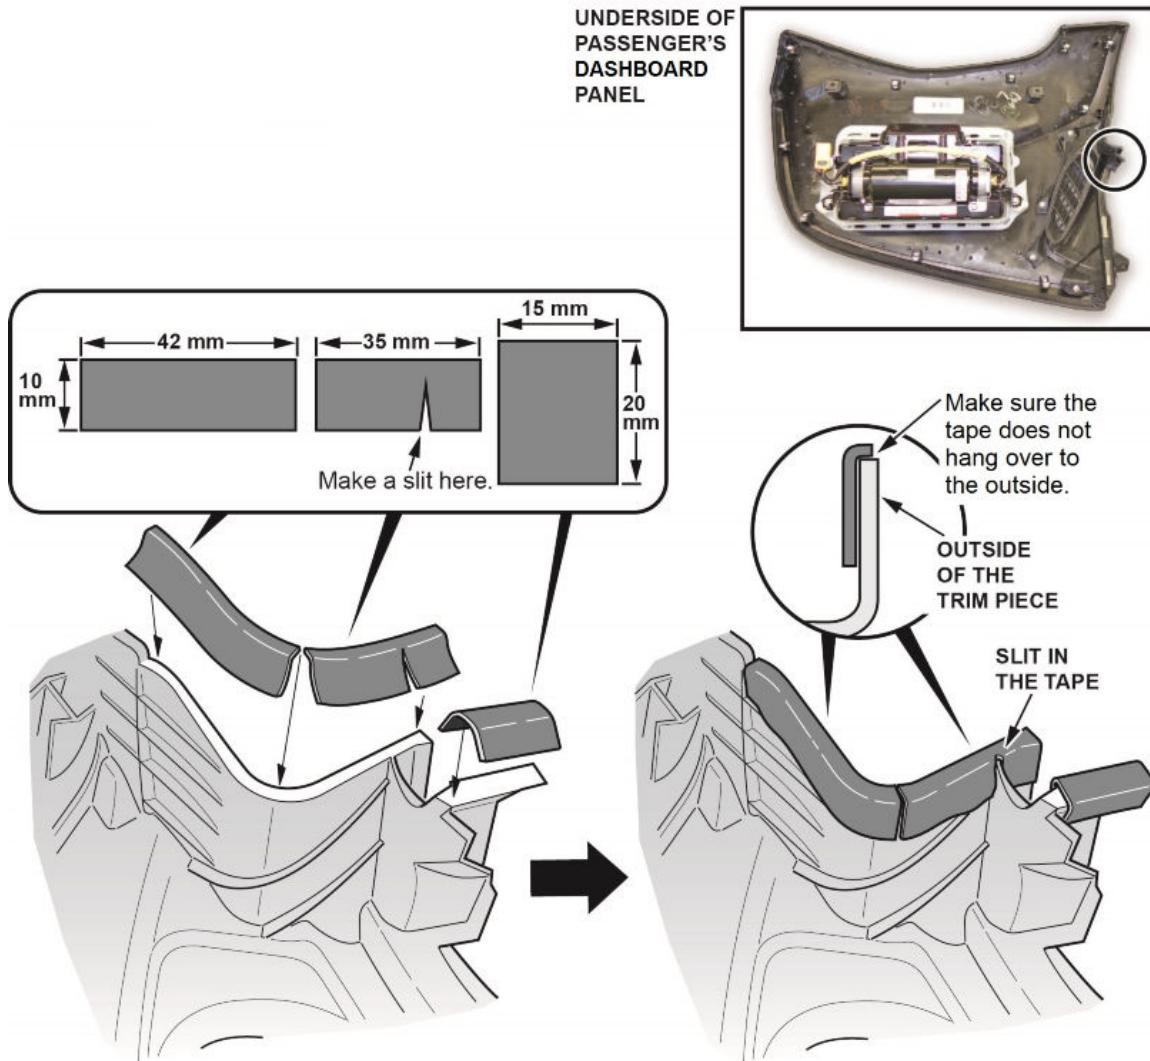
8. Check the underside of the dashboard panel, and make sure felt tape is properly applied to trim area as shown.

Cut and apply one 15 x 20 mm strip, one 35 x 10 mm strip, and one 42 x 10 mm strip of 1 mm-thick felt tape (P/N 06993-SA5-000). Slit the 35 x 10 mm strip as shown to clear the molded ridge behind the panel. Apply the felt strips as shown.

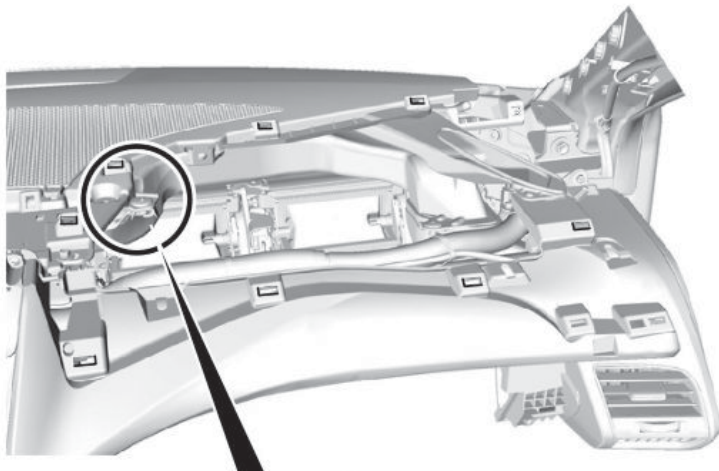
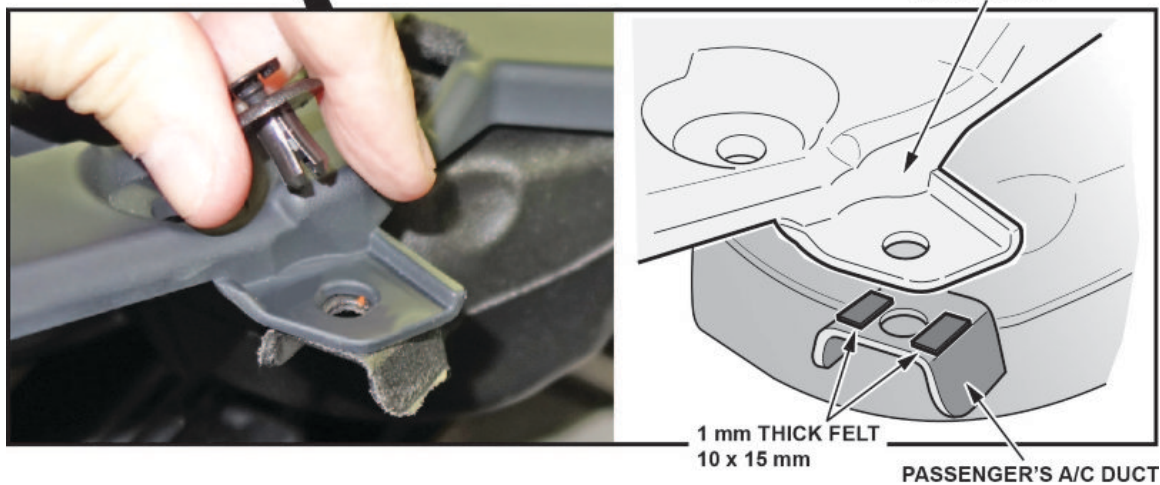
9. Remove the clip that holds the passenger's A/C duct to the dashboard as shown. Check the felt between the bottom of the dashboard panel clip hole and the top of the A/C duct clip hole. Replace the felt if it is missing or damaged.

- Remove any old felt from the dashboard.
- Clean the area with isopropyl alcohol.
- Cut and apply two 10 x 5 mm pieces of 1 mm-thick felt tape (P/N 06993-SA5-000).

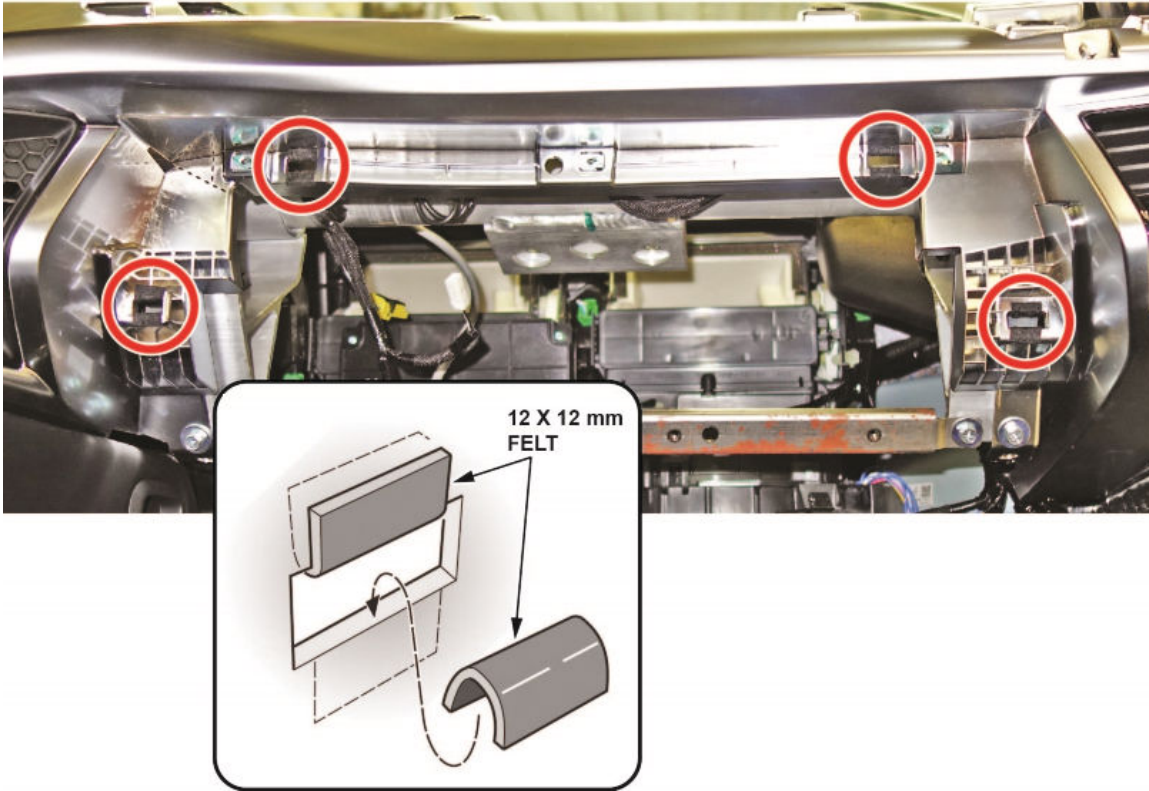
10. If there is a rattle from the glove box area, make sure felt is applied to the four clip hole locations that attach the glove box. Replace the felt if it is missing or damaged.

- Remove any old felt from the glove box.
- Clean the area with isopropyl alcohol.
- Cut and apply four 12 x 12 mm pieces of felt (P/N 06993-SA5-000) to the four clip hole locations that attach the glove box.

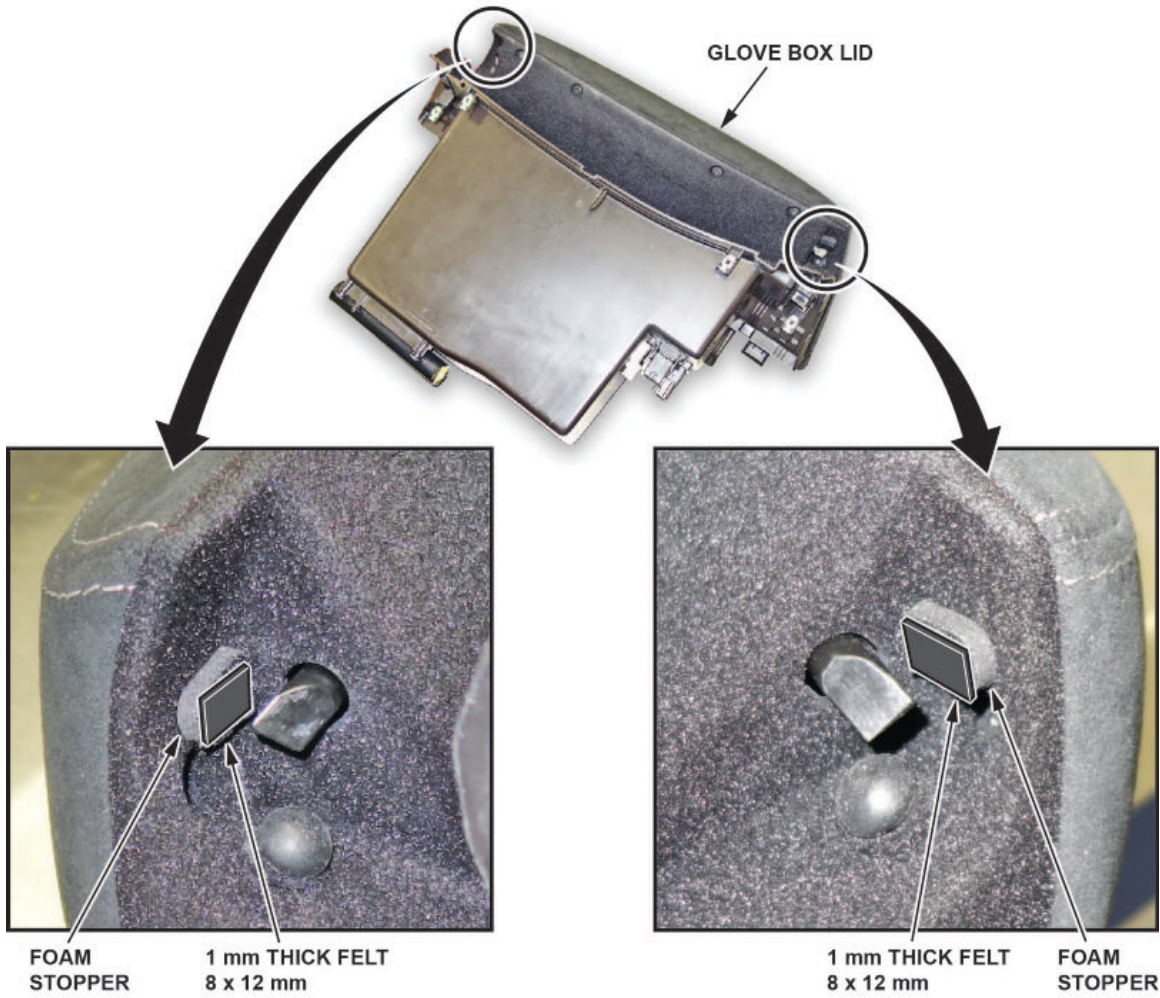
11. Make sure there is felt tape applied to the foam stoppers on the glove box door. Replace the felt if it is missing or damaged.

- Remove any old felt from the foam stoppers.
- Clean the area with isopropyl alcohol.
- Cut and apply two 8 x 12 mm pieces of 1 mm-thick felt tape (P/N 06993-SA5-000) over the existing foam stoppers in the glove box.

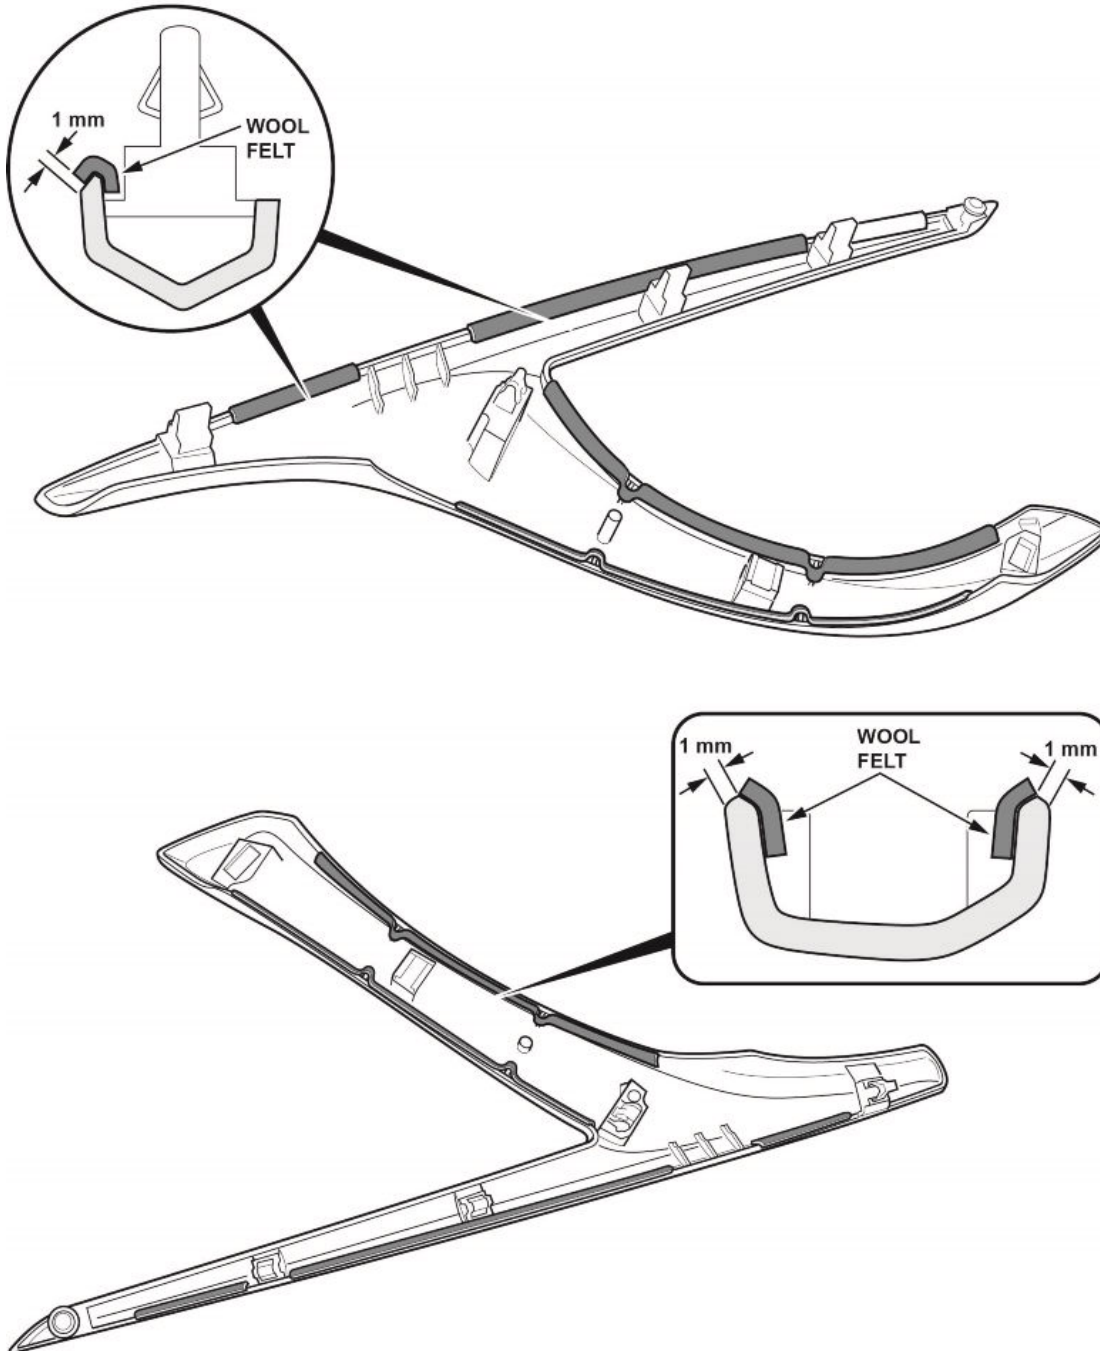
1. Remove the door grip cover. Refer to the service information.
2. Check that felt is properly applied at the edges as shown. The felt prevents the plastic trim and leather from making noise. Replace the felt with 1 mm-thick felt tape (P/N 06993-SA5-000) if it is missing or damaged.

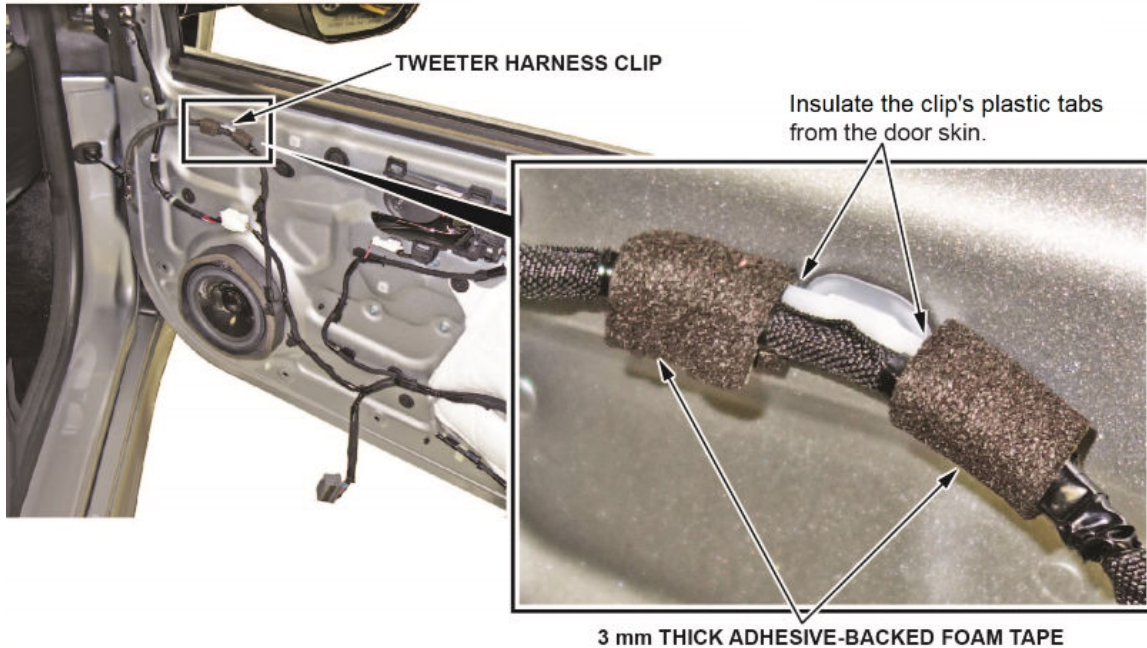
- When applying the felt, make sure it is not visible when the handle is installed.
 - Before installing the door grip cover, make sure all of the metal clips securing the handle grip cover are properly installed and undamaged. Replace any missing or damaged clips.
3. Remove the door panel. Refer to the service information.
 4. Make sure the tweeter harness clip is insulated properly with foam tape. Replace the foam tape if it is missing or damaged.

- Remove any old felt from the harness clip.
 - Clean the area with isopropyl alcohol.
 - Insulate the harness clip with 3 mm-thick foam tape (P/N 06990-SA5-000). Both plastic tabs on the harness clip should be insulated so it does not contact the door skin.
5. Install all parts in the reverse order of removal.

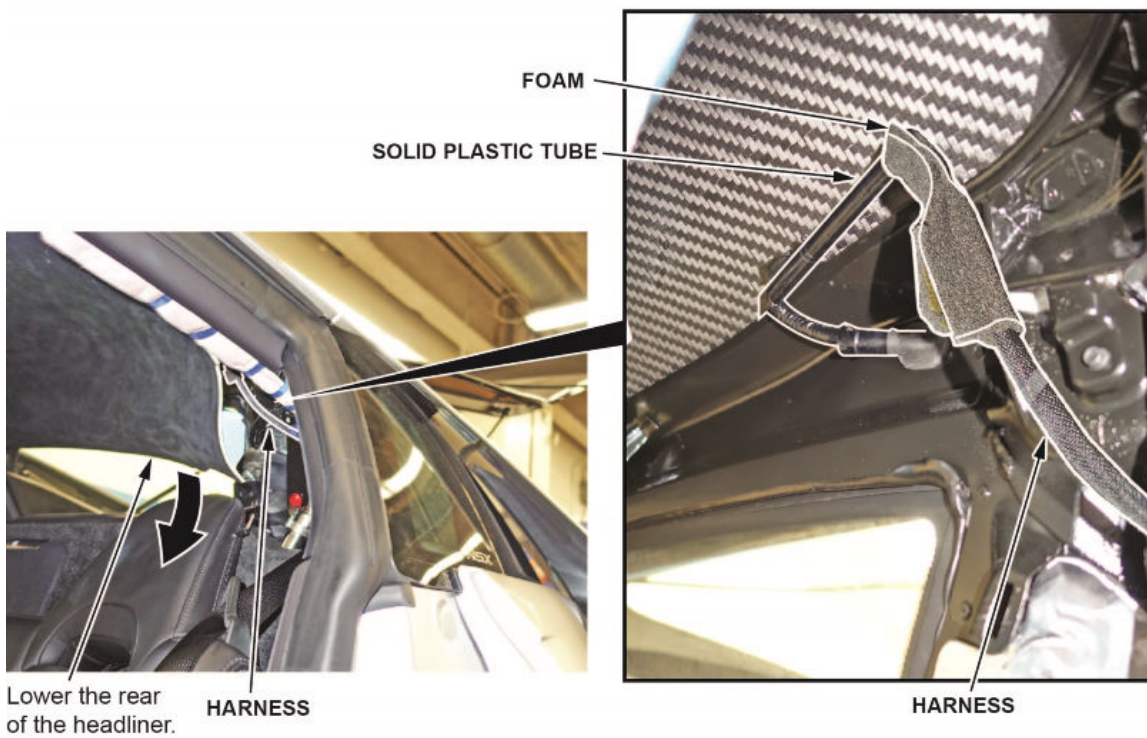
1. Remove the A-pillar trim, and lower the rear section of the headliner. Refer to the service information.
2. Check that foam is properly applied to the harness as shown. If the foam is missing or damaged, replace it.
 - Remove any old foam from the harness.
 - Clean the area with isopropyl alcohol.
 - Insulate the harness with 3 mm-thick foam tape (P/N 06990-SA5-000). Cut a 100 x 50 mm piece of foam, and wrap the harness as shown.
