NUMBER: 23-001-19 REV. B

Dash and Door Appliques Delaminating - X77 Warranty Extension

2012 - 2017 (WK) Jeep Grand Cherokee (SRT Only)

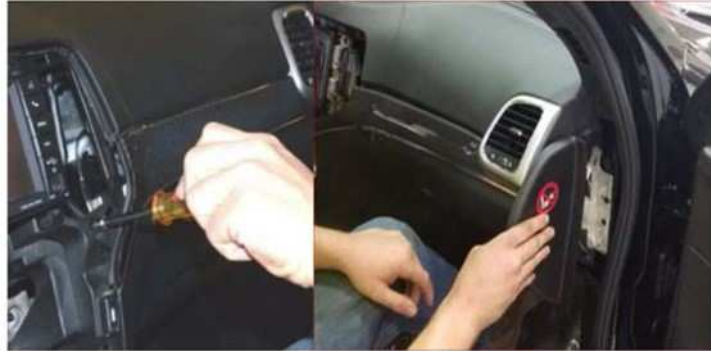
Fig. 3
Screw and End Cap

1. Remove the center IP bezel. Refer to the detailed procedures available in DealerCONNECT > Service Library under: 23 - Body/IP/Bezel, Instrument Panel, Center/Removal.
2. Using a 7 mm socket, remove one inboard screw (Fig. 3) .

3. Loosen the passenger door seal and remove the IP end cap (Fig. 3) .

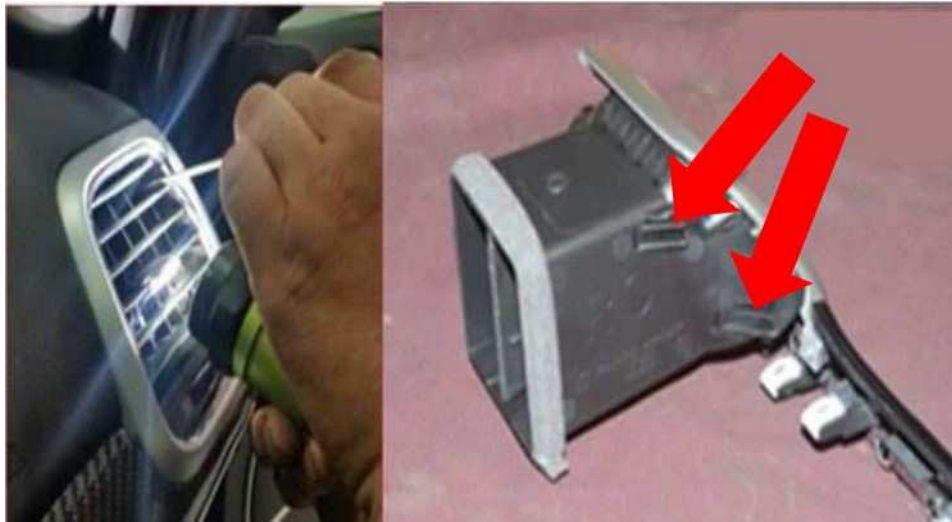
Fig. 4
Retaining Clips

- Using a hook tool or small screw driver, disengage the outboard clips. Access the clips by going through the air vent (Fig. 4) and (Fig. 5) .

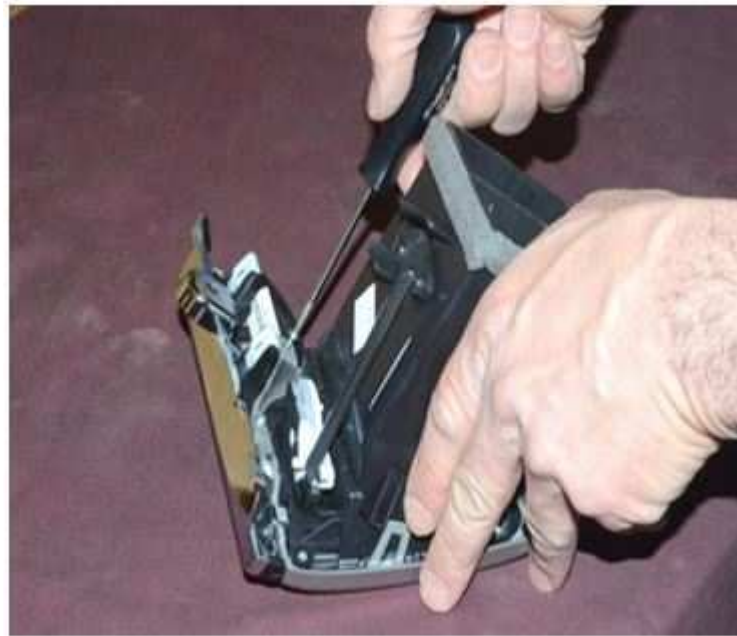
Fig. 6
Retaining Screws for the Air Vents

6. Using a T-10 Torx, remove the two screws that hold the air vent to the applique (Fig. 6) . Discard applique.

7. Using a T-10 Torx, install the air vent to the new applique with two screws.
8. Install the applique assembly to the IP by applying light pressure to the applique to engage the clips.
9. Install the one inboard screw using a 7 mm socket.
10. Install the IP end cap and door seal.
11. Install the center IP bezel. Refer to the detailed procedures available in DealerCONNECT > Service Library under: 23 - Body/IP/Bezel, Instrument Panel, Center/Installation.

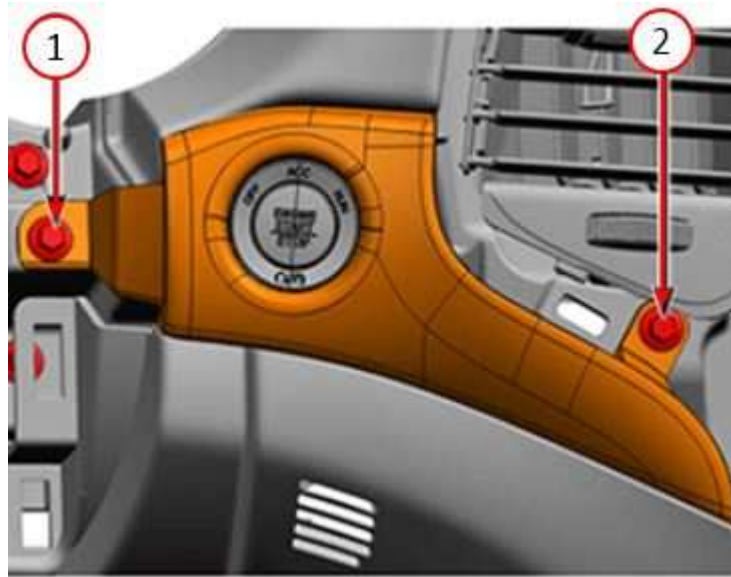
Fig. 7
7 mm Retaining Screws

- Using a 7 mm socket, remove the two screws holding the applique to the IP (Fig. 7) .

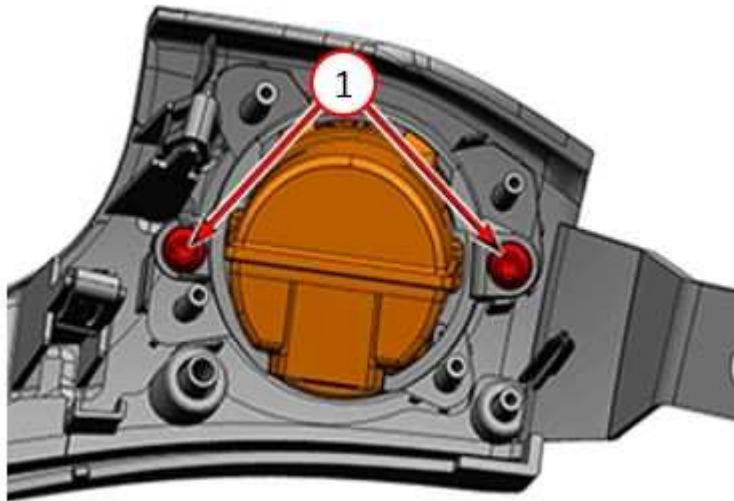
Fig. 8
KIN Trim Retaining Screws

- Disengage the remaining clips and remove the applique.
- Disengage the connector for the Keyless Ignition Node (KIN).
- Using a T-10 Torx, remove the two screws that hold the KIN to the applique (Fig. 8) . Discard applique.

- Install the KIN on the new applique with two screws.
- Reconnect the KIN connector to the back of the KIN.
- Install the new applique to the IP by pushing the applique to engage the clips.
- Using a 7 mm socket, install the two screws (Fig. 8) .

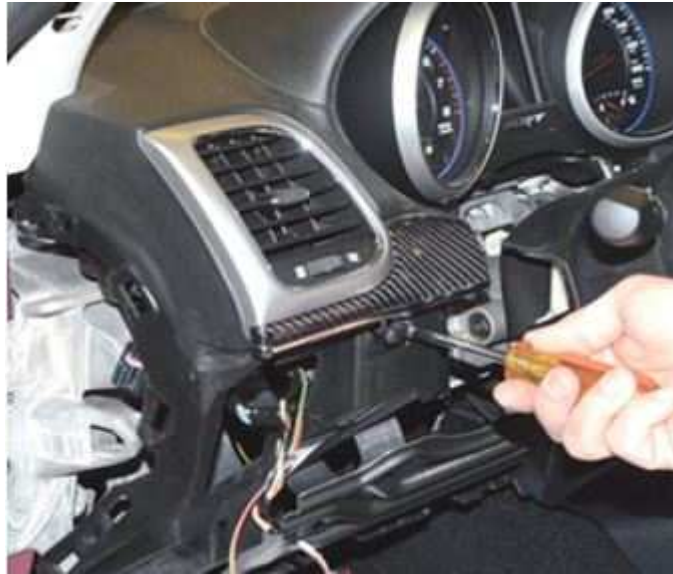
Fig. 9
Retaining Screw

1. Loosen the driver door seal and remove IP end cap.
2. Remove the knee blocker. Refer to the detailed procedures available in DealerCONNECT > Service Library under: 10 - Restraints/Air Bag, Knee Blocker/Removal.
3. Using a 7 mm socket, remove one screw (Fig. 9) .

4. Using a hook tool or small screw driver, disengage air vent outboard clips and remove applique assembly.
5. Using a T-10 Torx, remove the two screws that hold the air vent to the applique. Discard applique.
6. Install the air vent to the new applique with two T-10 Torx screws.
7. Install the applique assembly to the IP by pushing the applique to engage the clips.
8. Using a 7 mm socket, install the one inboard screw.
9. Install the knee blocker. Refer to the detailed procedures available in DealerCONNECT > Service Library under: 10 - Restraints/Air Bag, Knee Blocker/Installation.
10. Install the IP end cap and door seal.
11. Install the center stack bezel. Refer to the detailed procedures available in DealerCONNECT > Service Library under: 23 - Body/IP/Bezel, Instrument Panel, Center/Installation.

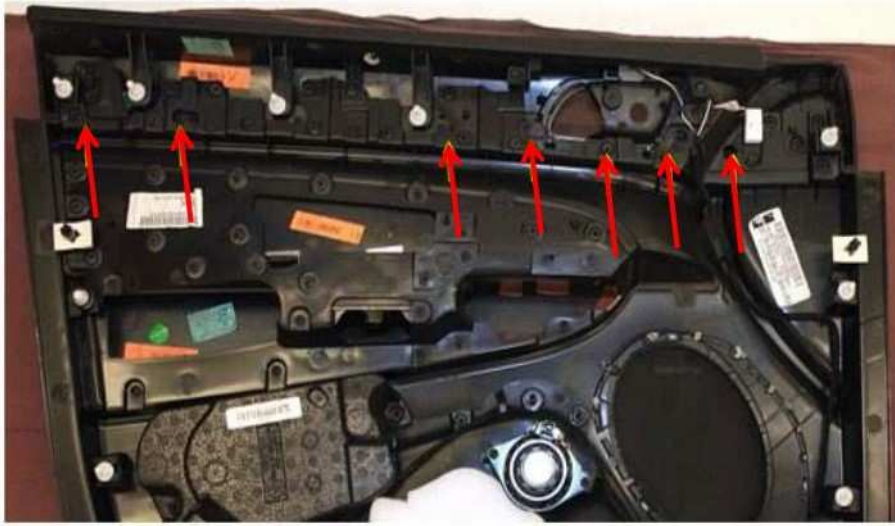
Fig. 10
Seven Retaining Screws on the Front Door Panel

2. Place the door panel on a clean surface and using a T-20 Torx remove the retaining screws that hold the applique to the door panel. Discard applique(s). Note the locations of the seven front door panel retaining screws and six screws for the rear door panel (Fig. 10) and (Fig. 11) . Repeat this step for any door panel.

3. Using a T-20 Torx, install the new applique on the door panel and tighten the seven screws. Repeat this step for any front or rear door panel.
4. Install the front or rear door panel. Refer to the detailed procedures available in DealerCONNECT > Service Library under: 23 - Body/Door - Front/Panel, Door Trim/Installation and 23 - Body/Door - Rear/Panel, Door Trim/Installation.

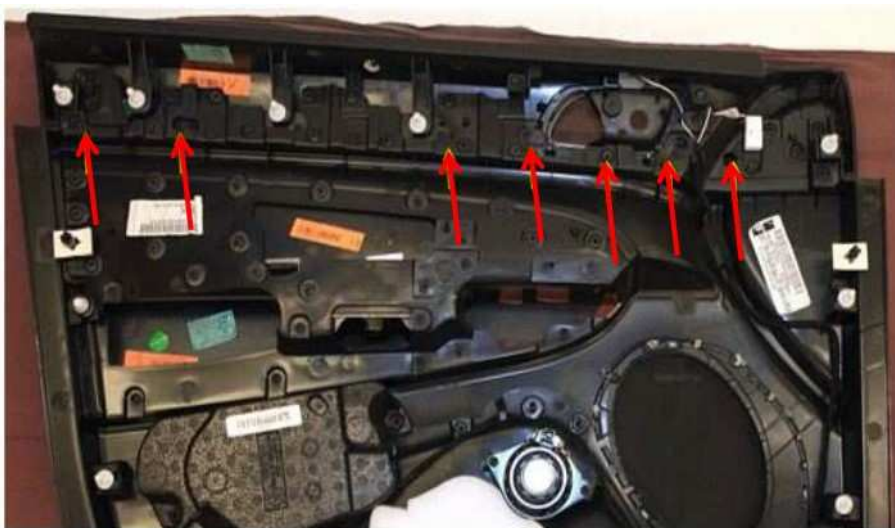
Fig. 11
Six Retaining Screws on the Rear Door Panel
